1. Policy Particulars :- THIRD PARTY CLAIM

ADJUSTMENT ON REPAIR COST FOR VEHICLE NO. SKV 1080R

PHOTOGRAPHS FOR VEHICLE NO. SKV 1080R

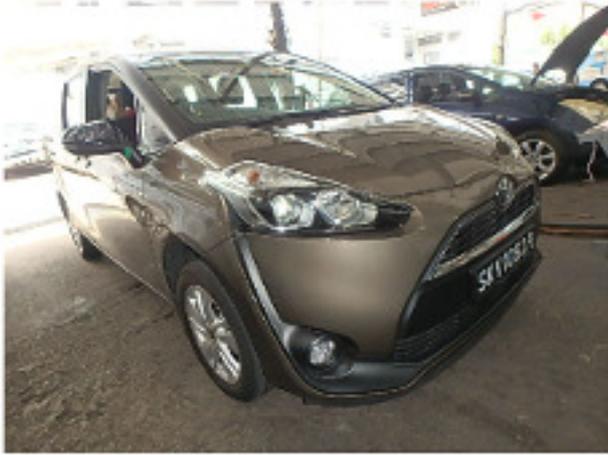
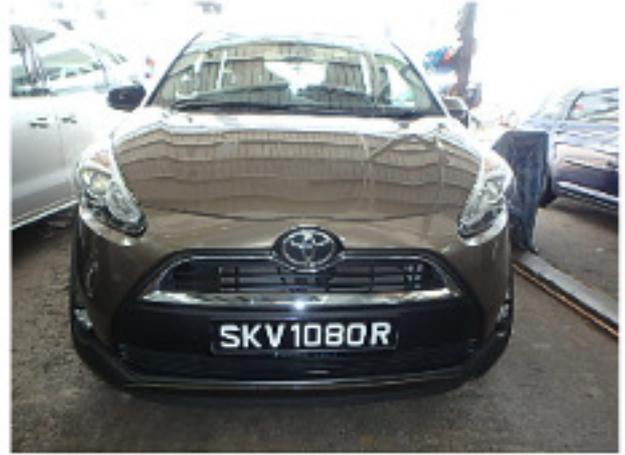
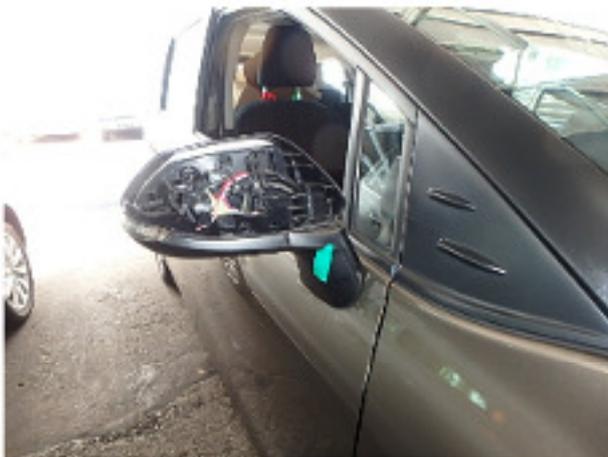
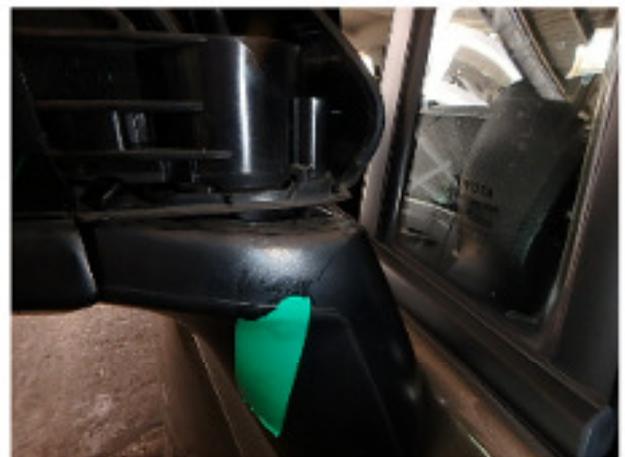
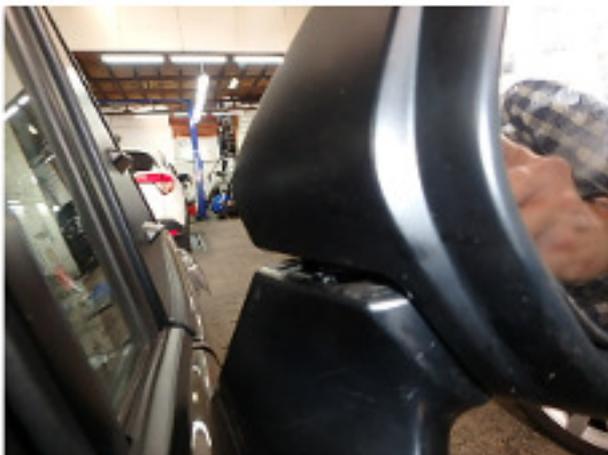
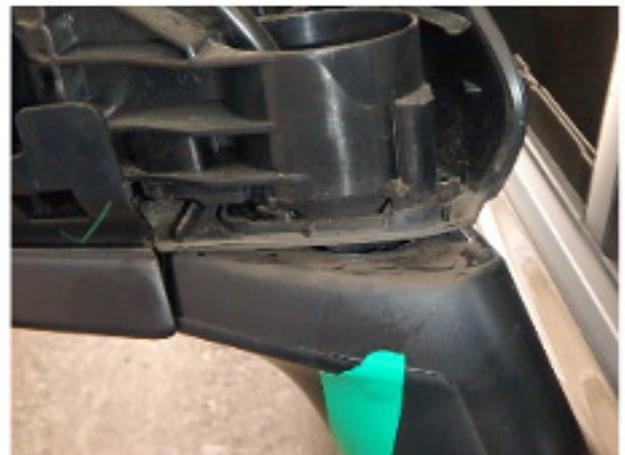
THE VEHICLE SUSTAINED DAMAGES AT THE FRONT O/S DOOR MIRROR.
DAMAGES SEE DETAILS.

Qty	Description of Parts	Condition	Estimate By Workshop (\$)	Our Adjusted (\$)
	REPLACEMENT OF PARTS			
1	RH SIDE MIRROR ASSY	CRACKED	872.20	872.20
	LESS 25% DISCOUNT		-218.05	-218.05
			654.15	654.15
	LABOUR			
	TO REMOVE & RENEW RH SIDE MIRROR .		60.00	60.00
	TO PUTTY AND SPRAY RH SIDE MIRROR BACK COVER .		50.00	50.00
			110.00	110.00
	GRAND TOTAL		764.15	764.15
RECOMMENDED COST OF REPAIRS				764.15
