Affiliated to Federation Internationale Des Experts En Automobile							
LONPAC INSURANCE BHD Ref :			Ref : CC4/LPC20010310	CC4/LPC20010310/Ebs3q2				
	BEACH ROAD 04/07 THE CONC	DURSESINGAPORE 199555	Date: 10-12-2020 Code: LPC2

1.	1. Policy Particulars :- THIRD PARTY CLAIM							
	Insured Veh.	GBD 5089S	Veh. Inspected	GBH 977R				
	Policy No.	Z19VC05003729	Coverage (\$)	0.00				
	Claim No.	19/20/20/VC05/023702	Excess (\$)	0.00				
	Assign From	ONG LI LI	Assign Date	25/09/2020

ADJUSTMENT ON REPAIR COST FOR VEHICLE NO. GBH 977R

PHOTOGRAPHS FOR VEHICLE NO. GBH 977R

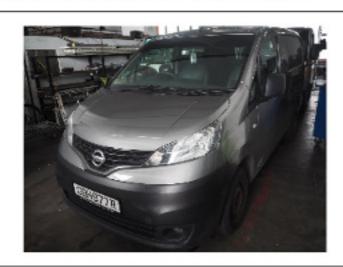
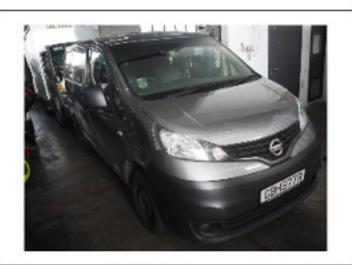
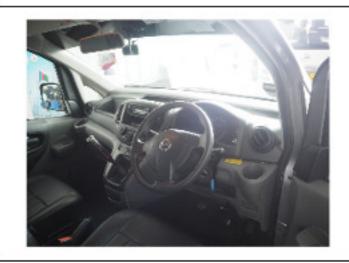
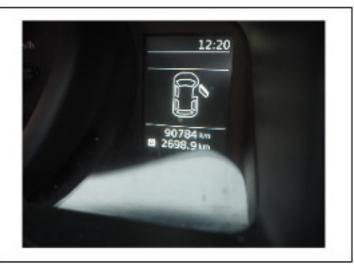
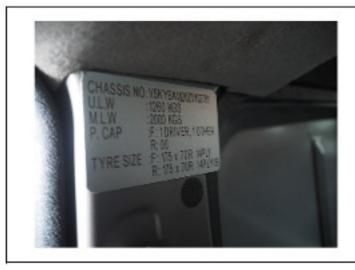
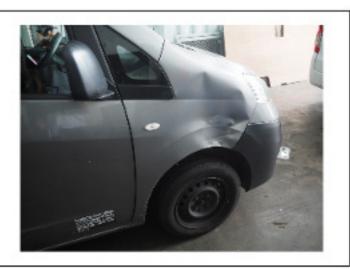
4.		Description	on of Damages					
	THE VEHICLE SU	STAINED DAMAGES AT THE FRO	ONT O/S PORTION.					
	DAMAGES SEE D	ETAILS.						
5.		General	Information					
	Accident Date	23/09/2020	Inspection Date	15/10/2020				
	Survey held at	EFFICIENT MOTOR & ENGINEE	ERING WORKS PTE LTD					
	56 LOYANG WAY #06-07 LOYANG ENTERPRISE BUILDING SINGAPORE 508775							
5a.		Re	emarks					
	A)THE INSPECTION WAS CONDUCTED ON A"WITHOUT PREJUDICE" BASIS. B)IN ACCORDANCE TO YOUR INSTRUCTIONS, WE HAVE NOT AUTHORISED REPAIRS.							
5b.	·							
	ESTIMATED NORMAL PERIOD FOR REPAIR: 3 Working Days
