SKP 9301H (HL)
DoA: 26/09/20 @ 1450

ACCIDENT INVOLVING SKP9301H [OUR CLIENT] & SMA5281M [YOUR INSURED]
ON 26/09/2020.

ESTIMATED REPAIR COSTS FOR SKP9301H

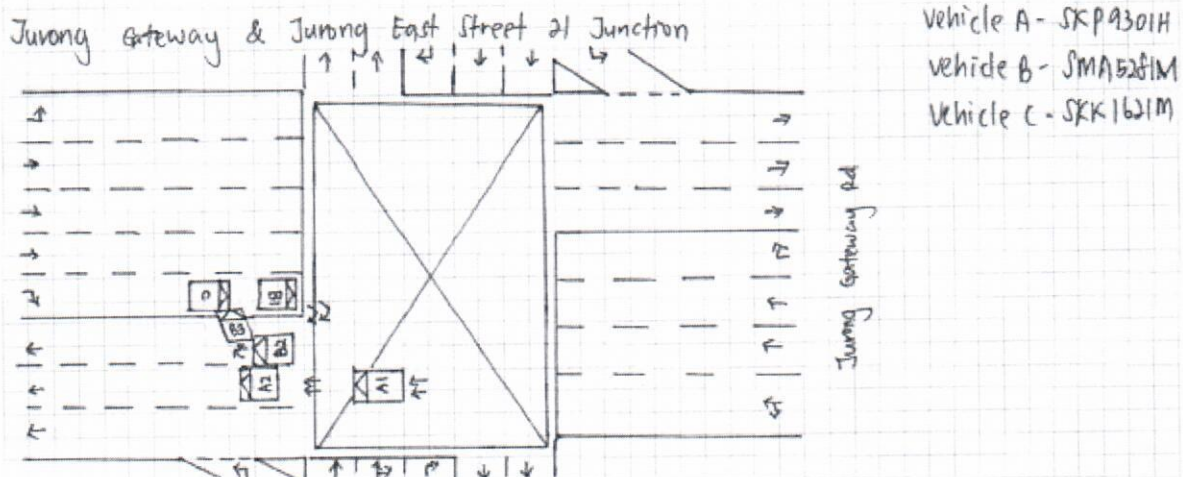
Sketch Plan #2

On the stated date and time, I, vehicle A (SKP9301H) was travelling straight along at the stated location. Suddenly, vehicle B (SMA5261M) made an U-turn and collided onto the front right portion of my vehicle, then ended up mounting the kerb and collided onto vehicle C (SKK1621M) from the opposite direction of the lane.
