CLAIMANT: GG WASTE MANAGEMENT PTE LTD

ACCIDENT INVOLVING XE256T & XE5058R & SBS3198U ON (MMDDYYYY) 28-Jul-20 ALONG TUAS AVENUE 12 AT ABOUT 1135 HOURS

VEHICLE APPRAISAL REPORT

Our Reference : KAAS/TA/6040/0256/TP/07.20
Vehicle Number : XE 256T

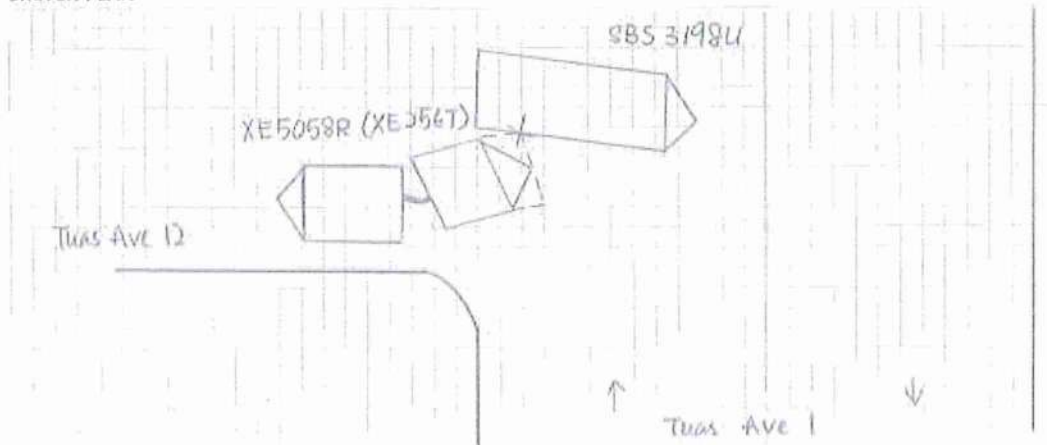
Sketch Plan #2

On 05/07/2020, my vehicle was facing some clutch problem, so it had to be towed from 80 Tuas Ave 1 to 13 Pioneer Sector 1. I followed in the tow truck XE5058R while my vehicle was being towed. However, when the tow truck was turning from Tuas Ave 1 into Tuas Ave 12, the tow truck suddenly stopped. I then alighted from the tow truck and saw that my vehicle had hit onto a turning bus. No injury. That's all.

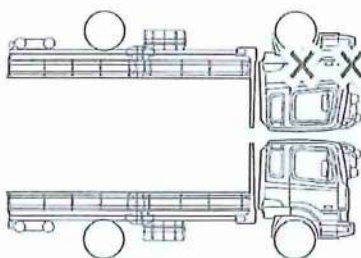
Damages sustained were consistent with the subject vehicle being involved in a collision with another vehicle and the impact was delivered Diagonally to the LH Side from rear to front; left to right; portion of the vehicle.

The general area of damages is at the LH Side portion
(Please refer to the parts list and photographs as attached for more information)

The estimated repair costs submitted by Messrs R&S Engineering Works Pte Ltd is \$ 41,157.58 .
We have adjusted the cost to \$ 30,785.12 and the repairer has agreed to undertake the repairs at a
Contract Lump Sum of \$ 24,600.00 to a acceptable quality and standards.
However, we have not given authorization and instruction to the repairer to proceed with the repairs.

The repairs should be completed within a reasonable period of 8 working days.
