ACCIDENT ON 11/05/2020 INVOLVING VEHICLE NO. SDZ 848L and VEHICLE NO. SJF1476D
ALONG KAKI BUKIT ROAD 4, SYNERGY@KB, SINGAPORE 417800.

AUTOMOBILE ASSESSMENT REPORT

Assessment of Vehicle No : SDZ 848L
Date of Accident : 11/05/2020
Date of Inspection : 12/05/2020

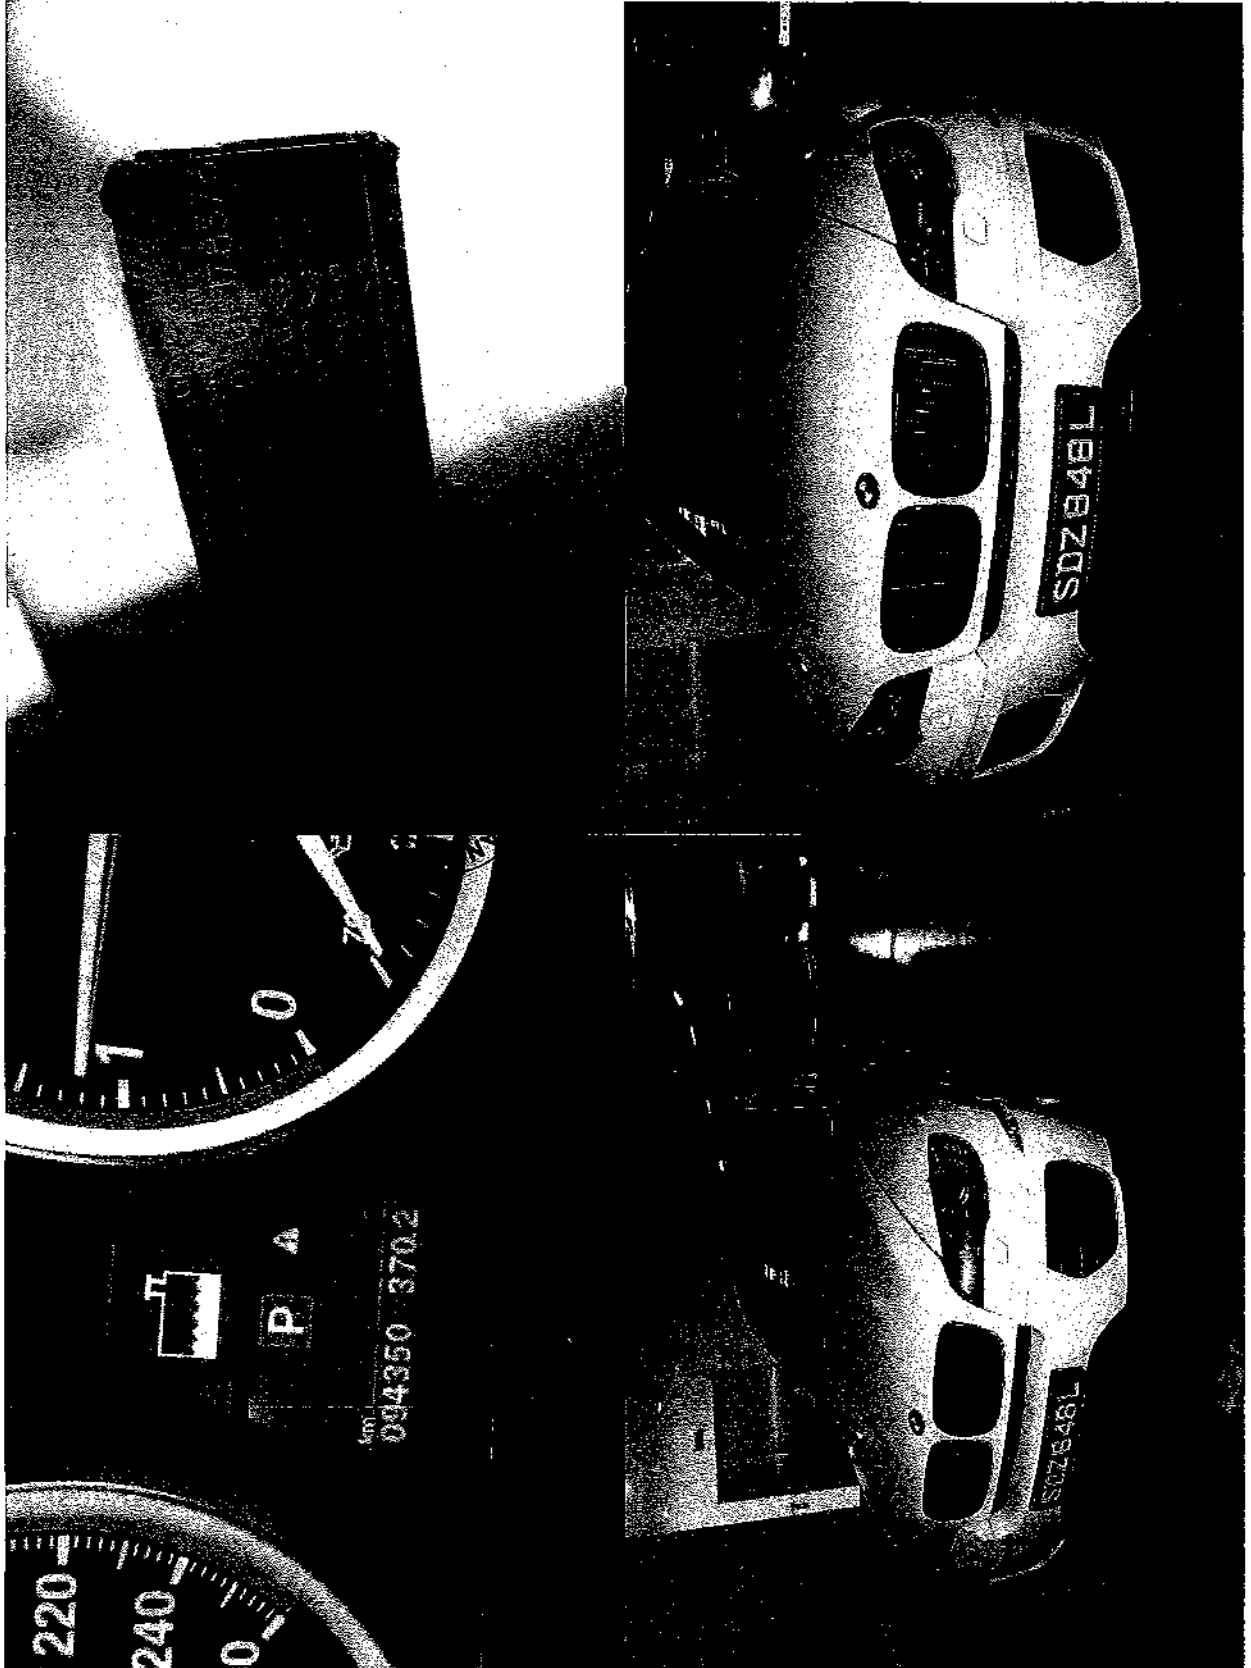
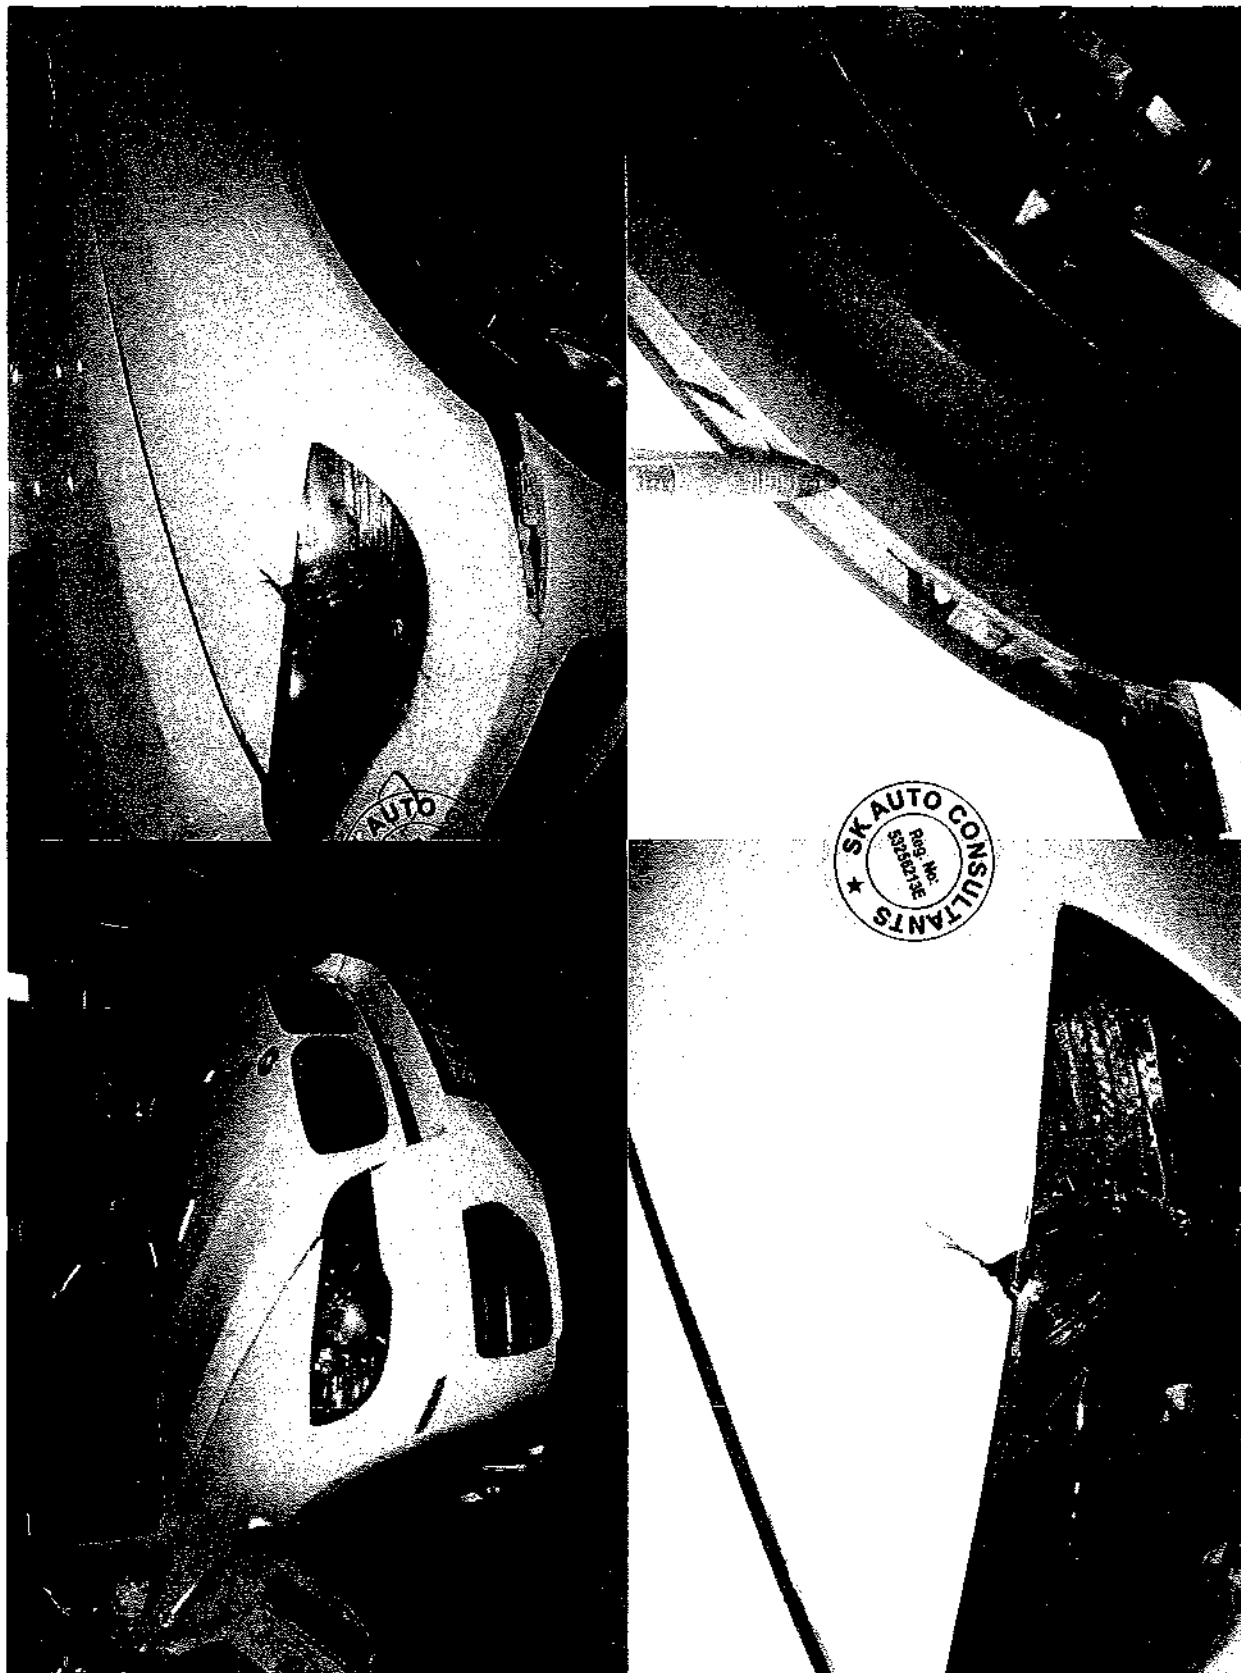
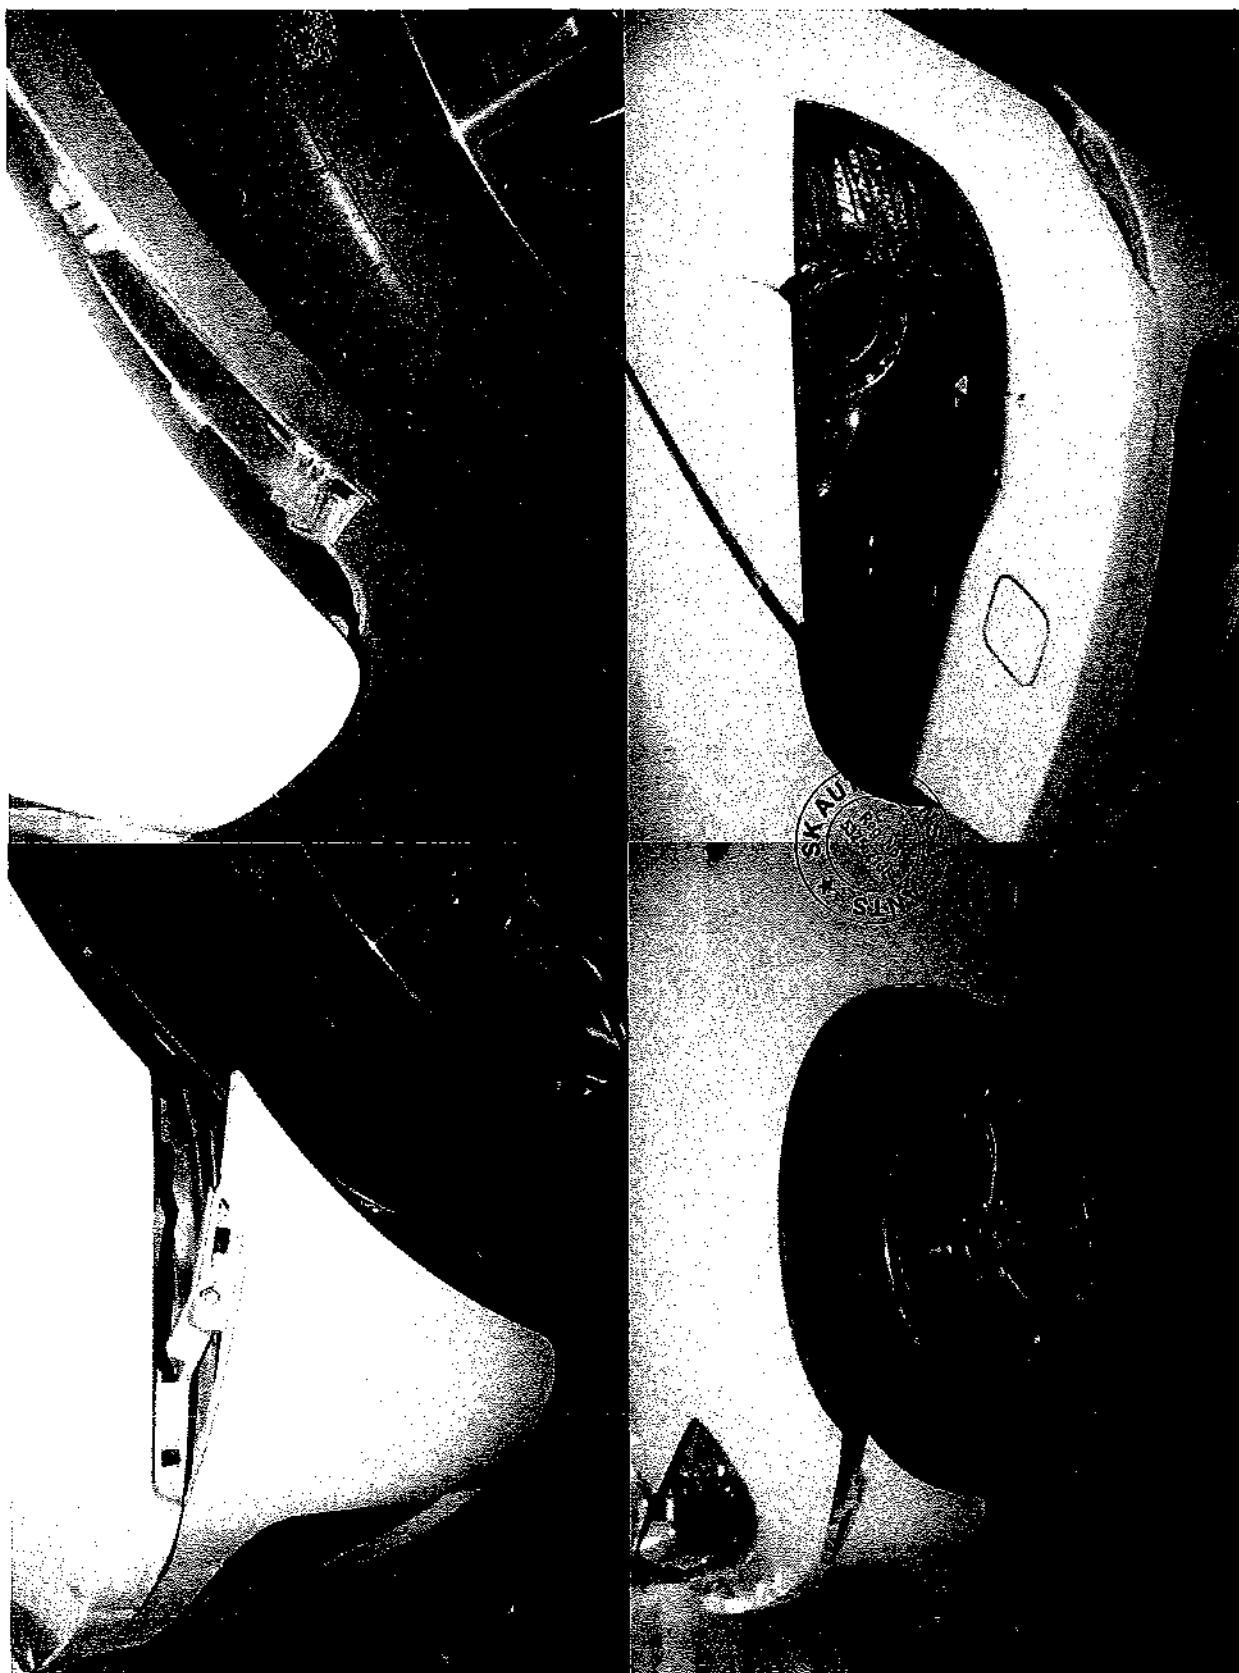
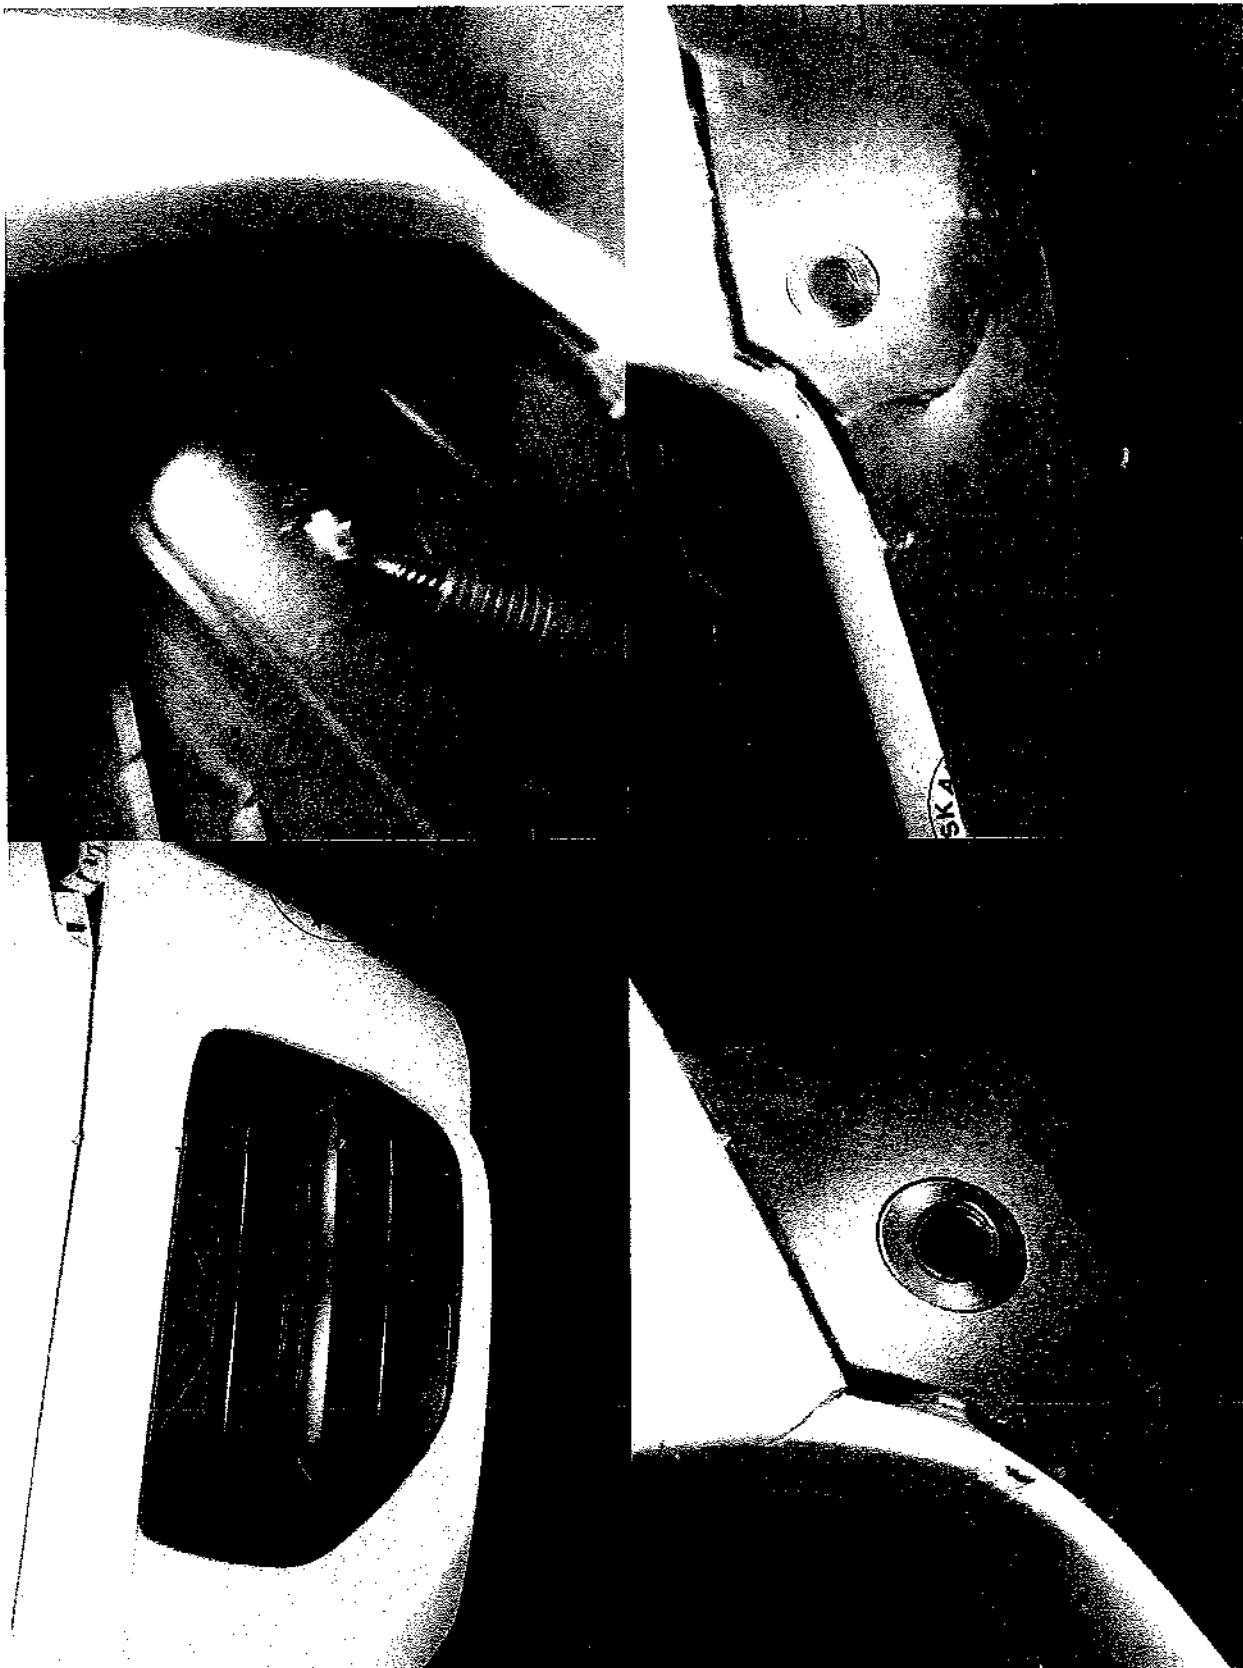
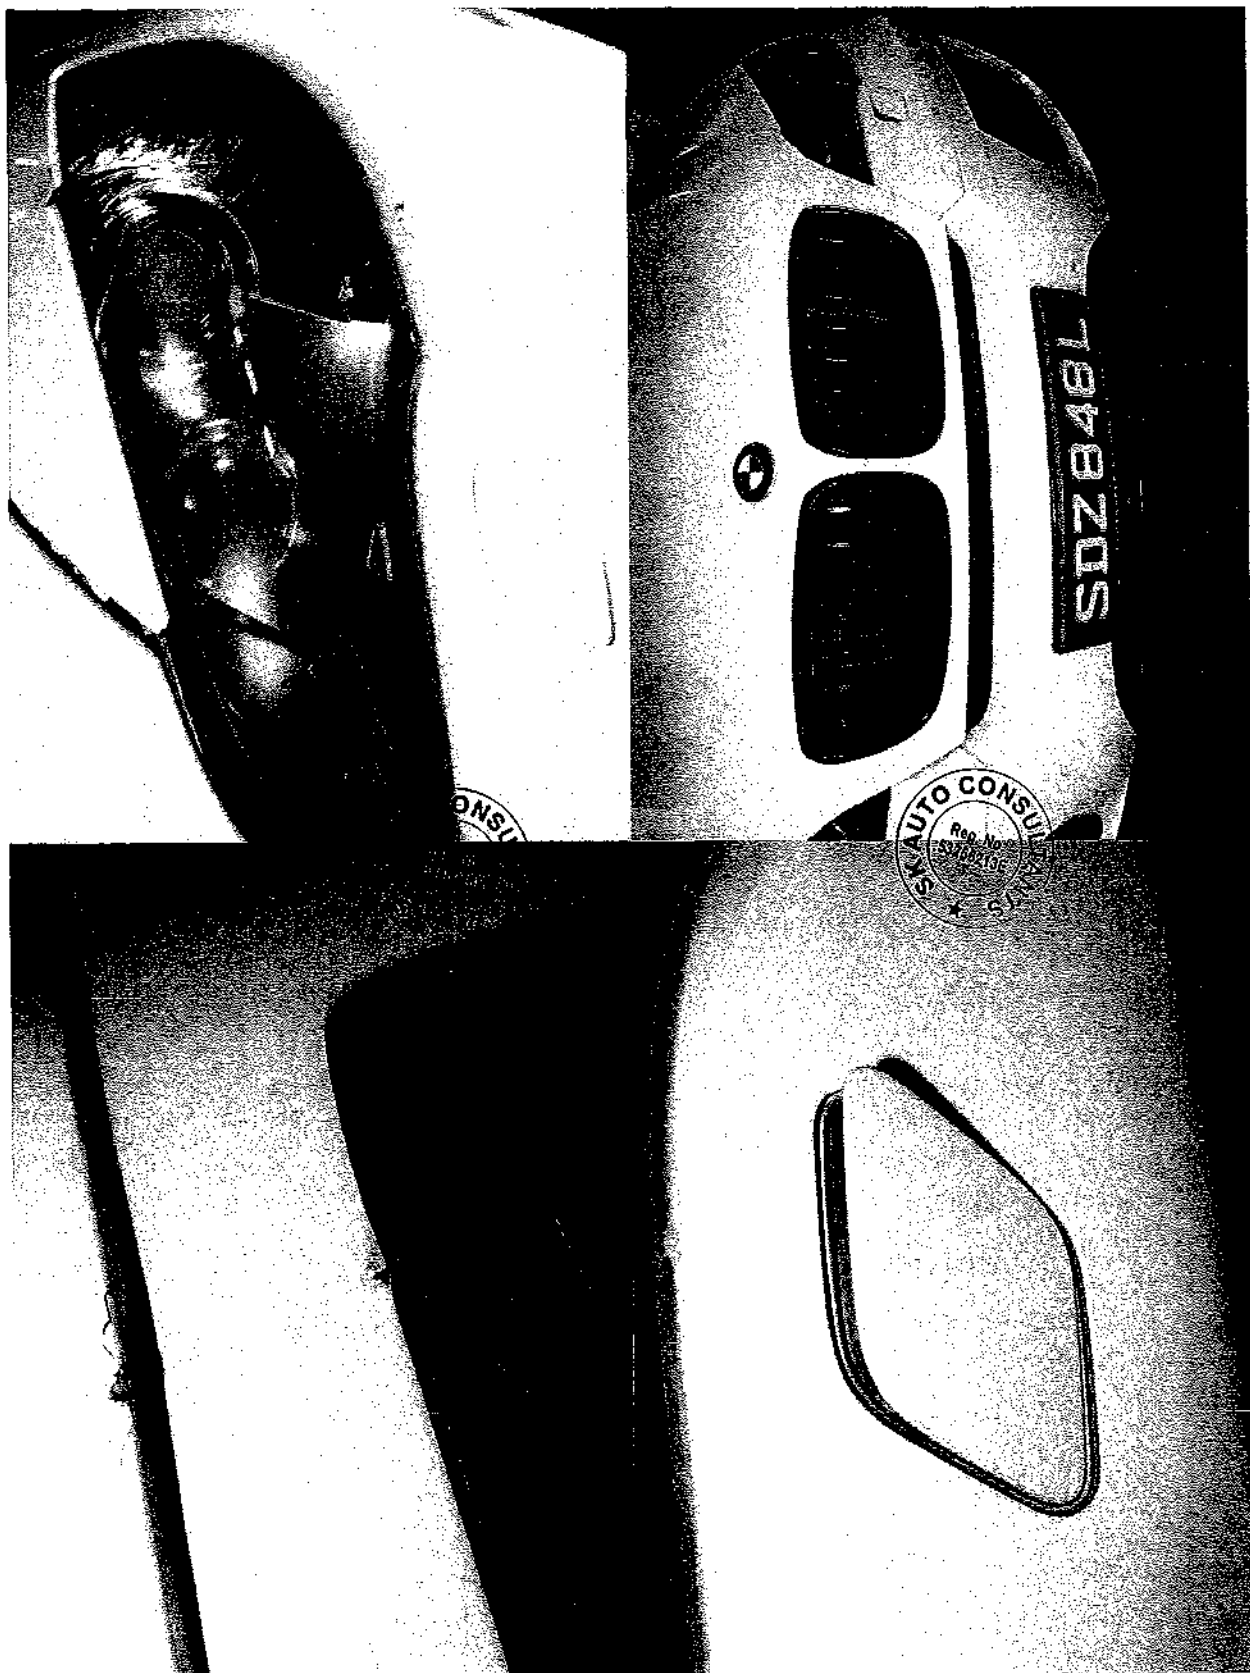
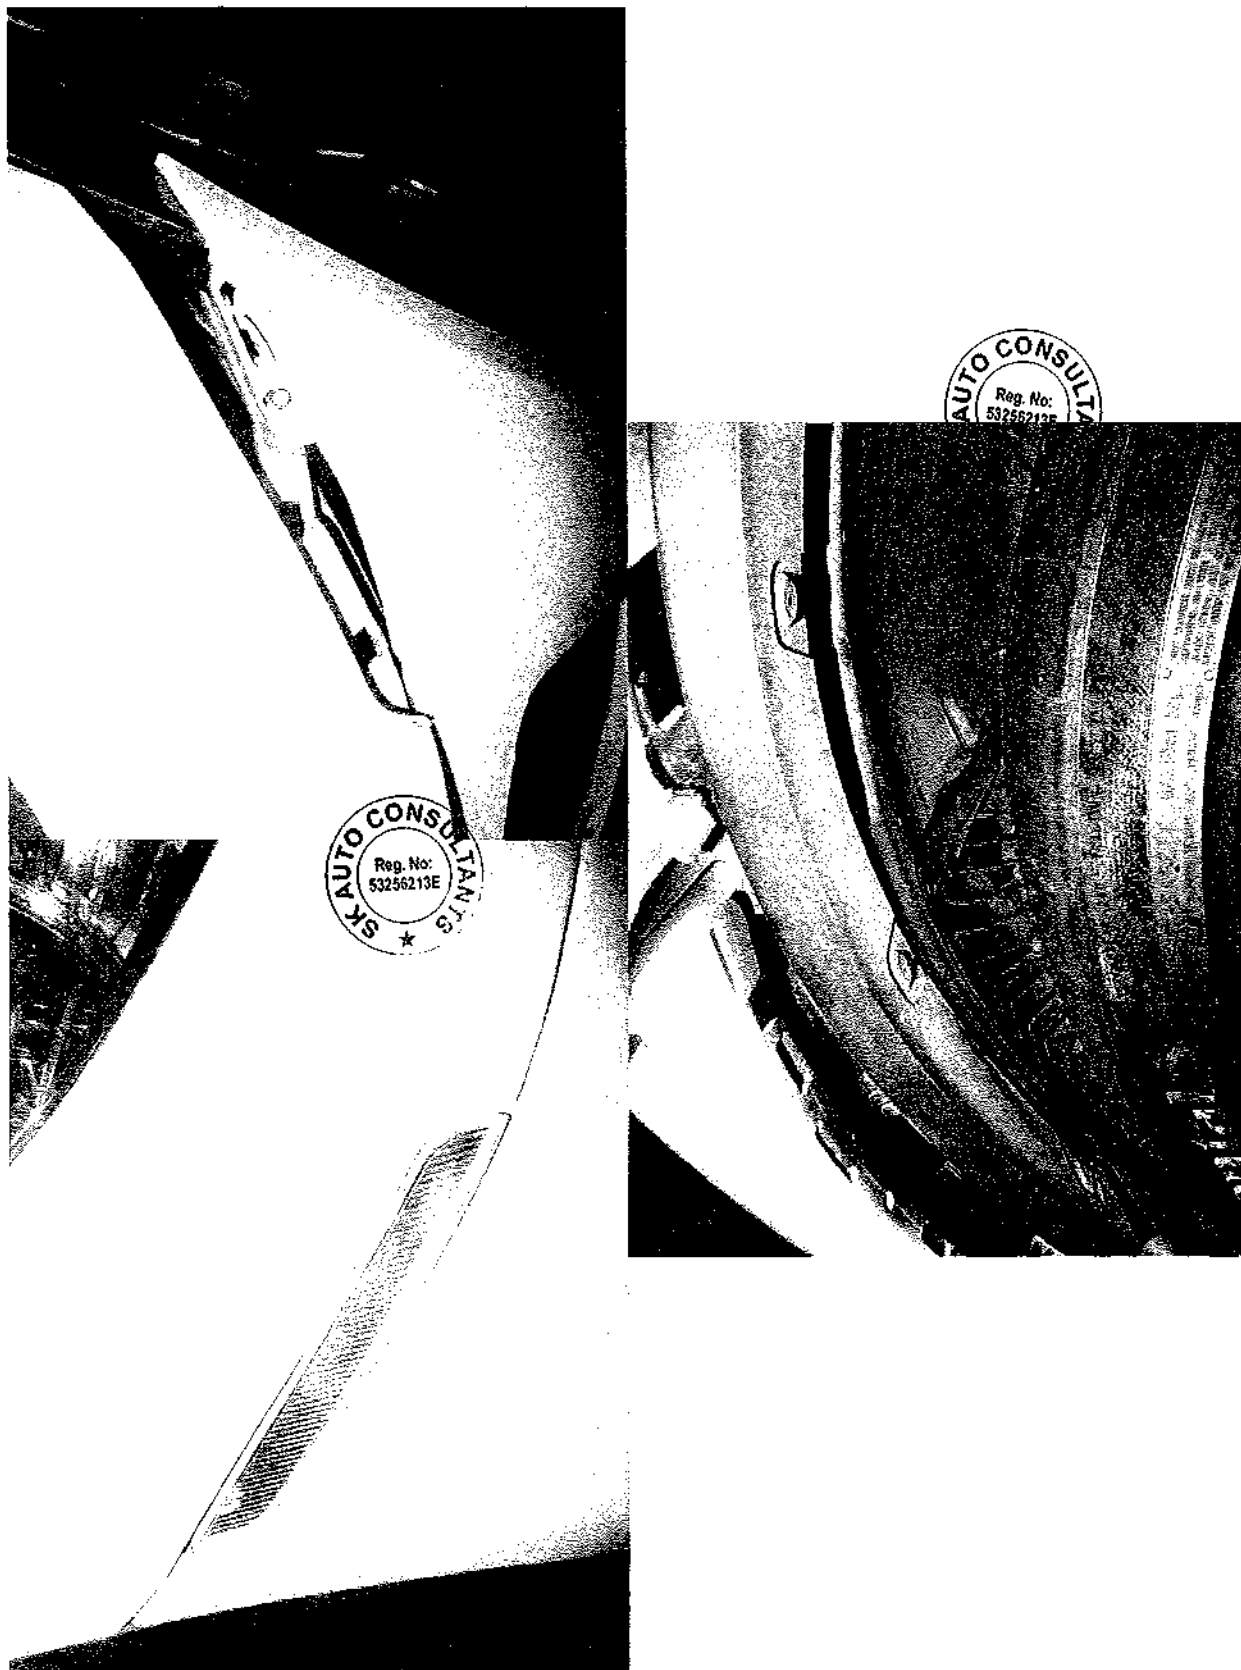
VEHICLE REGN.NO. SDZ 848L

At the time of inspection observed that this vehicle had sustained damages to the FRONT (Left side) portion
(There was a hard impact on the front left side portion with damages induced into the internal parts on the left side of the car)

Estimated Amount : S\$27,235.31
Adjusted Amount : S\$22,500/-
Estimated Repair Days* : 10 days
*(including spray painting and work process)
