LKK Auto Consultants Pte Ltd

Vehicle No. SKX 7899X

ADJUSTMENT ON REPAIR COST FOR VEHICLE NO. SKX 7899X

PHOTOGRAPHS FOR VEHICLE NO. SKX 7899X

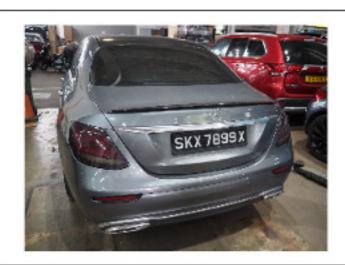
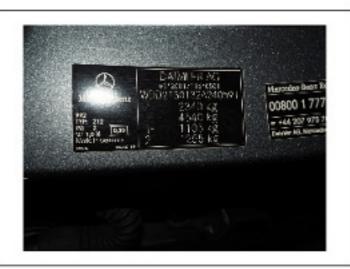
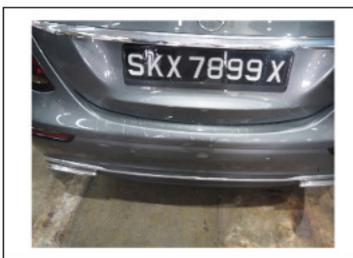
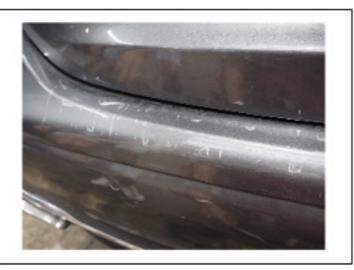
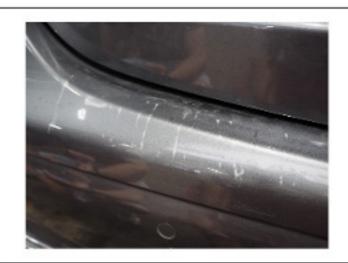
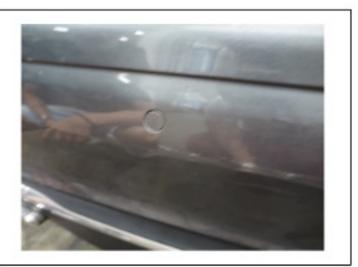
4.		<u> </u>	on of Damages			
	THE VEHICLE SU	STAINED DAMAGES AT THE REA	AR PORTION.			
	DAMAGES SEE D	ETAILS.				
5.		General	Information			
	Accident Date	22/10/2020	Inspection Date	23/10/2020		
	Survey held at	ADVANCE AUTO GARAGE				
		23 KAKI BUKIT AVENUE 4 #04-0	01 AAS KAKI BUKIT CENT	RE SINGAPORE 415933		
5a.		Re	emarks			
	A)THE INSPECTION WAS CONDUCTED ON A"WITHOUT PREJUDICE" BASIS. B)IN ACCORDANCE TO YOUR INSTRUCTIONS, WE HAVE NOT AUTHORISED REPAIRS.					
5b.	Estimate Days of Repair					
	ESTIMATED NORI	MAL PERIOD FOR REPAIR:	4 Work	ing Days

Qty	Description of Parts	Condition	Estimate By Workshop (\$))	Our Adjusted (\$)
	REPLACEMENT OF PARTS			
1	REAR BUMPER	DEFORMED	1,685.00	1,685.00
2	REAR BUMPER SIDE SHOLDER @\$86.00	NOT NECESSARY	172.00	-
1	REAR BUMPER LOWER GARNISH	DEFORMED	325.00	325.00
1	REAR BUMPER LOWER GARNISH CHROME MOULDING	CUT	362.00	362.00
2	REAR BUMPER SIDE REFLECTOR @\$64.00	CRACKED	128.00	64.00
1	REAR BUMPER REINFORCEMENT	TO REPAIR SEE LABOUR	763.00	-
4	REVERSE SENSOR @\$265.00	DAMAGED (2 PCS ONLY)	1,060.00	530.00
1	REAR END PANEL	TO REPAIR SEE LABOUR	1,350.00	-
1	REAR END PANEL TOP GARNISH	DEFORMED	172.00	172.00
2	TAILLAMP @\$725.00	N/S CRACKED	1,450.00	725.00
1	BOOTLID	TO REPAIR SEE LABOUR	2,402.00	-
1	BOOTLID LOCK	NOT NECESSARY	295.00	-
1	BOOTLID WEATHERSTRIP	NOT NECESSARY	325.00	-
1	MERCEDES BENZ LOGO	NECESSARY	90.00	90.00
2	REAR EXHAUST CHROME PIPE @\$345.00	NOT NECESSARY	690.00	-
	LESS 10% DISCOUNT		-1,126.90	-395.30
			10,142.10	3,557.70

270.00	70.00
	<u>LABOUR</u>			
	PANEL BEATING ,REMOVE AND REFIT PARTS.INCLUSIVE OF THE REPAIR OF REAR BUMPER REINFORCEMENT,REAR END PANEL AND BOOTLID.		1,000.00	500.00
	SPRAY PAINTING TO AFFECTED AREA.		800.00	500.00
