AUTOMOBILE INSPECTION REPORT OF ACCIDENT VEHICLE SJV 3864U INSURED VEHICLE SHD 8643B ACCIDENT ON 26/10/2020

PHOTOGRAPHS FOR VEHICLE NO. SJV 3864U

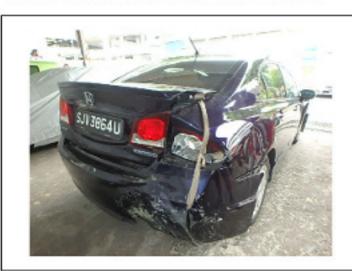
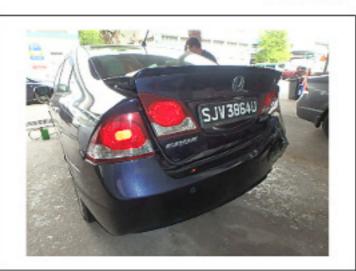
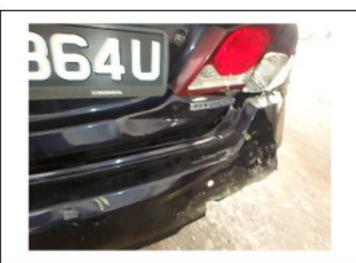
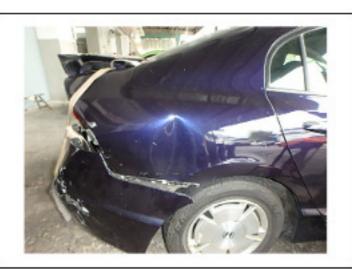
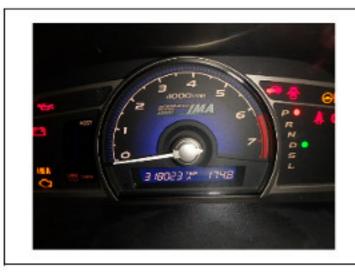
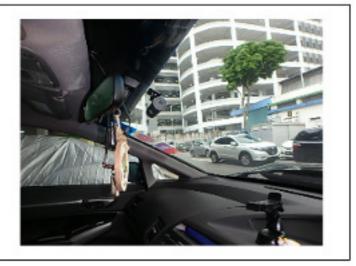
The vehicle sustained damages at the rear o/s and front portion. The Estimated repair cost of such vehicle is \$\$19,284.16 (Sin Dollars: Nineteen Thousand Two Hundred Eighty four and sixteen cents only.) (Exclude check items \$\$7,625.44 Nett) (Details see photographs enclosed)

In view of this repair work, we are of the opinion that it would be **uneconomical** to proceed with the repairs and recommend it's to be written off as "**uneconomical Total Loss**".
