Affiliated to Federation Internationale Des Experts En Automobile				
MS FIRST CAPITAL INSURANCE LTD 36 ROBINSON ROAD #16-01 CITY HOUSESINGAPORE 068877			Ref: CC4/FCI20012085/Kga3q2	
			Date: 16/02/2022	
			Code: FCI2

ADJUSTMENT ON REPAIR COST FOR VEHICLE NO. SJR 5609Z

PHOTOGRAPHS FOR VEHICLE NO. SJR 5609Z

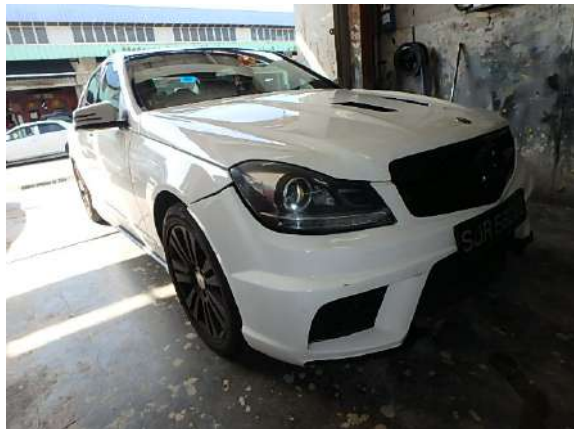
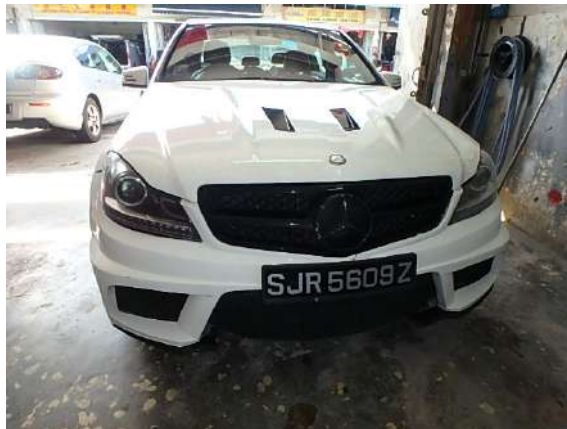
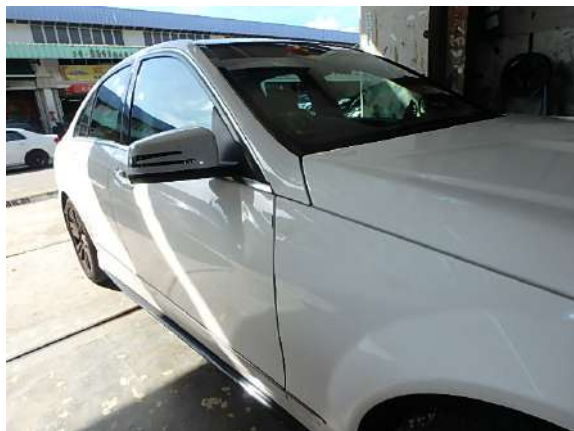
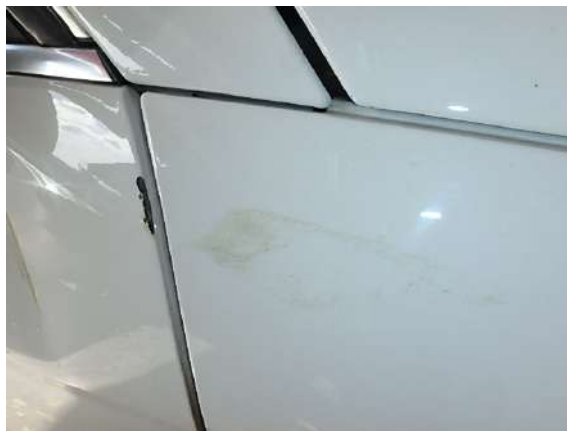
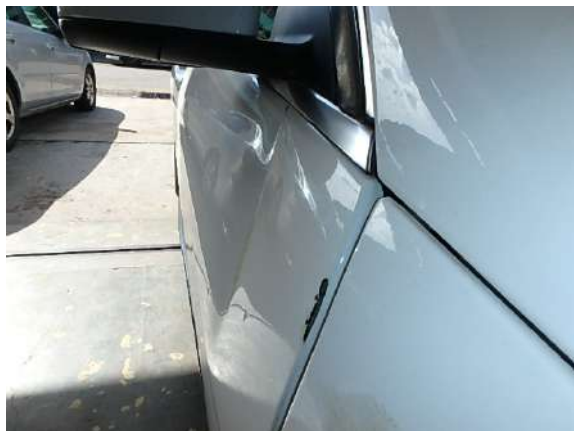
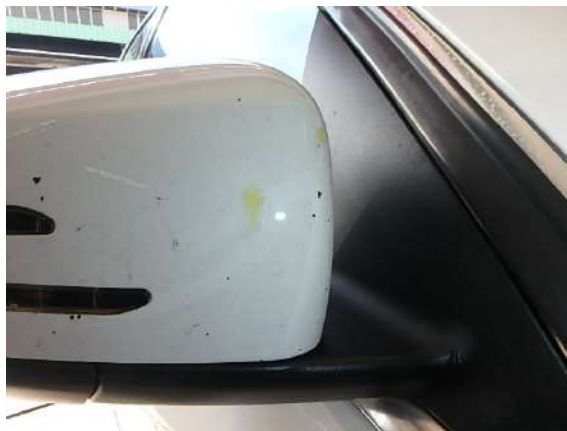
4. Description of Damages				
THE VEHICLE SUSTAINED DAMAGES AT THE O/S FRONT PORTION. DAMAGES SEE DETAILS.				
5. General Information				
Accident Date	31/10/2020	Inspection Date	03/05/2021	
Survey held at	CHENG HOE MOTOR PL BLK 1019 YISHUN IND. PARK A #01-374/382 SINGAPORE 768761			
5a. Remarks				
A)THE INSPECTION WAS CONDUCTED ON A"WITHOUT PREJUDICE" BASIS. B)IN ACCORDANCE TO YOUR INSTRUCTIONS, WE HAVE NOT AUTHORISED REPAIRS.				
5b. Estimate Days of Repair				
ESTIMATED NORMAL PERIOD FOR REPAIR:			3 Working Days

Qty	Description of Parts	Condition	Estimate By Workshop (\$)	Our Adjusted (\$)
	<u>REPLACEMENT OF PARTS</u>			
1	FRONT RH DOOR (N)	BENT	2,045.00	2,045.00
1	FRONT RH DOOR MOULDING (N)	DENTED	210.00	210.00
1	FRONT RH FENDER (N)	TO REPAIR SEE LABOUR	725.00	-
1	FRONT RH FENDER MOULDING (N)	NECESSARY	75.00	75.00
	LESS 10% DISCOUNT		-305.50	-233.00
			2,749.50	2,097.00
1	FRONT RH DOOR INNER RUBBER (50%) (SN)	NECESSARY	328.00	164.00
	LESS 10% DISCOUNT		-32.80	-

295.20	164.00
	<u>LABOUR</u>			
	REMOVE & REFIX FRT RH FENDER ,FRT RH DOOR ,SIDE MIRROR ,KNOCK & REPAIR FRT RH FENDER ,TRANSFER DOOR ATTACHMENT & REALIGN THE SAME.INCLUSIVE OF THE REPAIR OF FRONT RH FENDER.		500.00	400.00
	REMOVE & REFIX FRT RH DOOR GLASS ,CHECK CENTRAL LOCKING & POWER MIRROR .		60.00	60.00
	PUTTY & RESPRAY ON FRT RH FENDER ,SIDE MIRROR COVER ,FRT RH DOOR .		600.00	500.00
	RUSTPROOFING.		30.00	30.00
			1,190.00	990.00
GRAND TOTAL			4,234.70	3,251.00
RECOMMENDED COST OF LUMP SUM REPAIRS (TO ITS PRE-ACCIDENT CONDITION)				2,600.00
