Vehicle No. GBK 2932R  
Insured Veh. YN 185E  
Claim No. 20/20/20/VC00/023871  
Policy No. Z/20/VC00/108652  
Accident Date 04/11/2020  
Inspection Date 12/11/2020

| Affiliated to Federation Internationale Des Experts En Automobile | | | | |
|---|---|---|---|---|
| <b>1. Policy Particulars :- THIRD PARTY CLAIM</b> | | | | |

## ADJUSTMENT ON REPAIR COST FOR VEHICLE NO. GBK 2932R

### PHOTOGRAPHS FOR VEHICLE NO. GBK 2932R

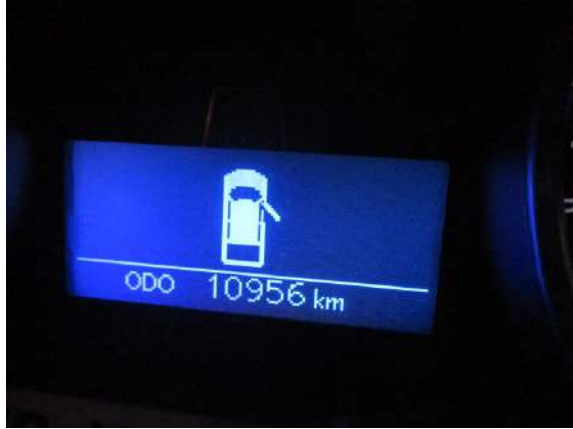
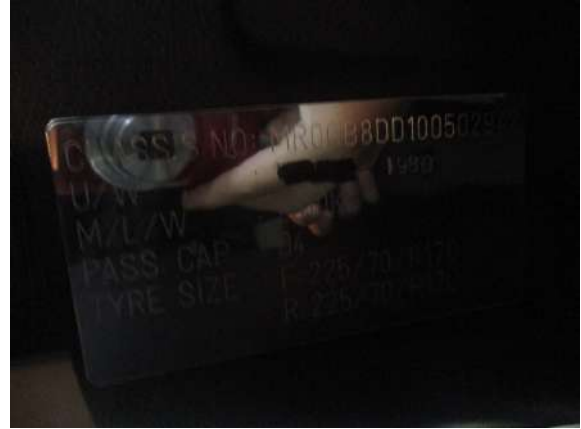
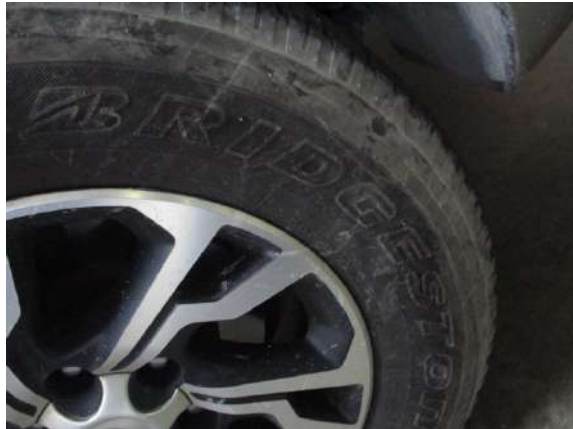
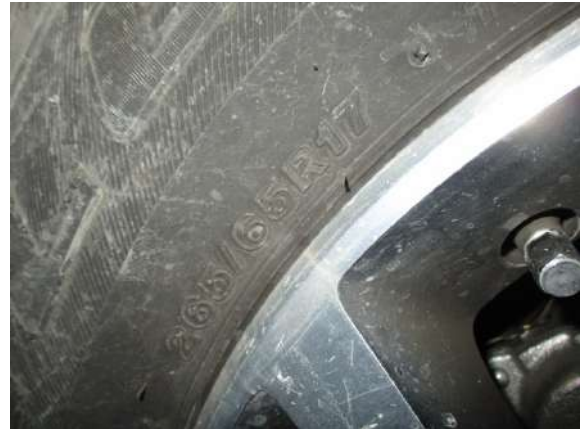
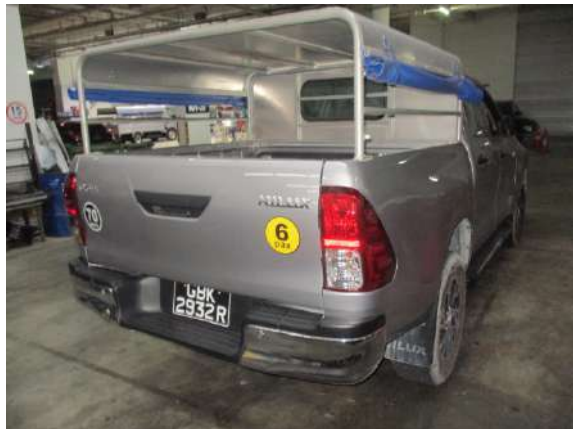
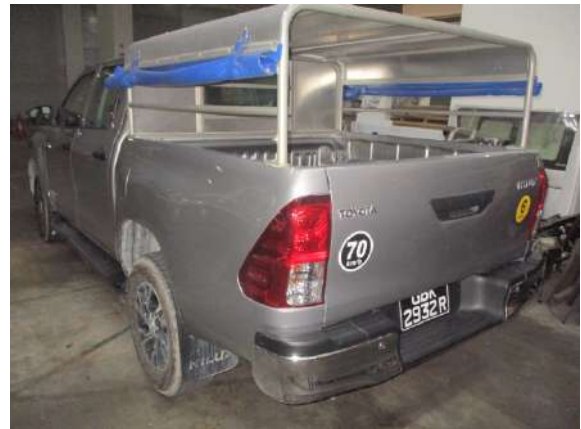
### INSPECTION

| Affiliated to Federation Internationale Des Experts En Automobile | | | | |
|---|---|---|---|---|
| THE VEHICLE SUSTAINED DAMAGES AT THE REAR PORTION.<br><br>DAMAGES SEE DETAILS. | | | | |
