From: Jasper Chua (LKK Auto)
Sent: May 7, 2021 6:06 PM
To: Chongmeng Ng
Subject: Sgh5454R/ sha3797P

The accident happened along the slip road of Jalan Bukit Merah leading towards Tiong Bahru Road. Traffic flow usually is quite heavy. This is a head to rear collision, where you mention that damages to third party taxi is minimal. The below are the considerations of the collision :

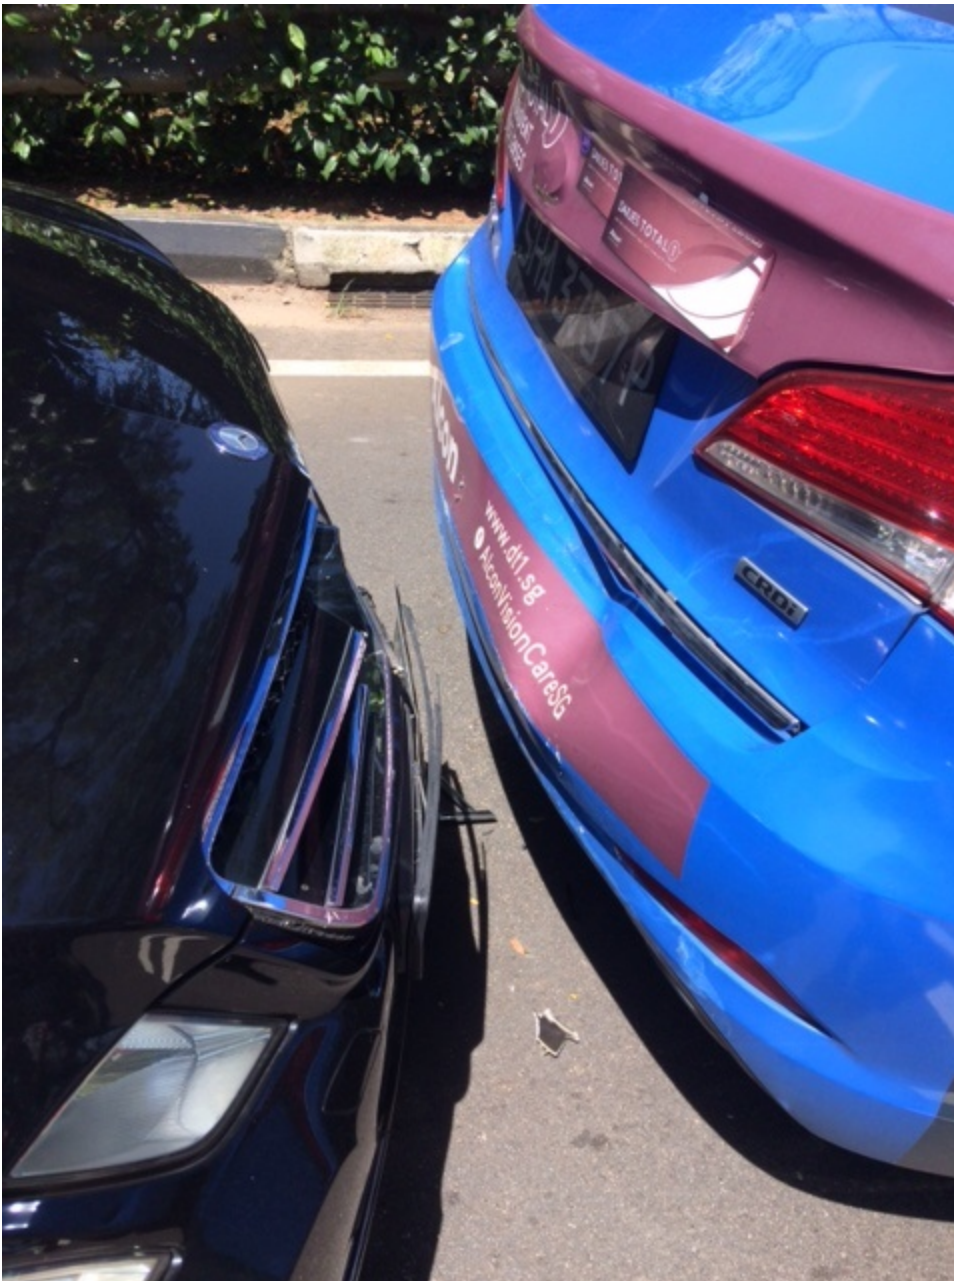
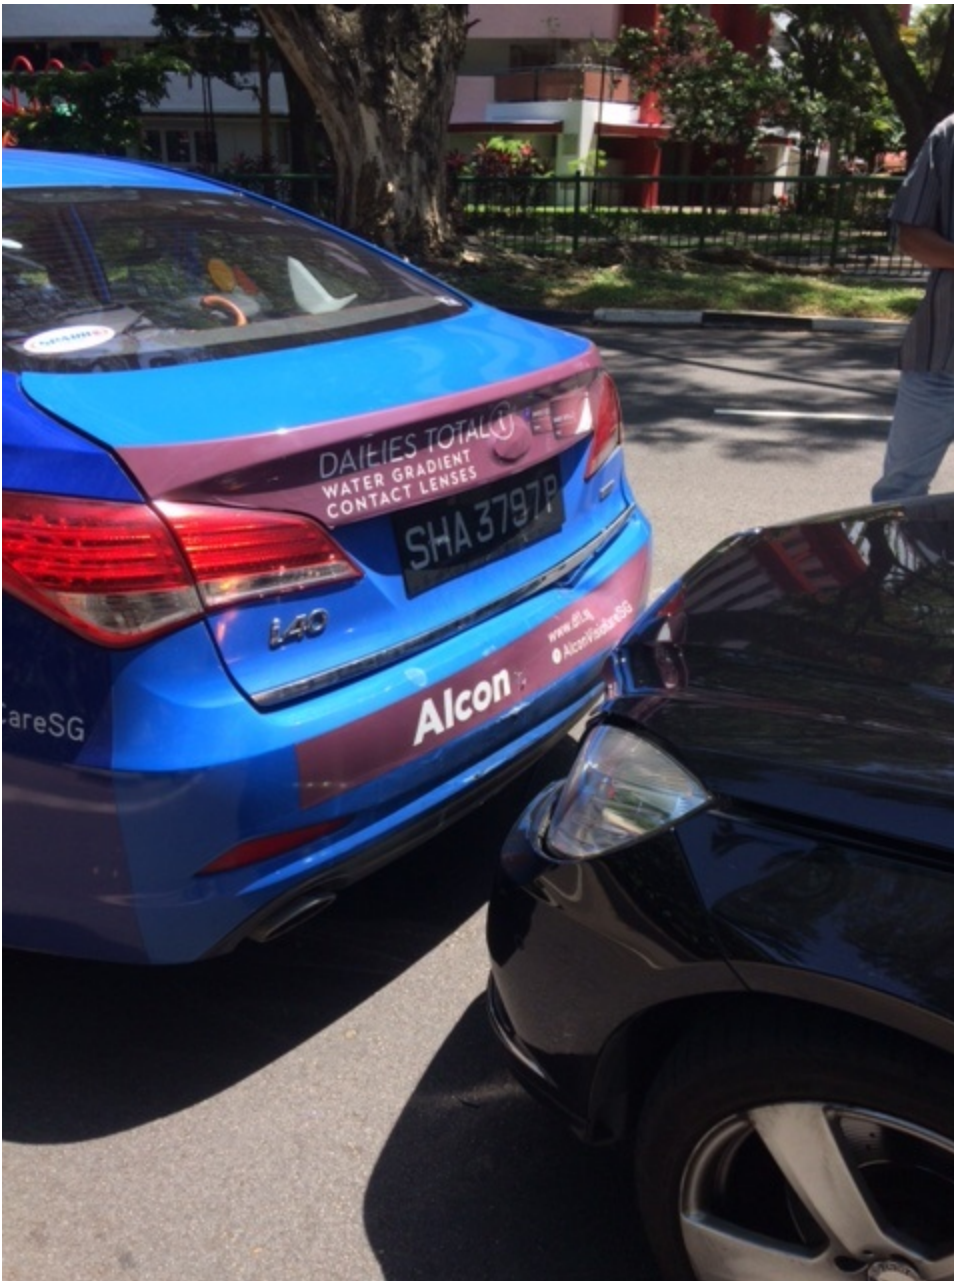
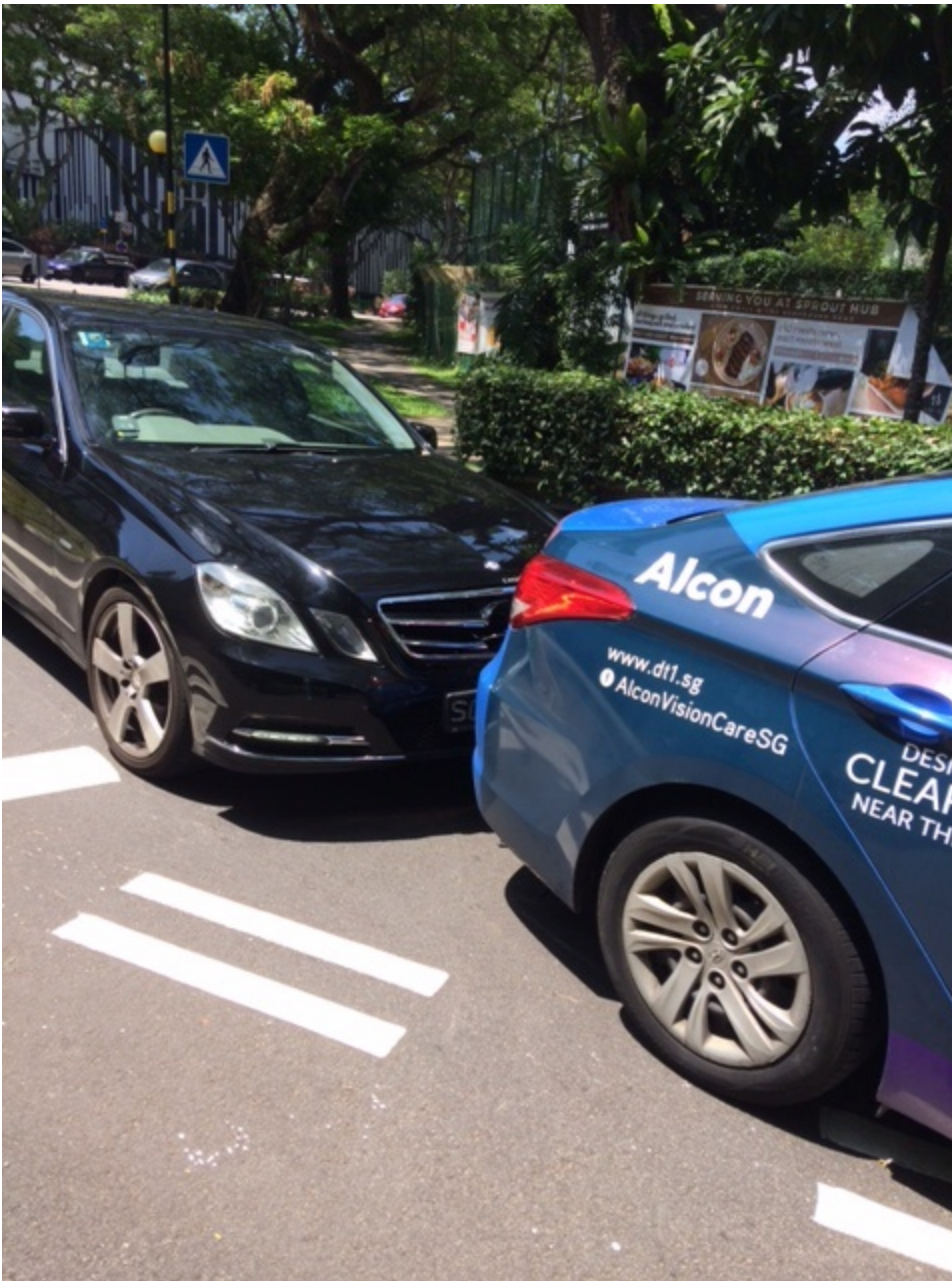
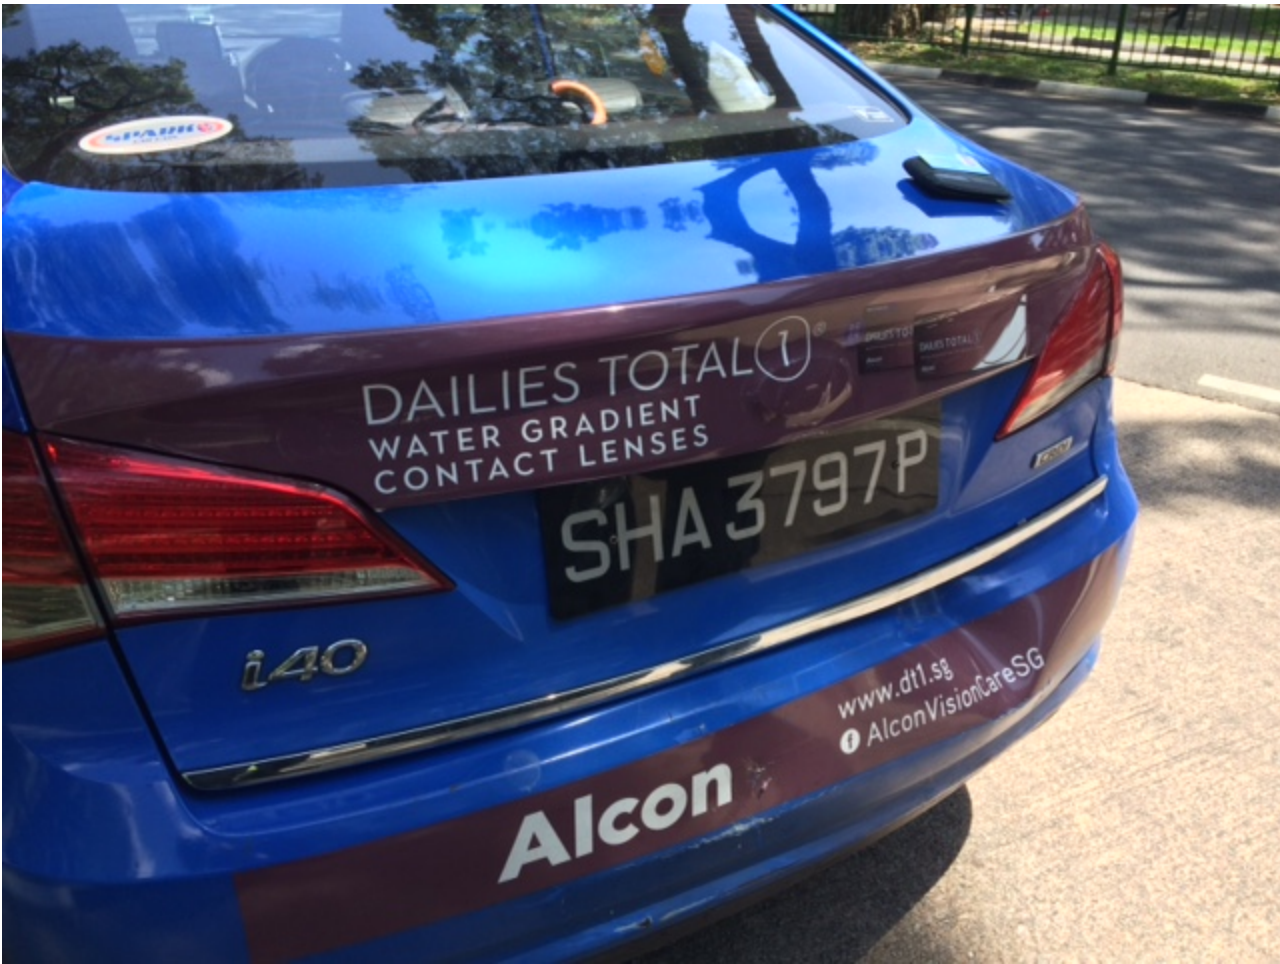
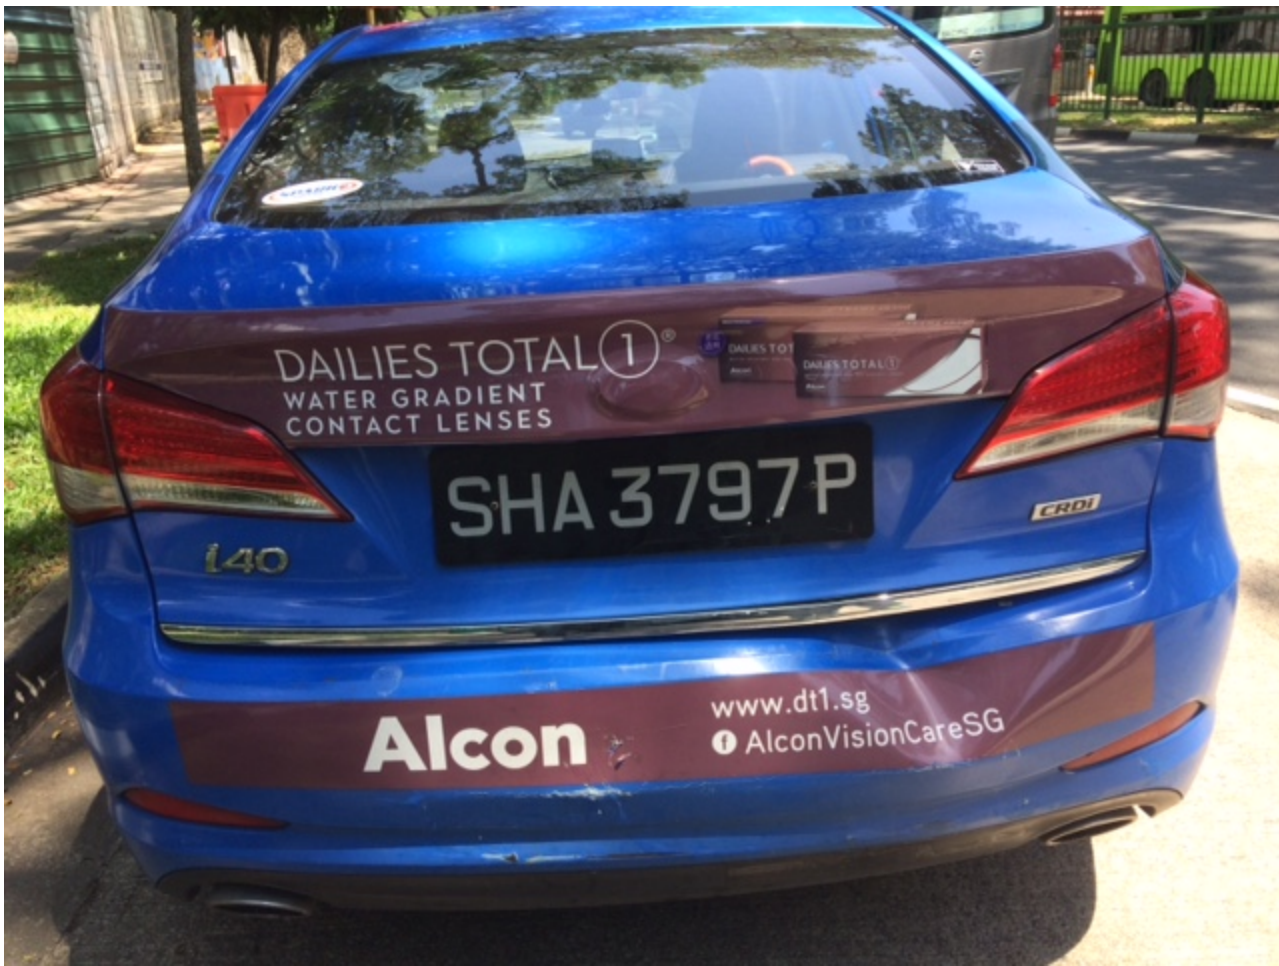
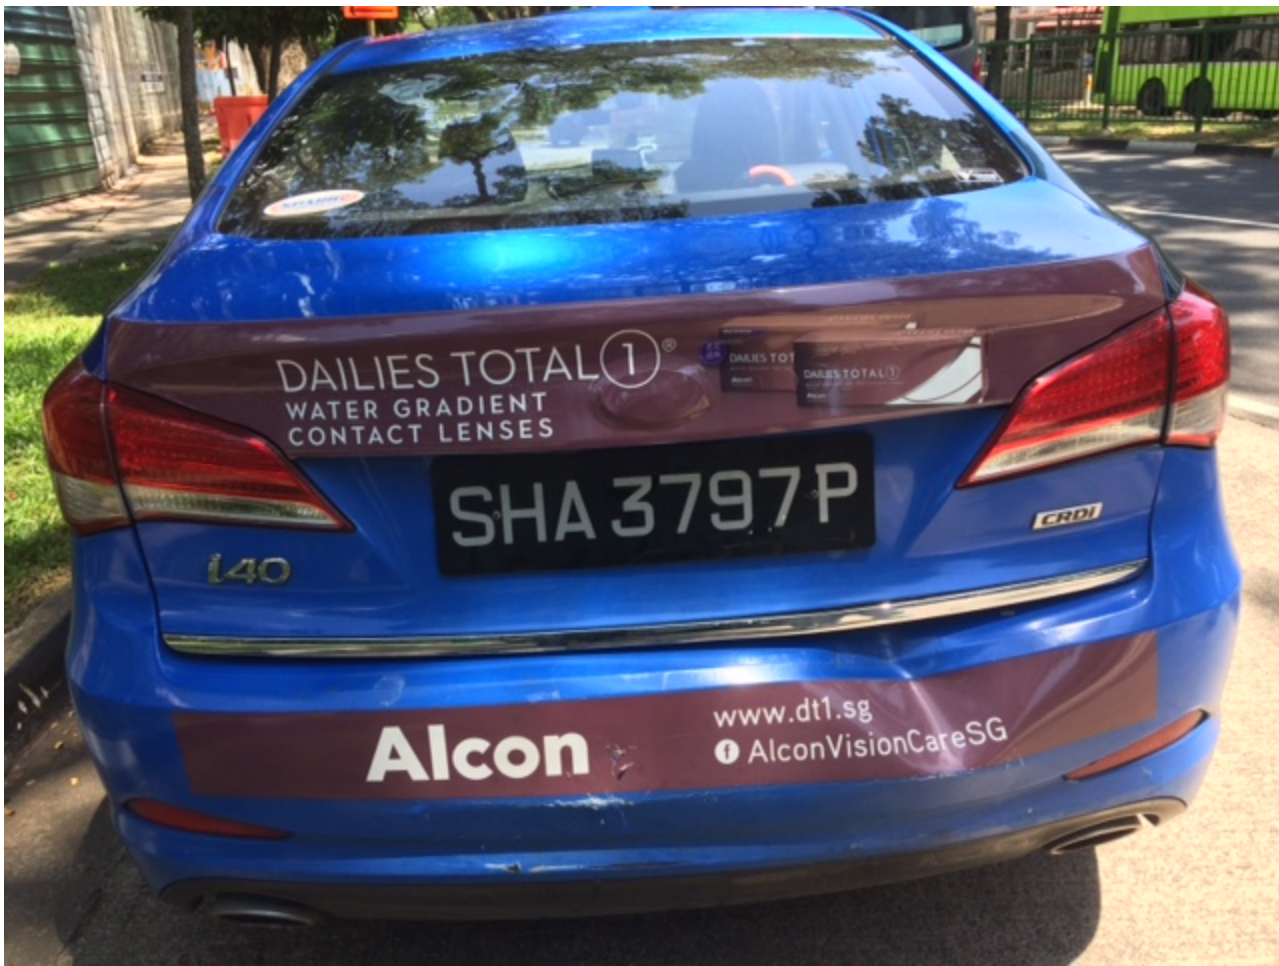
You said that taxi did not move off even though there was no vehicle on the main road causing you to collide into the rear of taxi. Scene photos you showed for both vehicles simply reveals that damage to taxi is not minimal as you alleged. The rear bumper is badly dented and the impact force cause the boot lid is damaged as well.

Please note the damage to SHA3797 P is minimal and taxi driver cannot over claim on this accident .

As we know , vehicles are designed to absorb impact energy caused by collision instead of resist energy. Therefore , taxi rear bumper has fully absorbed the impact caused by your vehicle. Again, the front portion of vehicle is designed to house most of mechanical and electrical components , which render the front portion solid and strong. Based on the damage to your vehicle which is a Mercedes model, we are convinced that it would be corresponding damage to taxi rear portion.

Our surveyor who have inspected and checked each and every damaged item before the repair and confirmed the damage is consistent. Next , the damage photos taken by you at the accident scene and photos taken by our surveyors are completely tally. Therefore , we are in the opinion and view that damage to taxi is fair and reasonable which reflects the actual circumstances of accident.
