ACCIDENT INVOLVING SKS 1919 M AND SJE 8298 K ON 24 JUNE 2020 ALONG PUNGGOL ROAD

ACCIDENT VEHICLE INSPECTION REPORT

Report no : 177M0620.NA

Vehicle no : SKS1919M

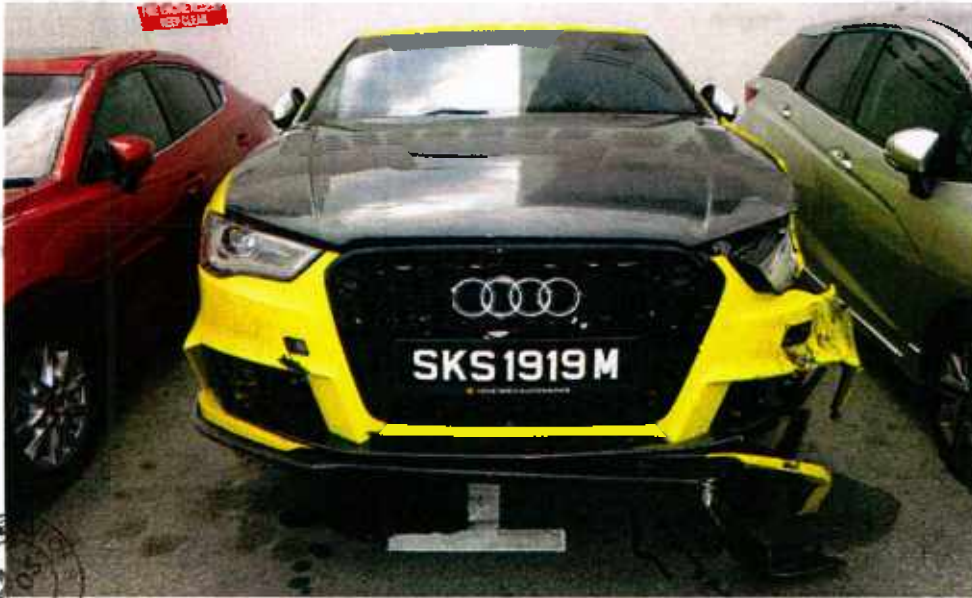
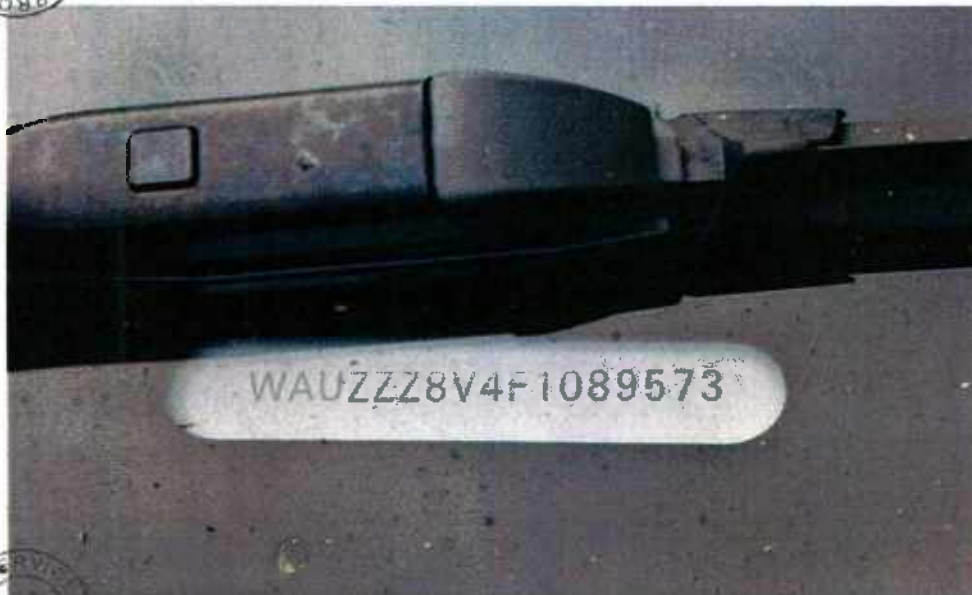
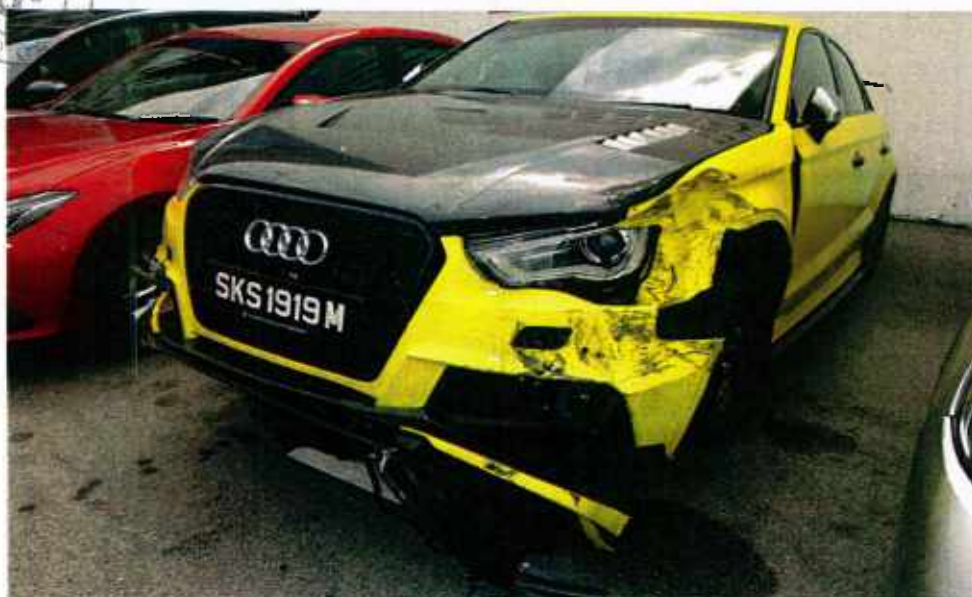
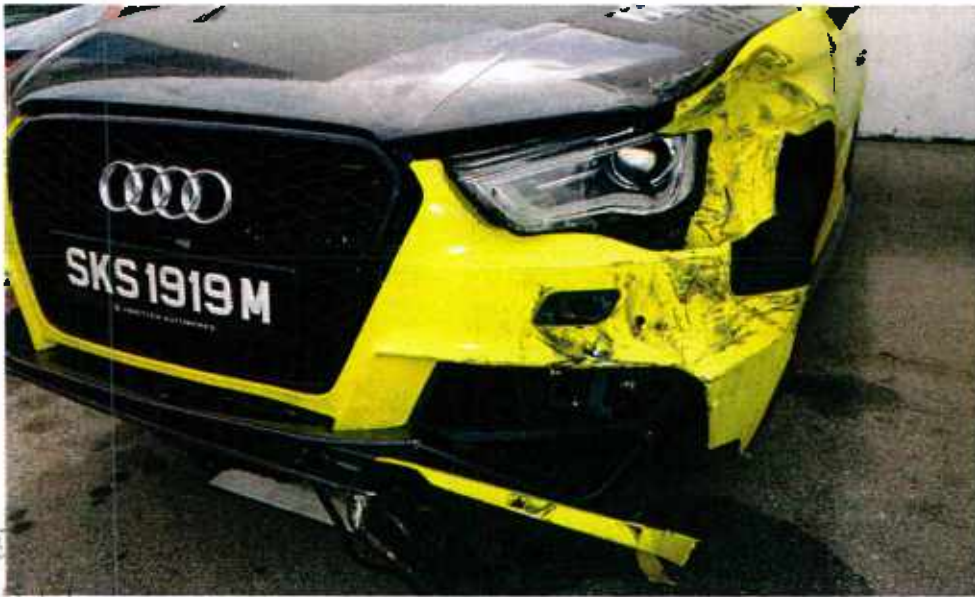
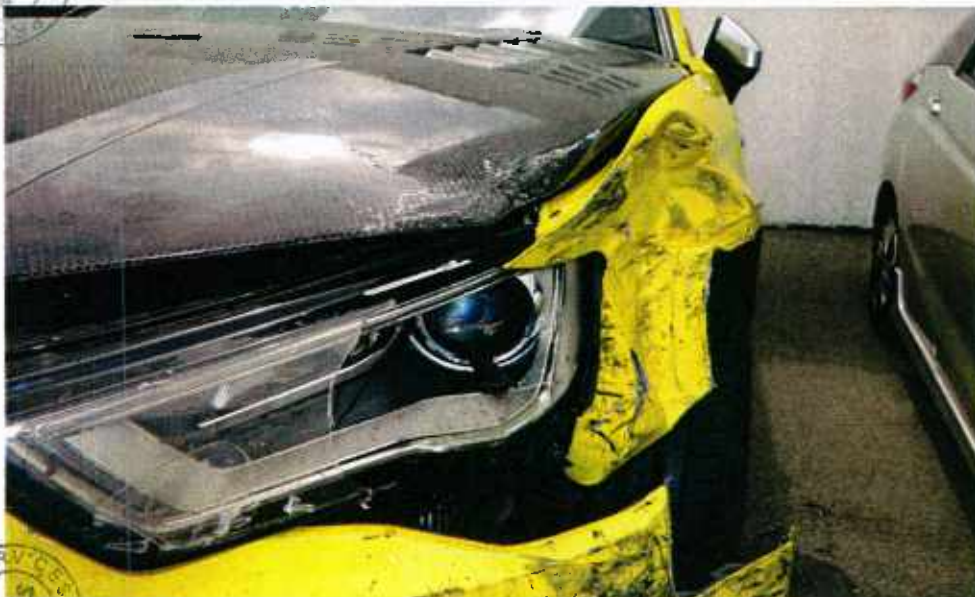
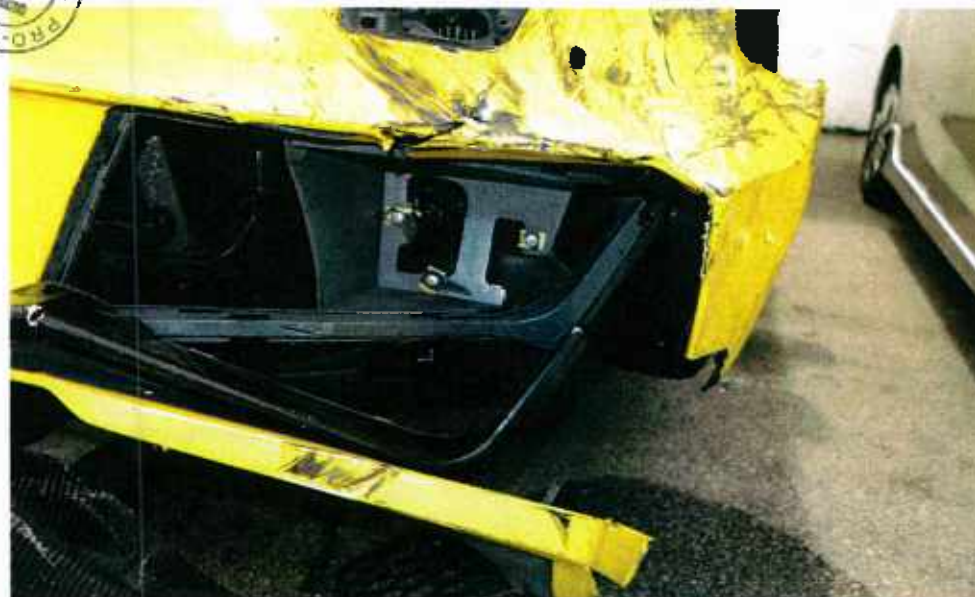
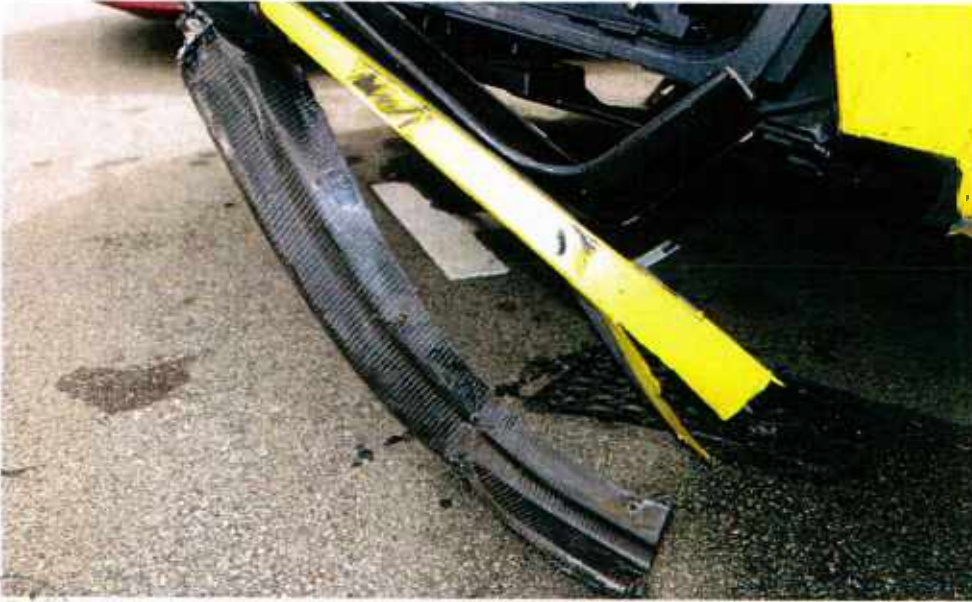
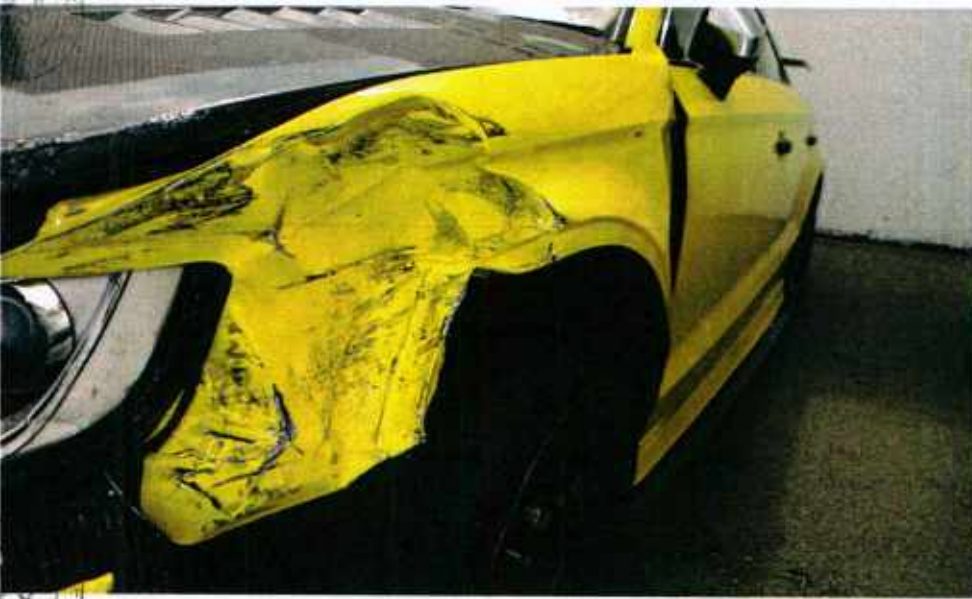
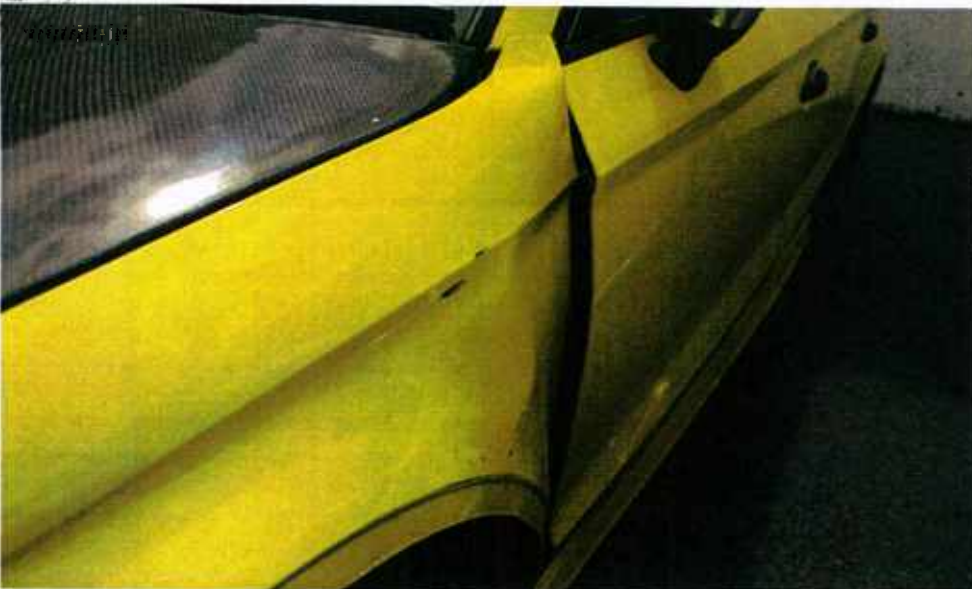
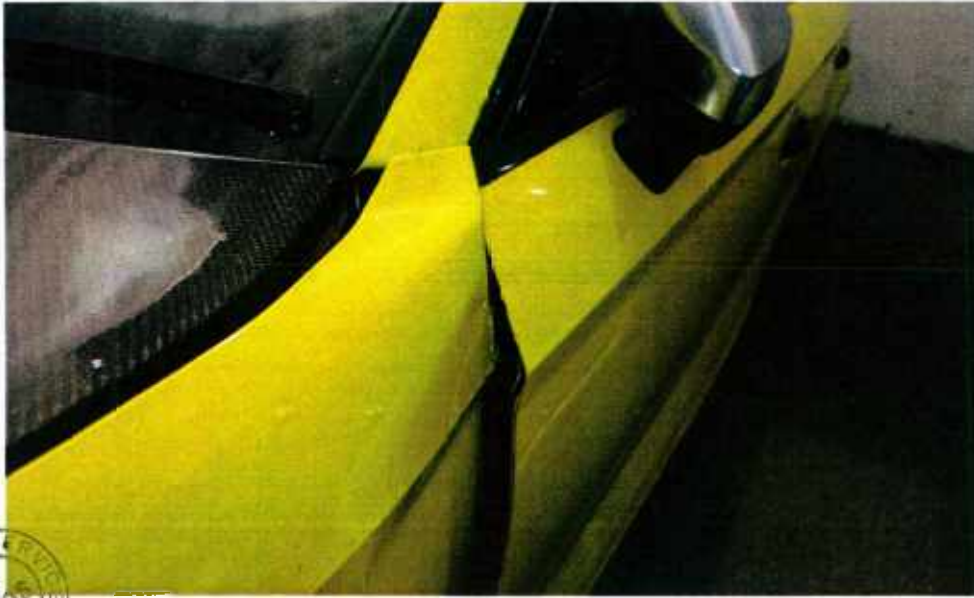
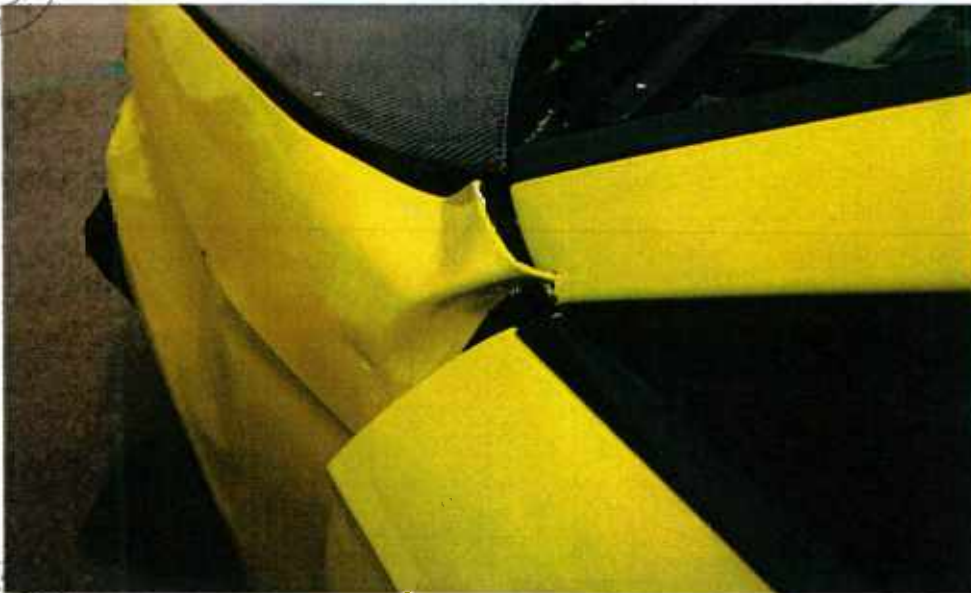
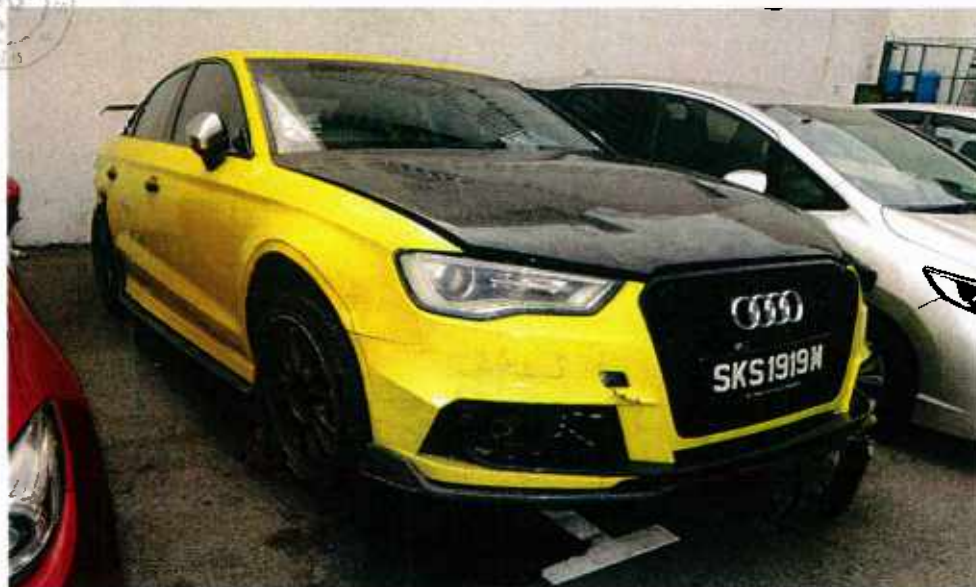
Front bumper broken, LH headlamp broken, RH headlamp leg broken, LH front fender crushed, RH front fender buckled/distorted, carbon fibre front bonnet dented/cracked, front suspension & undercarriage parts damaged, rear bumper grazed/tab broken, RH rear fender dented/bent/distorted, RH rear door dented/bent, RH front door grazed, wing mirror grazed, RH rear suspension & undercarriage parts damaged, etc. Please see para. 8 of this report for more details.

Cost of repairs : **\$53,500.00** (lump sum)

(a) The recommended cost of repair based on lump sum repairs would be **\$53,500.00**
