ACCIDENT VEHICLE INSPECTION REPORT

Report no : 249M0920.XY
Vehicle no : SMN5492C

Make/Model : **HONDA FIT 1.3GF CVT**
Chassis no : GK33422546
Engine no : L13B3937036
Date of registration : 16 August 2019
Engine capacity : 1317 cc
Odometer reading : 020341 km
Colour : Black

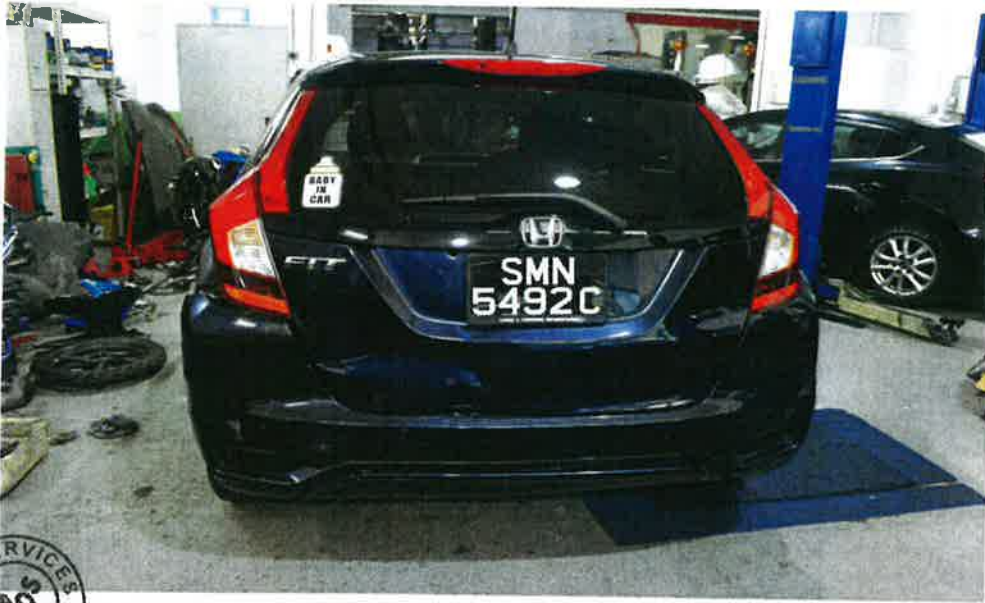
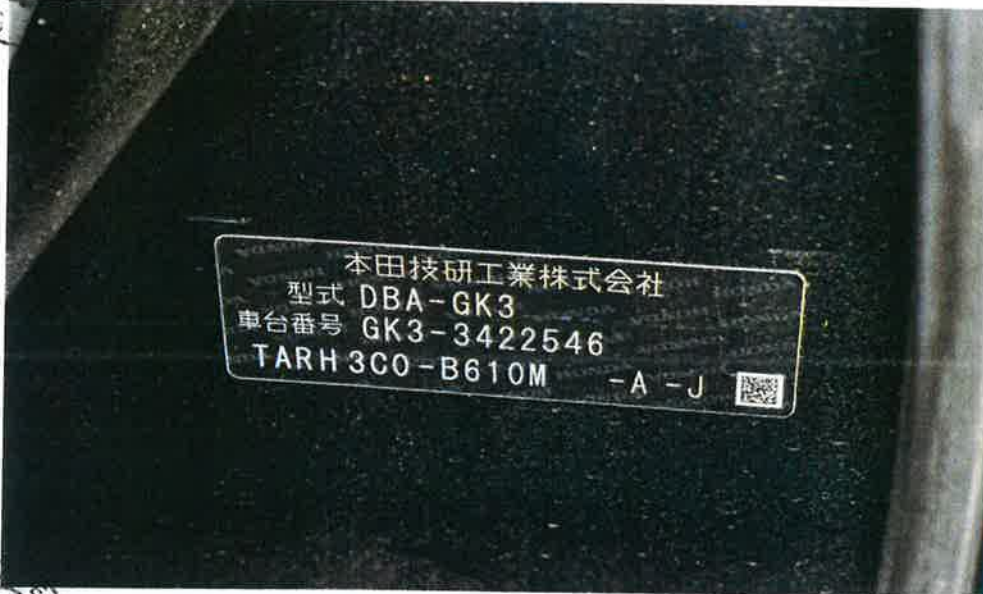
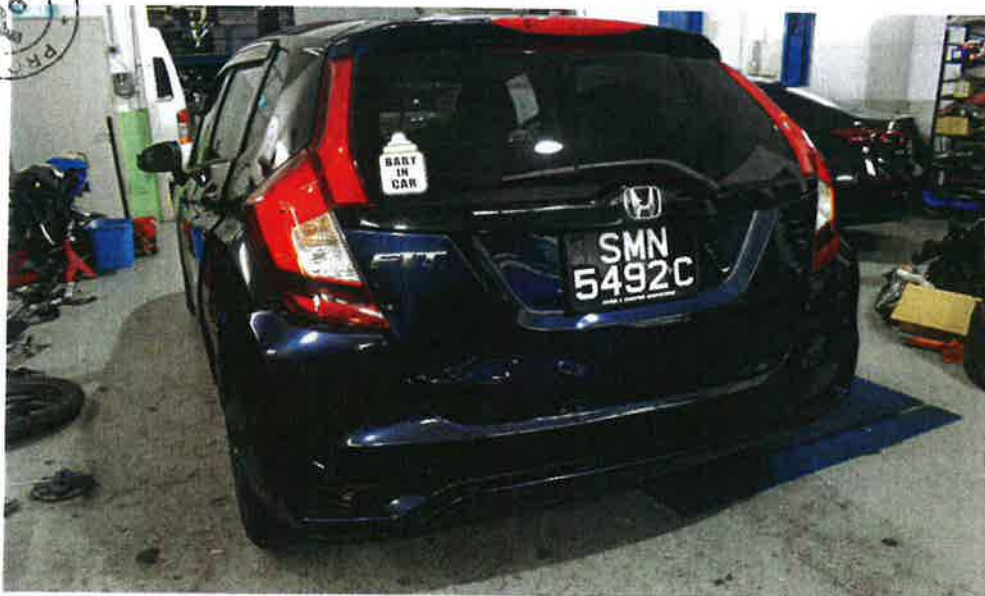
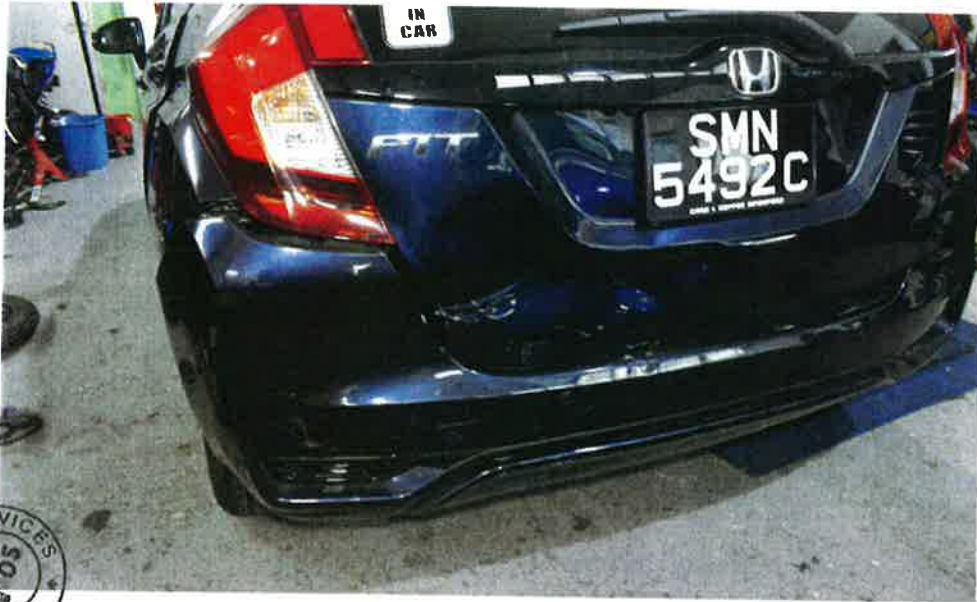
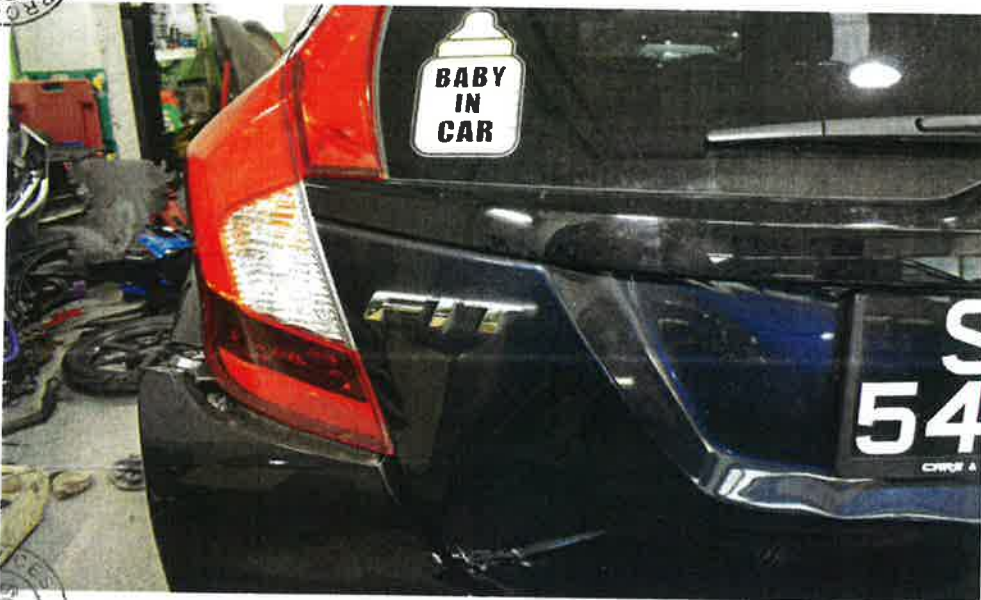
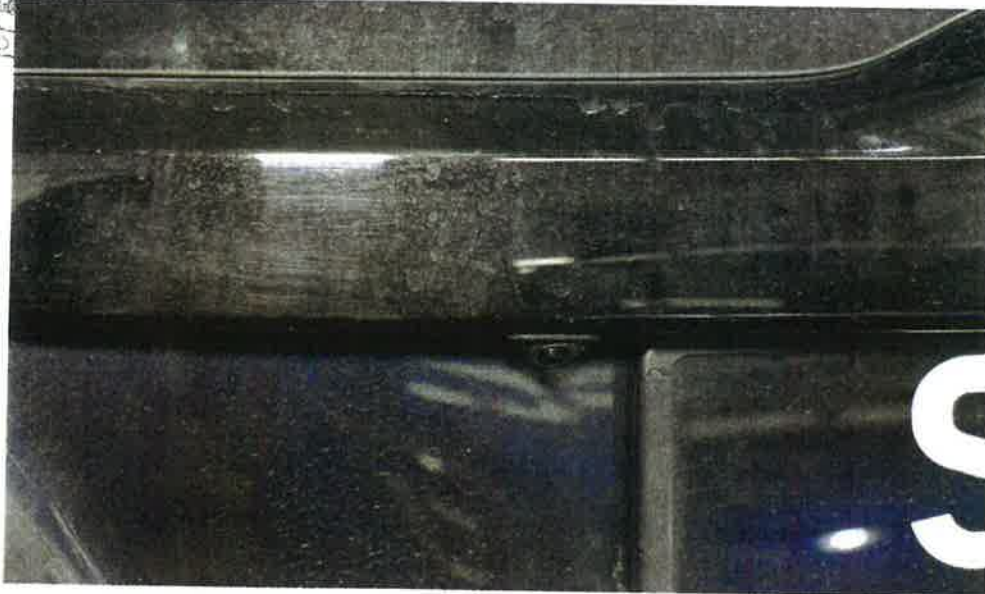
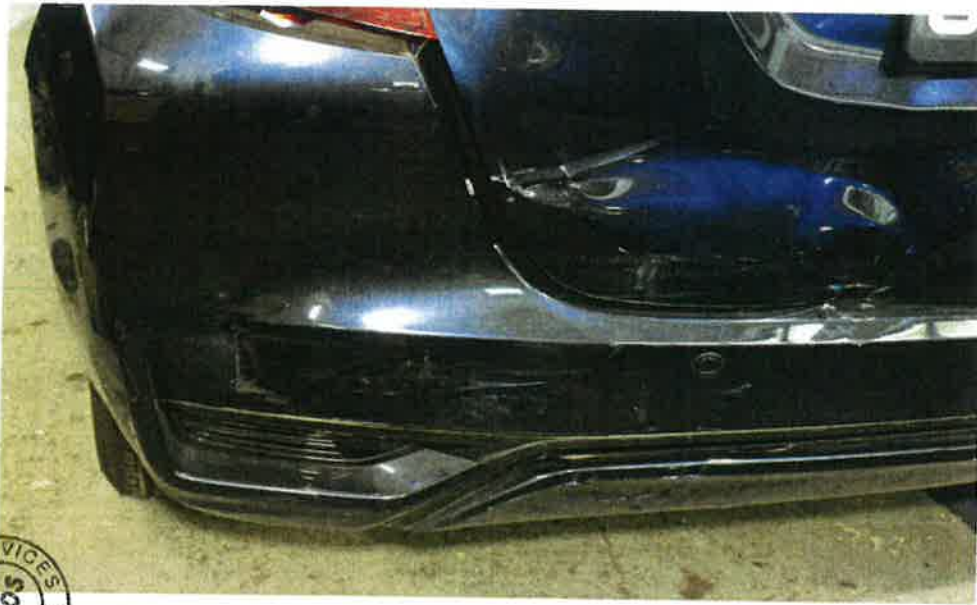
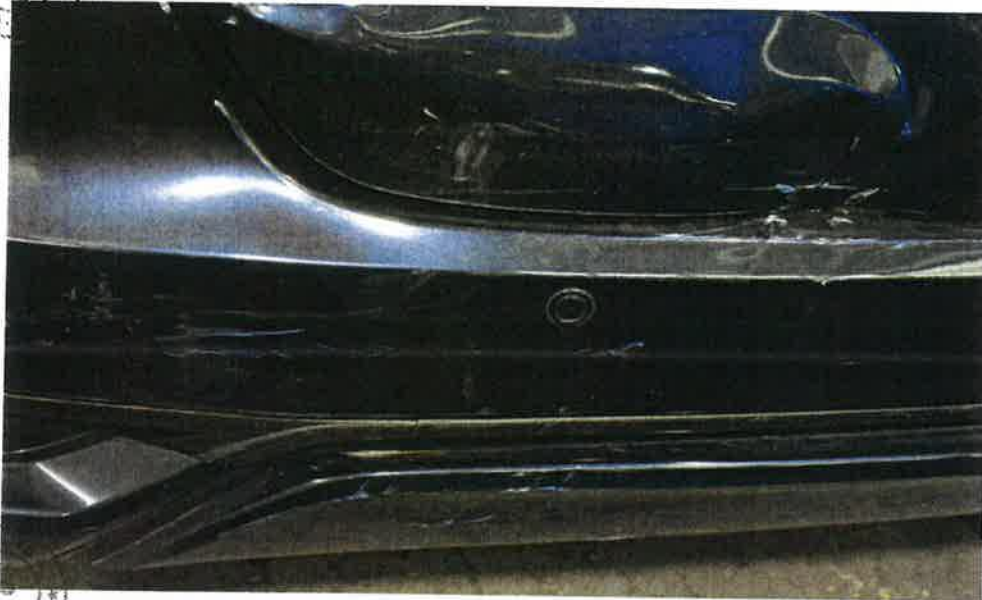
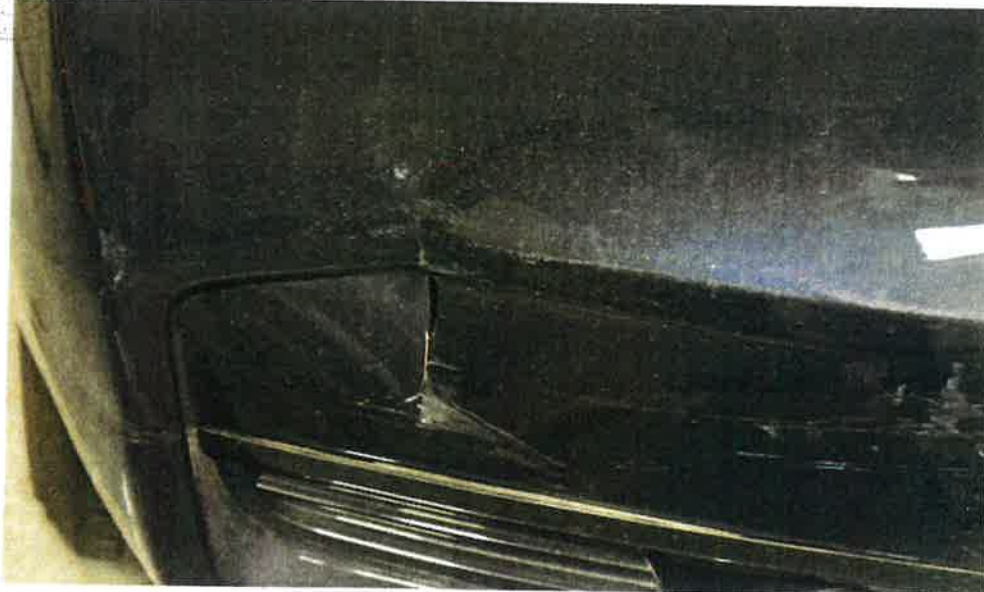
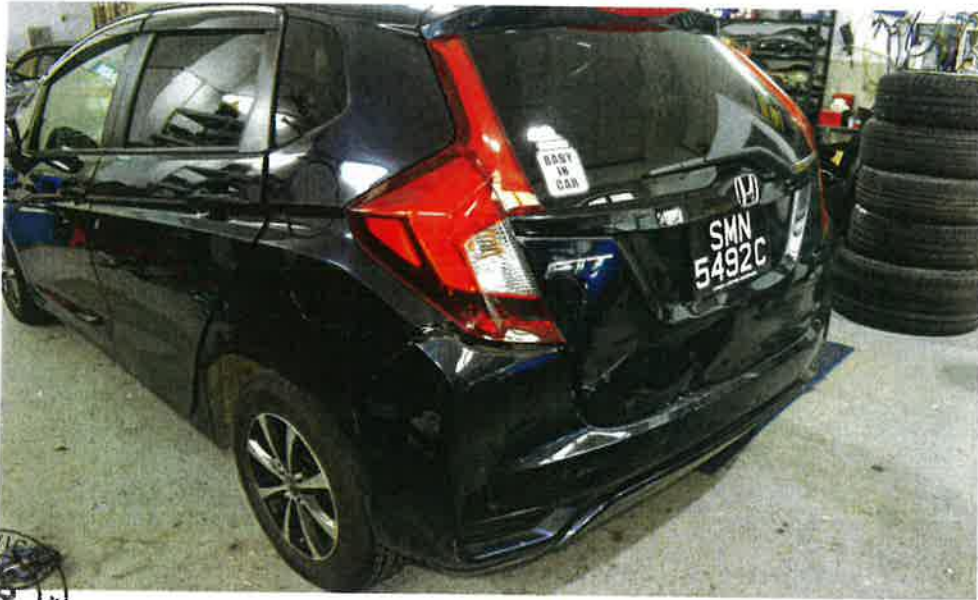
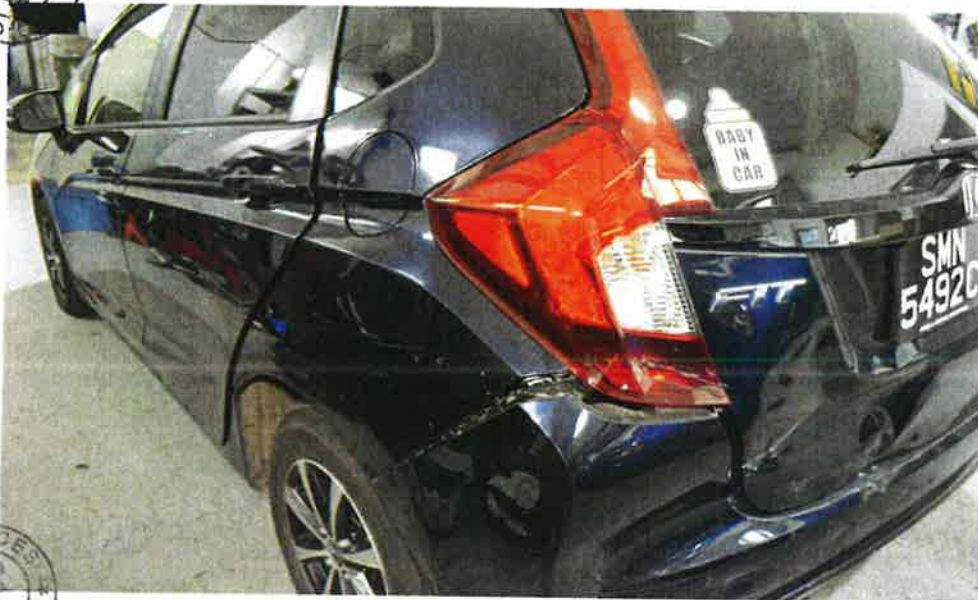
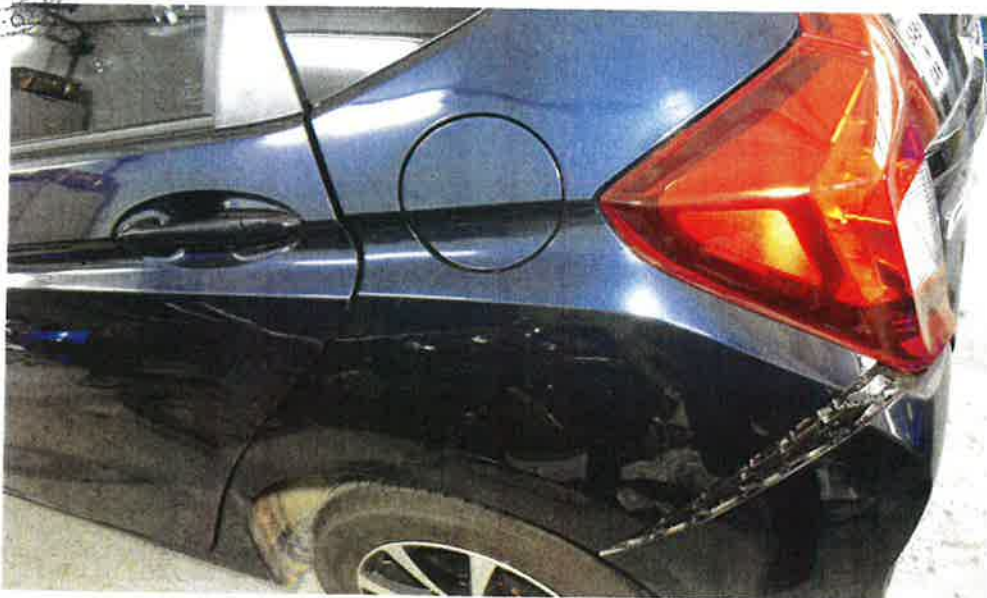
Rear bumper dented/torn/deformed, rear end panel dented/bent/distorted, spare tyre panel crumpled, rear LH fender buckled, taillamp base panels bent, rear LH door edge paintwork damaged, rear boot lid dented/bent/distorted, etc. Please see para. 8 of this report for more details.

Cost of repairs : \$10,132.82
No. of days taken : Eight (8)
