RE: PRE-REPAIR INSPECTION - ACCIDENT INVOLVING OUR INSURED VEHICLE GBF4624T AND SMJ8722R ON 25/08/2020

Report Ref : TP20080028

THIRD PARTY SURVEY ACCIDENT OCCURED ON 25 AUG 2020

Registration No : SMJ8722R
Model : MERCEDES BENZ C180
Year / Capacity : May 2013/ 1590 cc
Chassis No : WDD2040312A833022

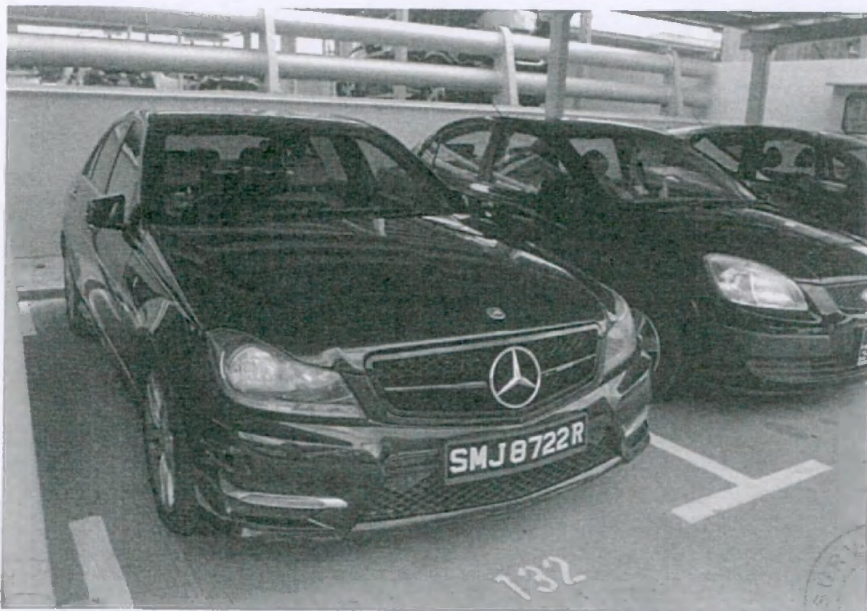
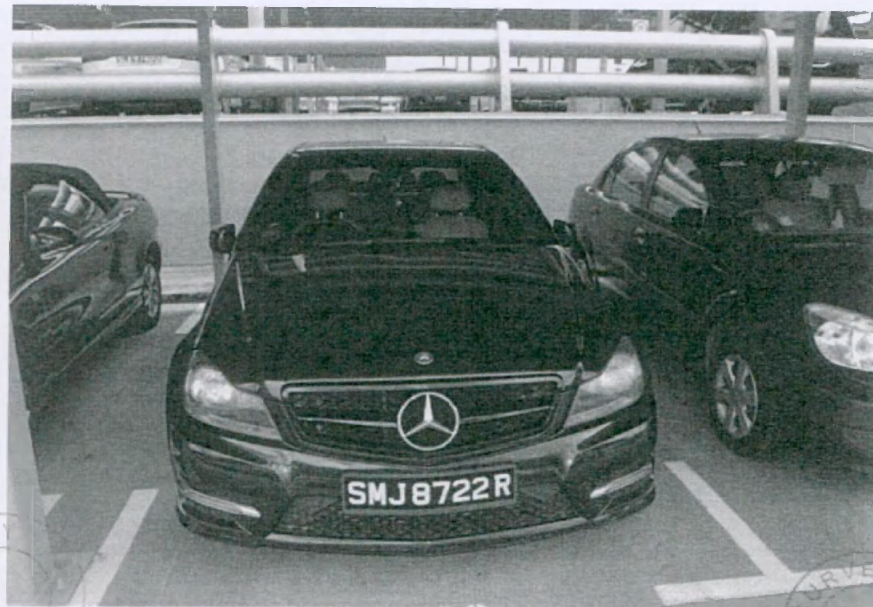
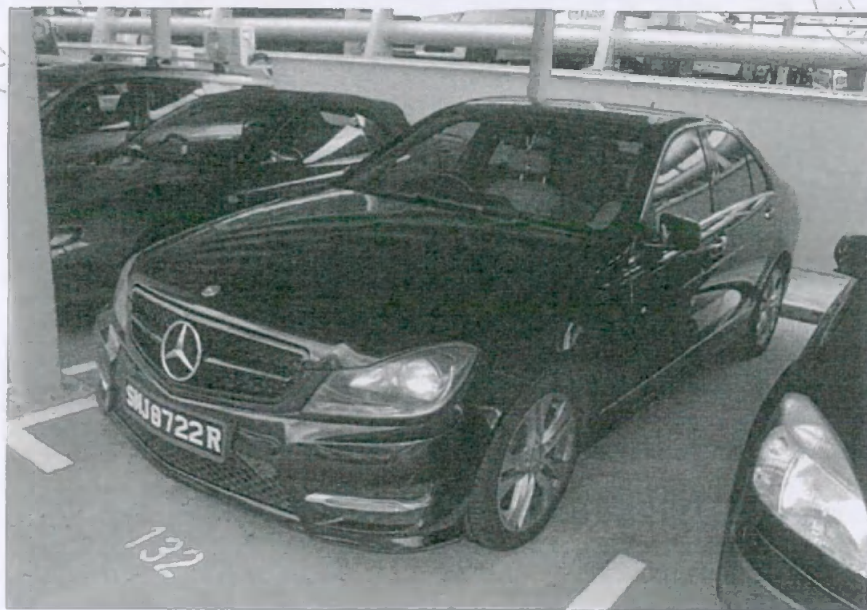
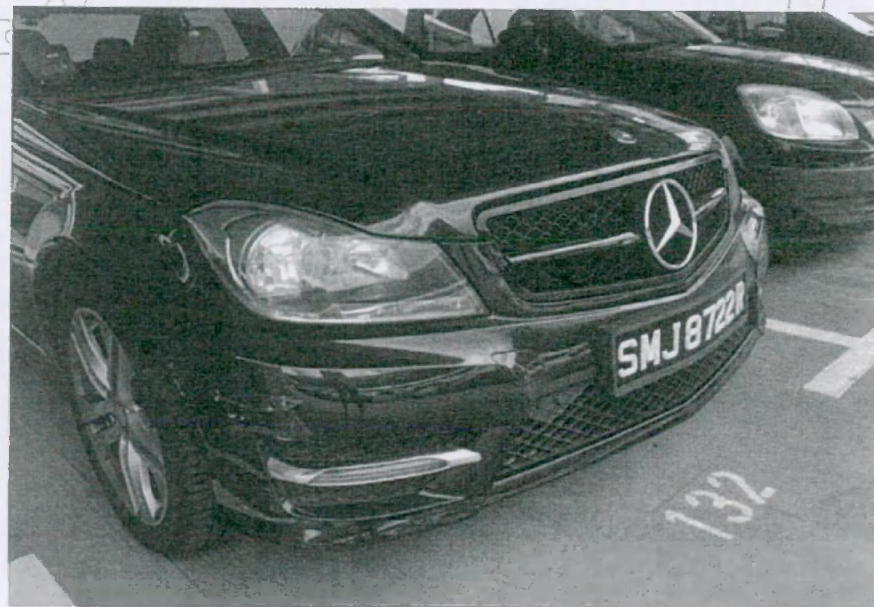
At the time of inspection, we noted that the vehicle has sustained an impact damages on the front side portion(s). For more detail of the damages, please see photograph attached.

1 pc	Front bumper	bent	\$ 1,850.00	\$ 1,850.00
10 pcs	Front bumper clips	necessary	\$ 129.00	\$ 129.00
1 pc	Front bumper sponge	deformed	\$ 286.60	\$ 286.60
1 pc	Front bumper tow cover	deformed	\$ 143.50	\$ 143.50
1 pc	Front bumper side retainer	bent	\$ 88.00	\$ 88.00
1 pc	Front bumper side bracket	bent	\$ 64.50	\$ 64.50
1 pc	Head Lamp	bend/distorted	\$ 2,339.00	\$ 2,339.00

S/No	JOB DESCRIPTIONS	Workshop Estimation (S\$)	Our Revised Estimation (S\$)
	Spare PartsTotal c/f	\$ 4,660.54	\$ 4,660.54
1	To check wiring system	\$ 180.00	\$ 150.00
2	To tuff coat affected areas	\$ 180.00	\$ 150.00
3	To respray affected areas	\$ 1,600.00	\$ 1,400.00
4	To renew damaged parts, straighten and repair front chassis member and aligned all parts	\$ 1,600.00	\$ 1,400.00
5	To polish and coating for new paint	\$ 1,400.00	\$ 1,400.00
	Total	\$ 9,620.54	\$ 9,160.54
