ASSIGNMENT

To Inspect Vehicle No:

Estimate Repair Cost to Vehicle No : YN362K

ACCIDENT STATEMENT

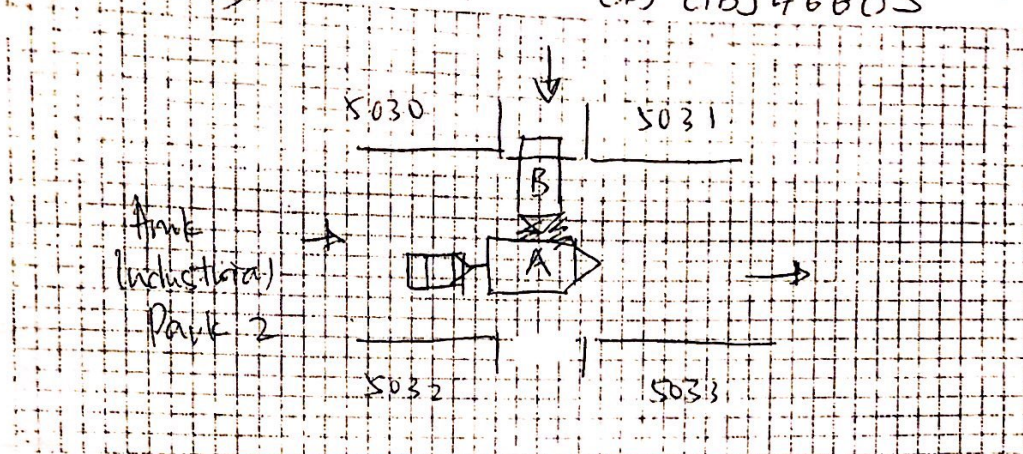
SKETCH PLAN

(A) YN 362 K

(B) GBJ46605

I was driving my lorry straight when suddenly a van came from my left and hit the left side of my lorry. I wish to state that it was my right of way and the van did not stop to check me oncoming.

The collision resulted in damages to the entire left side of my lorry from front to rear and punctured the left front tyre
