Vehicle No. SLE 1036Y
Insured Veh. SLV 8727B
Claim No. 20/20/20/VP00/023980
Policy No. Z/20/VP00/10536
Accident Date 06/12/2020
Inspection Date 16/12/2020

Affiliated to Federation Internationale Des Experts En Automobile				
LONPAC INSURANCE BHD 300 BEACH ROAD #17-04/07 THE CONCOURSE SINGAPORE 199555			Ref: CC4/LPC20013853/Kps3q2 Date: 15/01/2021 Code: LPC2

ADJUSTMENT ON REPAIR COST FOR VEHICLE NO. SLE 1036Y

PHOTOGRAPHS FOR VEHICLE NO. SLE 1036Y

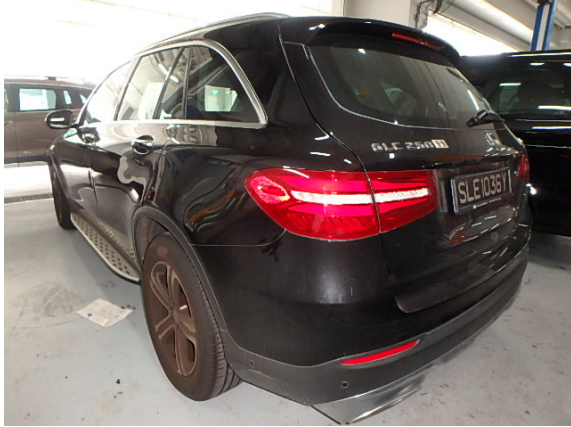
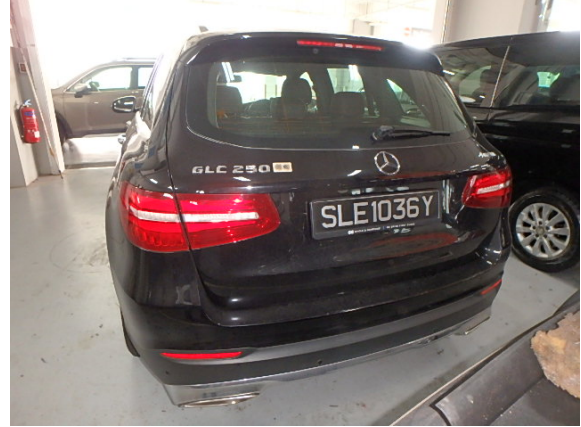
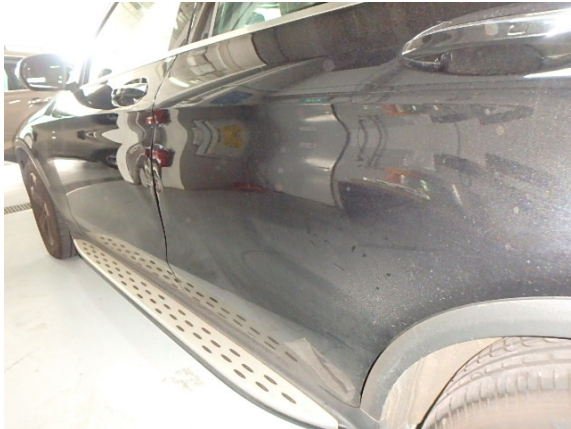
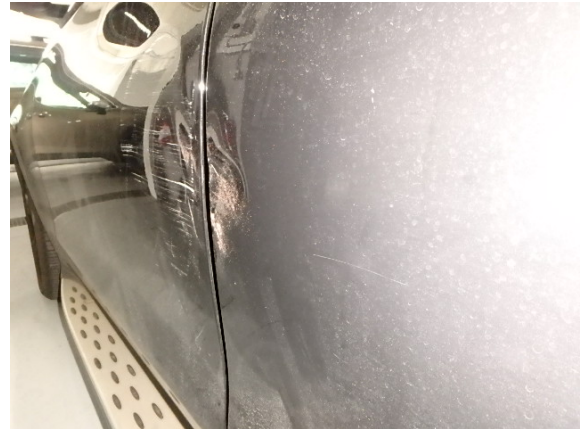
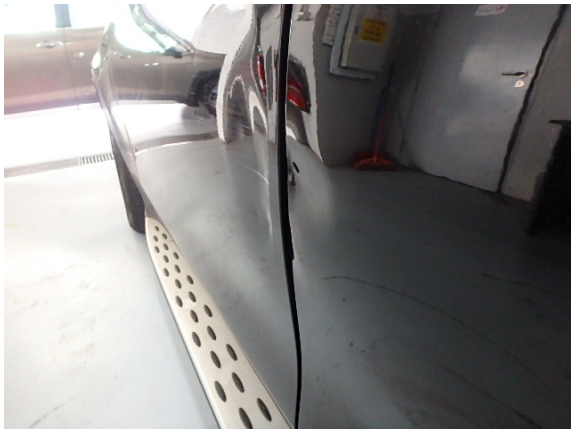
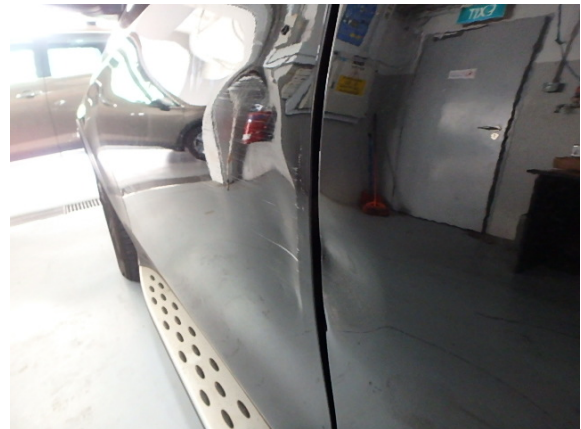
INSPECTION

4. Description of Damages				
THE VEHICLE SUSTAINED DAMAGES AT THE N/S BODY. DAMAGES SEE DETAILS.				
5. General Information				
Accident Date	06/12/2020	Inspection Date	16/12/2020	
Survey held at	TONG LUCK AUTO PL 160 SIN MING DRIVE #07-01/06 SIN MING AUTOCITY SINGAPORE 575722			
5a. Remarks

Qty	Description of Parts	Condition	Estimate By Workshop (\$)	Our Adjusted (\$)
	<u>REPLACEMENT OF PARTS</u>			
1	FRONT DOOR -LH (N)	BENT	2,696.00	2,696.00
1	FRONT DOOR WEATHERSTRIP -LH (N)	NECESSARY	328.00	328.00
1	REAR DOOR -LH (N)	BENT	2,925.00	2,925.00
1	REAR DOOR WEATHERSTRIP -LH (N)	NECESSARY	328.00	328.00
	LESS 10% DISCOUNT		-627.70	-627.70
			5,649.30	5,649.30
20	FRONT DOOR TRIMBOARD RIVETS -LH @\$13.00 (SN)	NECESSARY	260.00	60.00
20	REAR DOOR TRIMBOARD RIVET -LH @\$13.00 (SN)	NECESSARY	260.00	60.00
	LESS 10% DISCOUNT		-52.00	-

468.00	120.00
	<u>LABOUR</u>			
	TO TRANSFER LH FRONT AND REAR DAMAGED DOOR INTERIOR MECHANISM AND GLASS TO NEW DOOR .		300.00	120.00
	TO PANEL BEAT AND STRAIGHTEN LH FRONT & REAR DOOR HINGES ,INCLUDING REPLACEMENT OF PARTS AND ALIGN WHERE NECESSARY ,TO REFIT AND ADJUST THE SAME.		800.00	400.00
	TO CHECK AND RECTIFY WIRING SYSTEM.		80.00	20.00
	TO PUTTY AND SPRAY PAINT ON AFFECTED AREAS.		800.00	500.00
	TO APPLY RUST-PROOFING ON REPLACED AND REPAIRED PANELS.	NOT NECESSARY	120.00	-
			2,100.00	1,040.00
GRAND TOTAL			8,217.30	6,809.30
RECOMMENDED COST OF LUMP SUM REPAIRS (TO ITS PRE-ACCIDENT CONDITION)				5,400.00
