To Inspect Vehicle No: SJW 76280at Workshop m/s MOVAof 15, GAN YONGH MInsured: CTI

Make: TOYOTA COROLLA ALTIS 1.6 A c.c. 1598Colour: WHITE

# Estimate

## SINGAPORE ACCIDENT STATEMENT

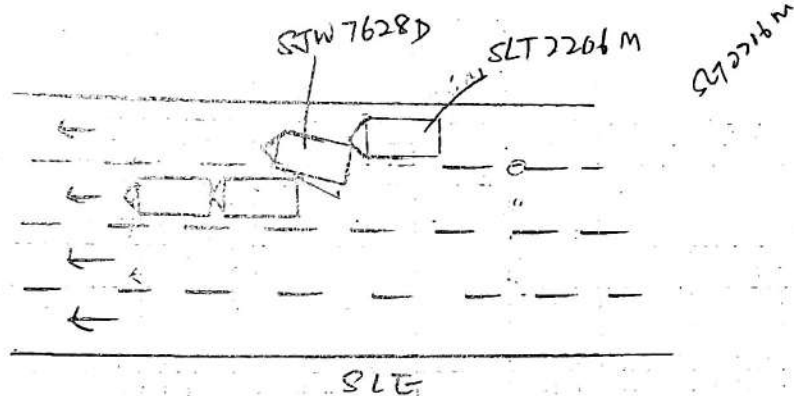
SKETCH PLAN

LICENSE PLATE: SJW 7628D	ACCIDENT DATE & TIME: 16/12/20 1230 hrs
CONTACT NUMBER: 96714033	E-MAIL ADDRESS: danielan280665@gmail.com
LOCATION: SLE Towards BKE Before PIE (10km)	
<p>When I was driving along SLE towards BKE at the 2nd lane. When I saw an accident in front I swerve my vehicle to the right side to avoid the collision, but unfortunately my vehicle still hit onto the front vehicle and vehicle SLT 2206M from behind hit the rear right portions of my vehicle. My vehicle damaged front left &amp; rear right portions.</p>	
<p>NOTE: PLEASE NOTE THAT YOUR INSURER MAY HAVE 14 DAYS TIME FRAME FOR YOU TO SUBMIT AN OWN DAMAGE CLAIM UNDER YOUR OWN POLICY. PLEASE CHECK YOUR POLICY FOR MORE INFORMATION</p>	
Please state:	
<input type="checkbox"/> Claim Own Policy <input checked="" type="checkbox"/> Claim Third Party <input type="checkbox"/> Claim OD/TP at other workshop <input type="checkbox"/> Reporting Only
