ASSIGNMENT

Veh No: SFZ 8008T Yr Regn: 28/04/2011

Make: BMW 740L c.c. 2974

Claims No. SNM 21D200497 / COI / TAN KL

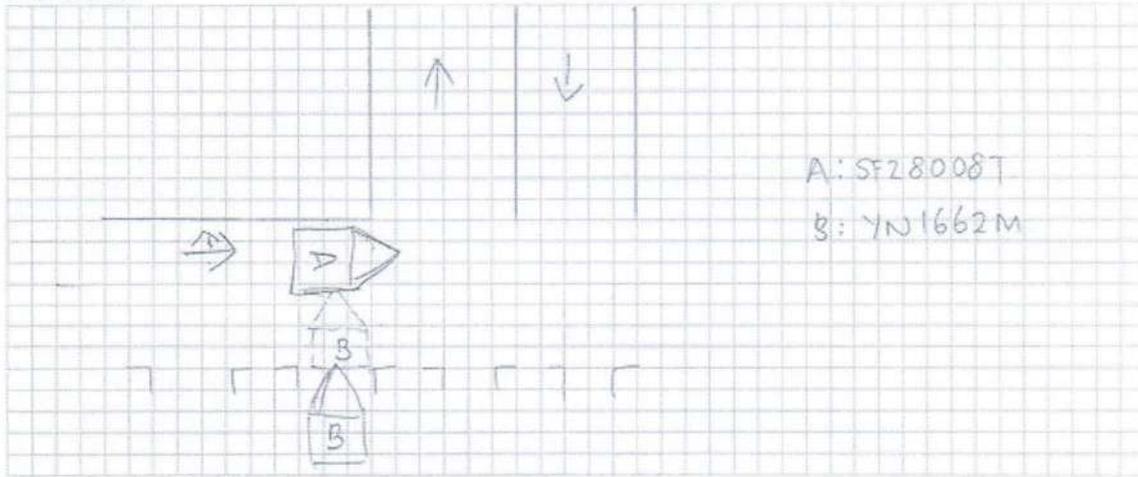
SKETCH PLAN

Pls refer to Police Report NO: T/20210120/2118.

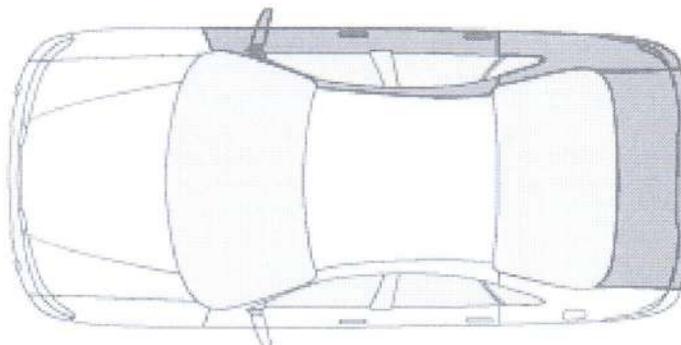
### Damage Areas

The U/C / Chassis frame / Body Structure affected due to collision.

All   
Underbody

Code	Description	Time Base 12 WU/h	Price = 42.00 SGD/h	
			WU	Price SGD
41 52 580	R + R RIGHT REAR DOOR		4.0	14.00
41 52 504	ADJUST R/R DOOR		2.0	7.00
41 52 501	RENEW R/R DOOR (REMOVED)		31.0	108.50
51 42 504)	RENEW R/R DOOR TRIM (REMOVED)		1.0	3.50
41 35 111	RENEW R/R SIDE PANEL		200.0	700.00
	INCLUDES: R + R REAR SEAT, SEAT BACKREST, TAILGATE, REAR WINDOW, TAIL LAMP, BUMPER, BUMPER CARRIER, BUMPER GUIDE, SILL MOULDING, LUGGAGE COMPARTMENT TRIM, REAR SILL COVER STRIP, UPPER C-PILLAR TRIM AND REAR DOOR			
51 12 657	RENEW REAR BUMPER TRIM (BUMPER REMOVED)		1.0	3.50
66 20 603	ADD/WORK PARK DISTANCE CONTROL		3.0	10.50
36 11 512	R + R R/R WHEEL/TYRE		6.0	21.00
36 11 500	TYRE PUNCTURE INITIALIZE DISPLAY		1.0	3.50
00 00 556	VEHICLE CHECK (BY VEHICLE DIAGNOSTIC SYSTEM)		3.0	10.50
66 53 515	CALIBRATE BACKUP CAMERA (AFTER VEHICLE TEST)		1.0	3.50
<b>Labour Cost</b>			<b>Hrs</b>	<b>WU</b>
<b>Panel / Mechanical Labour</b>			<b>21.10</b>	<b>253.0</b>

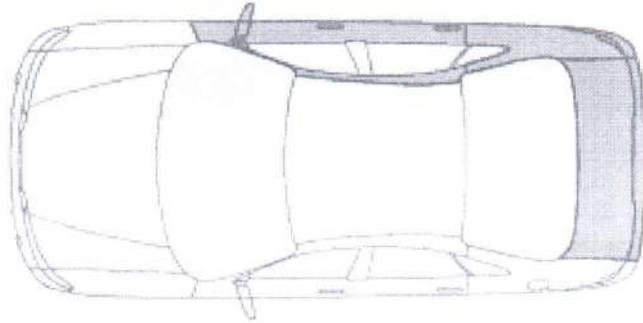
### Damage Areas

All   
Underbody

Code	Description	Time Base 12 WU/h	Price = 42.00 SGD/h	
			WU	Price SGD
41 52 580	R + R RIGHT REAR DOOR		4.0	14.00
41 52 504	ADJUST R/R DOOR		2.0	7.00
41 52 501	RENEW R/R DOOR (REMOVED)		31.0	108.50
51 16 905)	R + R R/R DOOR ROLLER BLIND		3.0	10.50
41 35 111	RENEW R/R SIDE PANEL		200.0	700.00
	INCLUDES: R + R REAR SEAT, SEAT BACKREST, TAILGATE, REAR WINDOW, TAIL LAMP, BUMPER, BUMPER CARRIER, BUMPER GUIDE, SILL MOULDING, LUGGAGE COMPARTMENT TRIM, REAR SILL COVER STRIP, UPPER C-PILLAR TRIM AND REAR DOOR			
36 11 512	R + R R/R WHEEL/TYRE		6.0	21.00
36 11 500	TYRE PUNCTURE INITIALIZE DISPLAY		1.0	3.50
00 00 556	VEHICLE CHECK (BY VEHICLE DIAGNOSTIC SYSTEM)		3.0	10.50
66 53 515	CALIBRATE BACKUP CAMERA (AFTER VEHICLE TEST)		1.0	3.50
2583	REAR BUMPER COVER REPAIR		20.0*	70.00
	<b>Labour Cost</b>		<b>Hrs</b>	<b>WU</b>
	<b>Panel / Mechanical Labour</b>		<b>22.60</b>	<b>271.0</b>
	<b>Total of Labour</b>			<b>948.50</b>
