## ASSIGNMENT

PK81030P

Toy Aqua

Des. of Damages: Fnt / Rear / O/S / N/S / U/C / Rooftop or

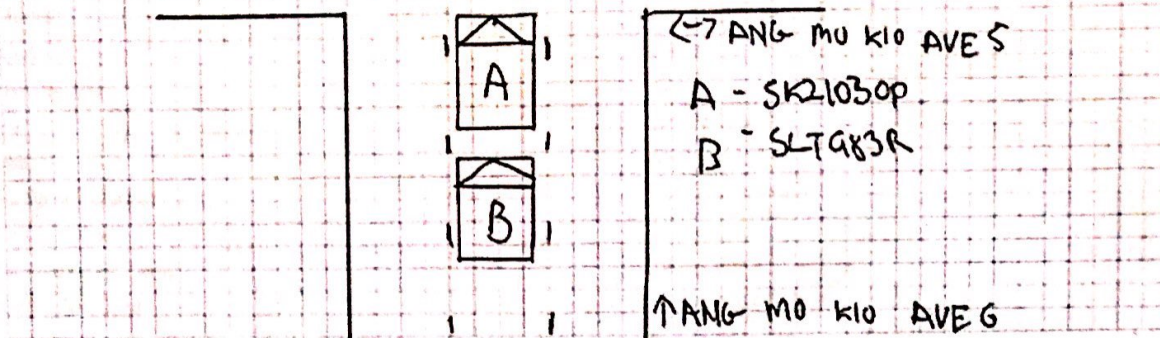
# SKETCH PLAN

I was stationary waiting for the traffic light to change. Subsequently Vehicle B collided against my vehicle rear
