REF: CS/MSG21002813/Dvd3

ASSIGNMENT

VEHICLE ALIGNMENT REPORT

REPAIR ESTIMATE

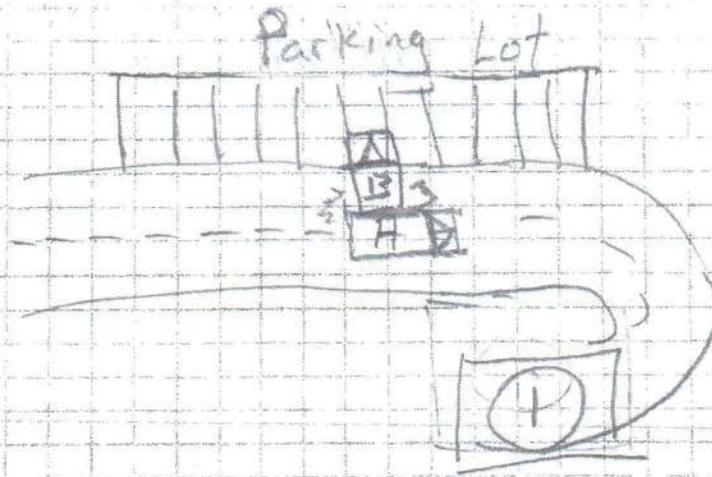
The Waterside Condo

On 1/3/2021 @ about 1635 hrs, i was dropping passenger at The waterside condo where inside the drive way, when i pass throught the parking lot, B vehicle SMA 706M suddenly reversed from parking lot and collided onto my vehicle center portion, no injured at that of accident. Particular had been exchange and scene photo taken.
