From: Bryan Ang (LKKAuto)
Sent: Monday, 15 March 2021 2:55 PM
To: Hwang, Shiang Yi; Veron Chen (LKKAuto)
Cc: SUR; assignments
Subject: RE: CMTD2100698/SYH - OD _ CLAIM _ SLM3239Z _ DOA 04.03.2021- OWN DAMAGED (TYRE BOLD)

Please assist to arrange survey for vehicle no SLM3239Z. We are suspected the tyre bald.

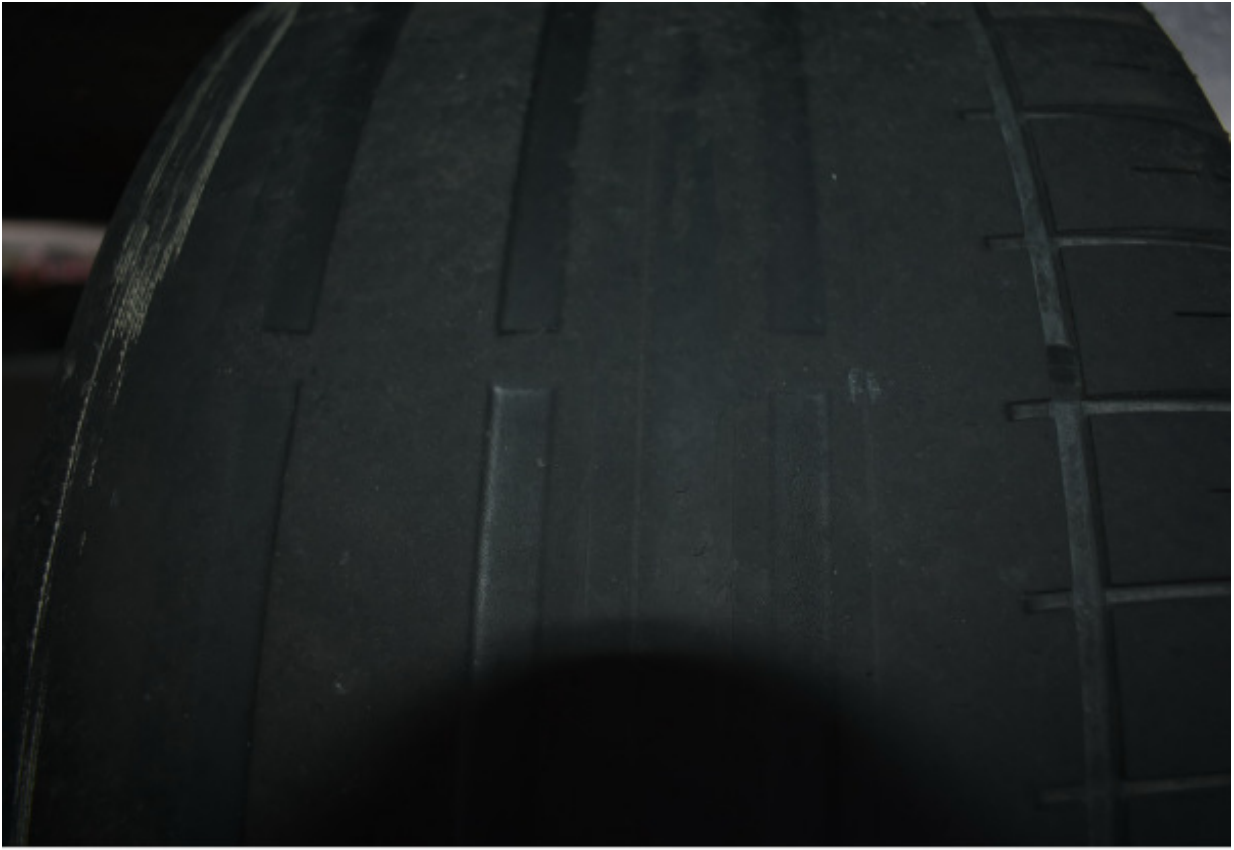
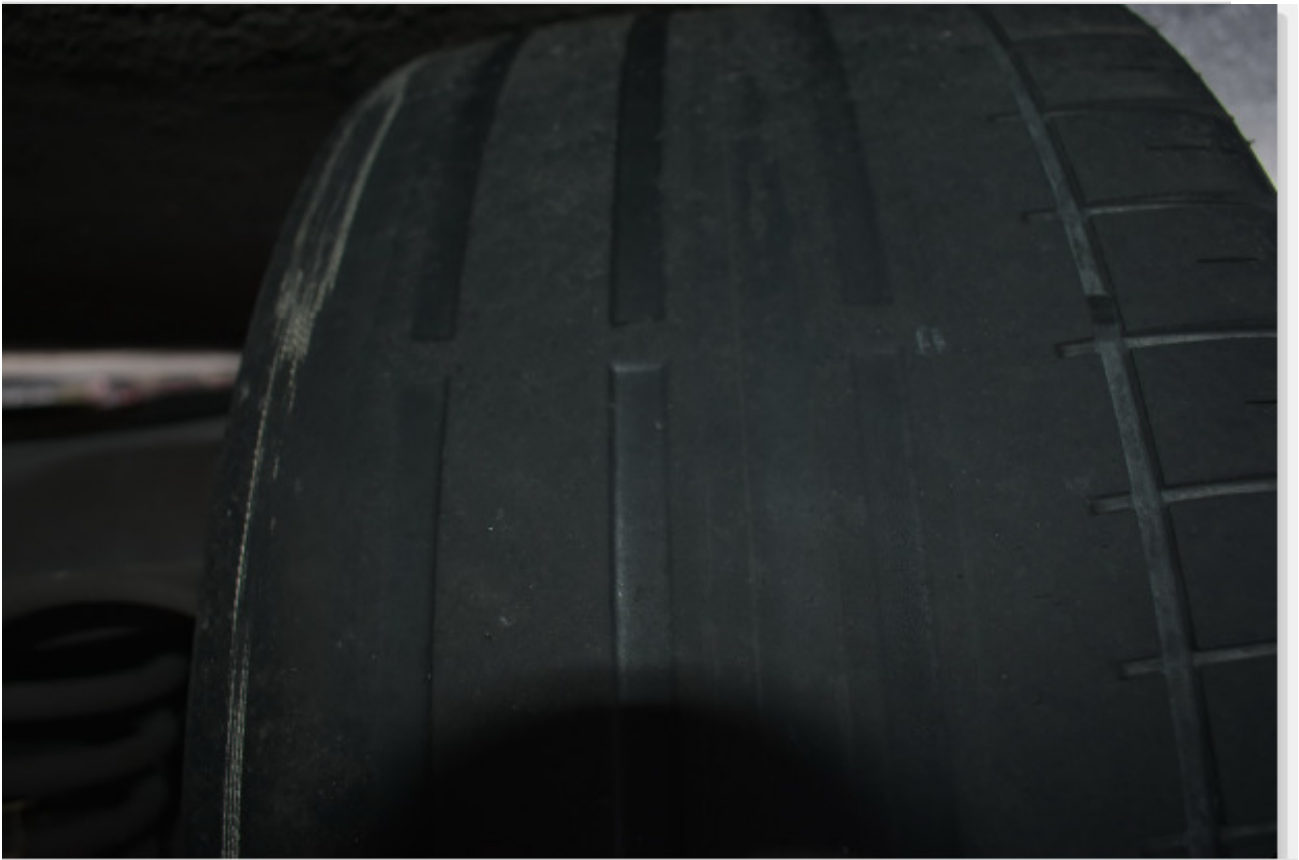
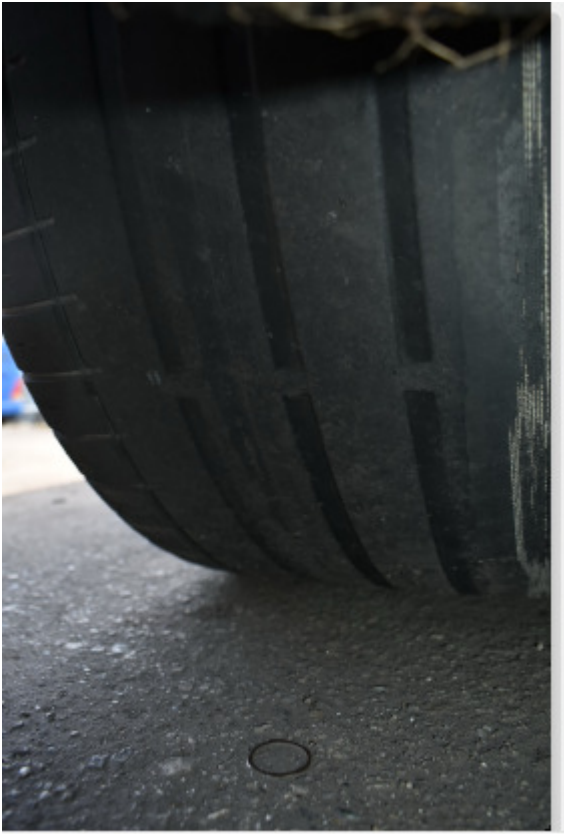
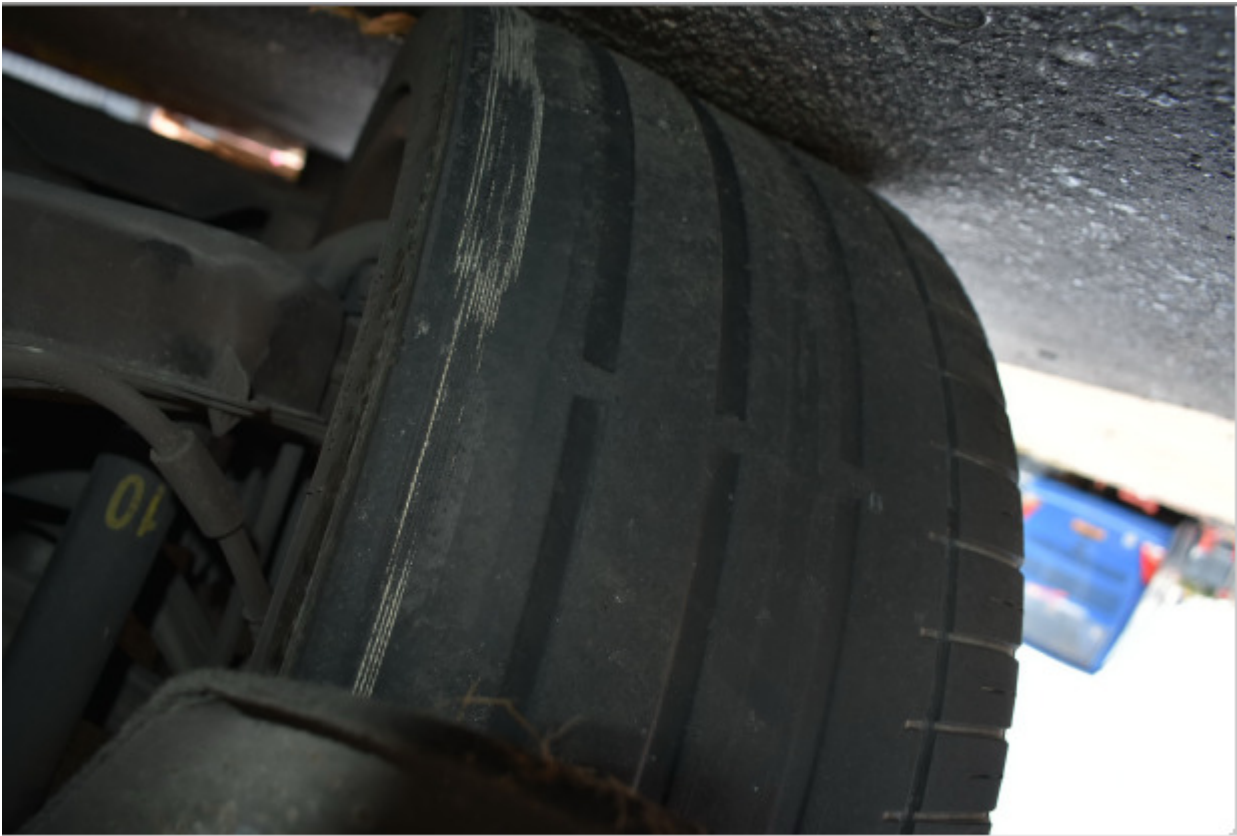
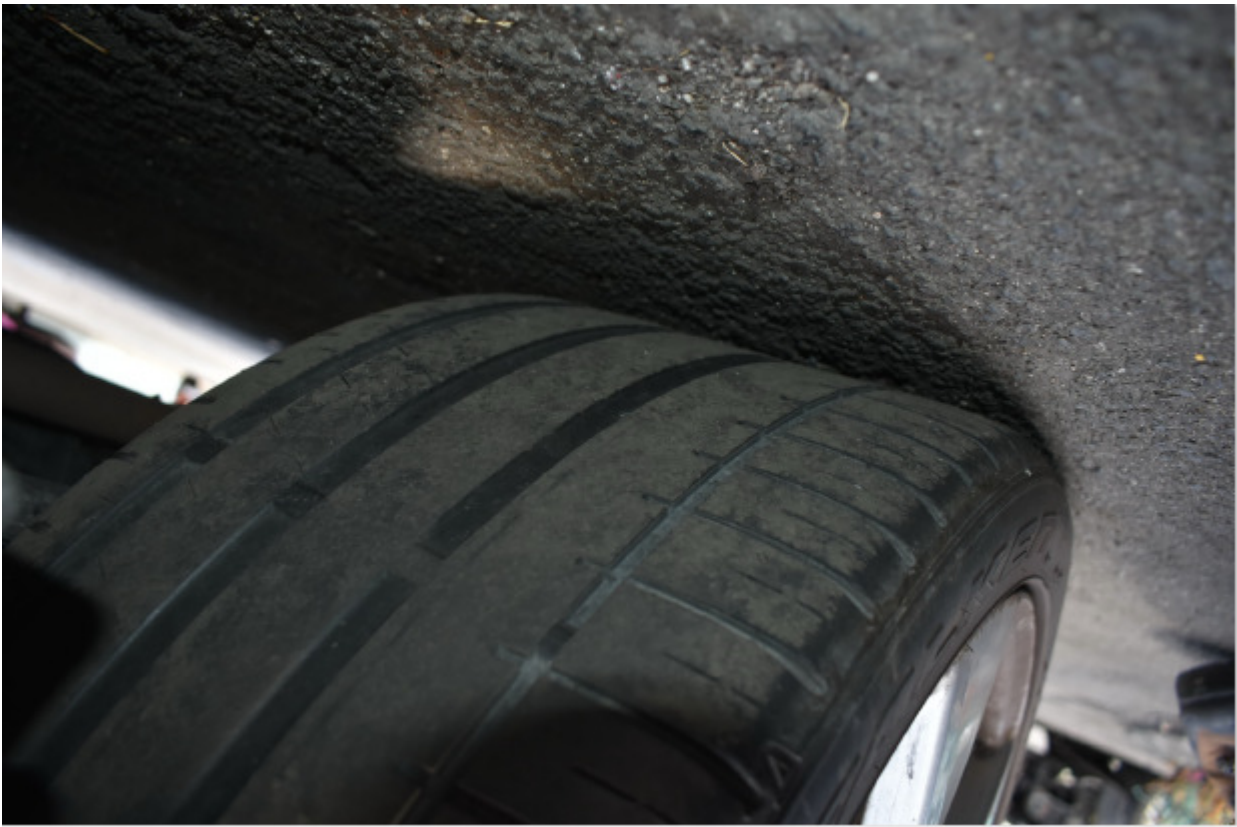
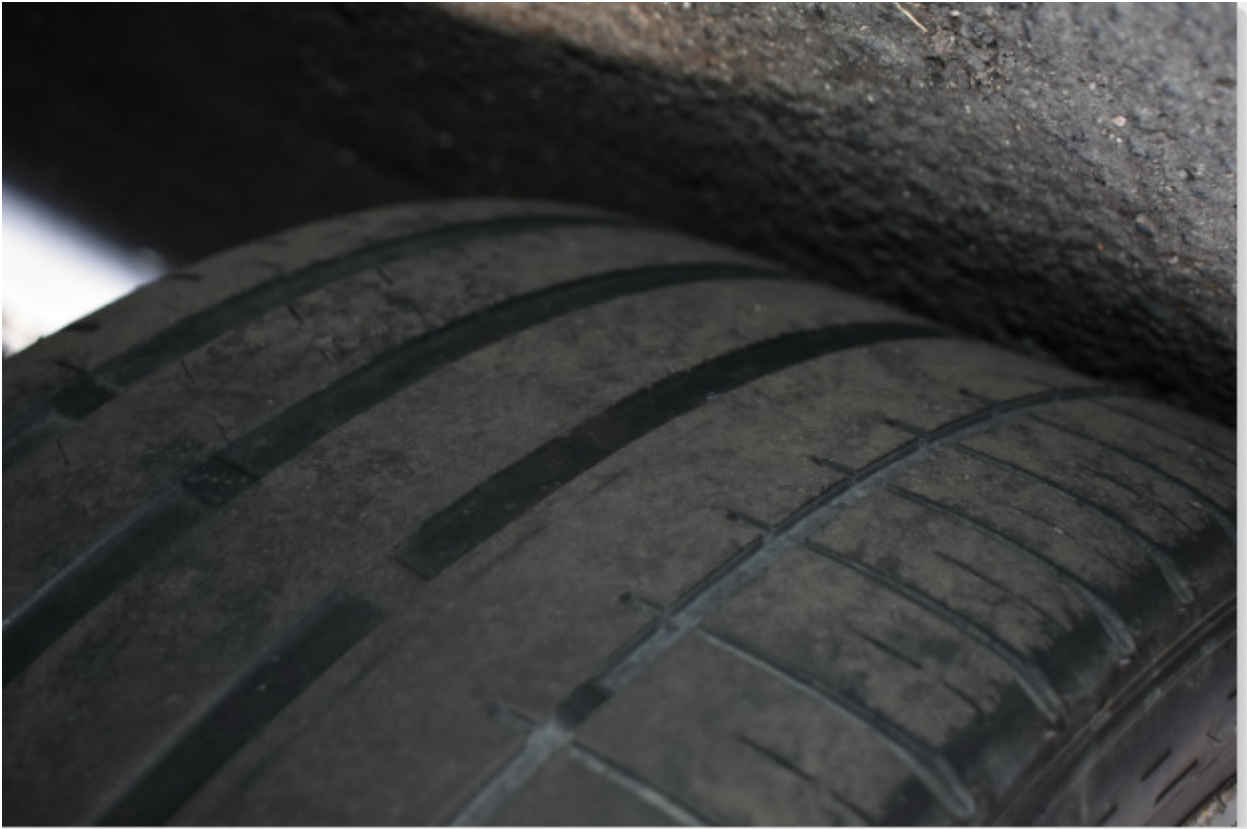
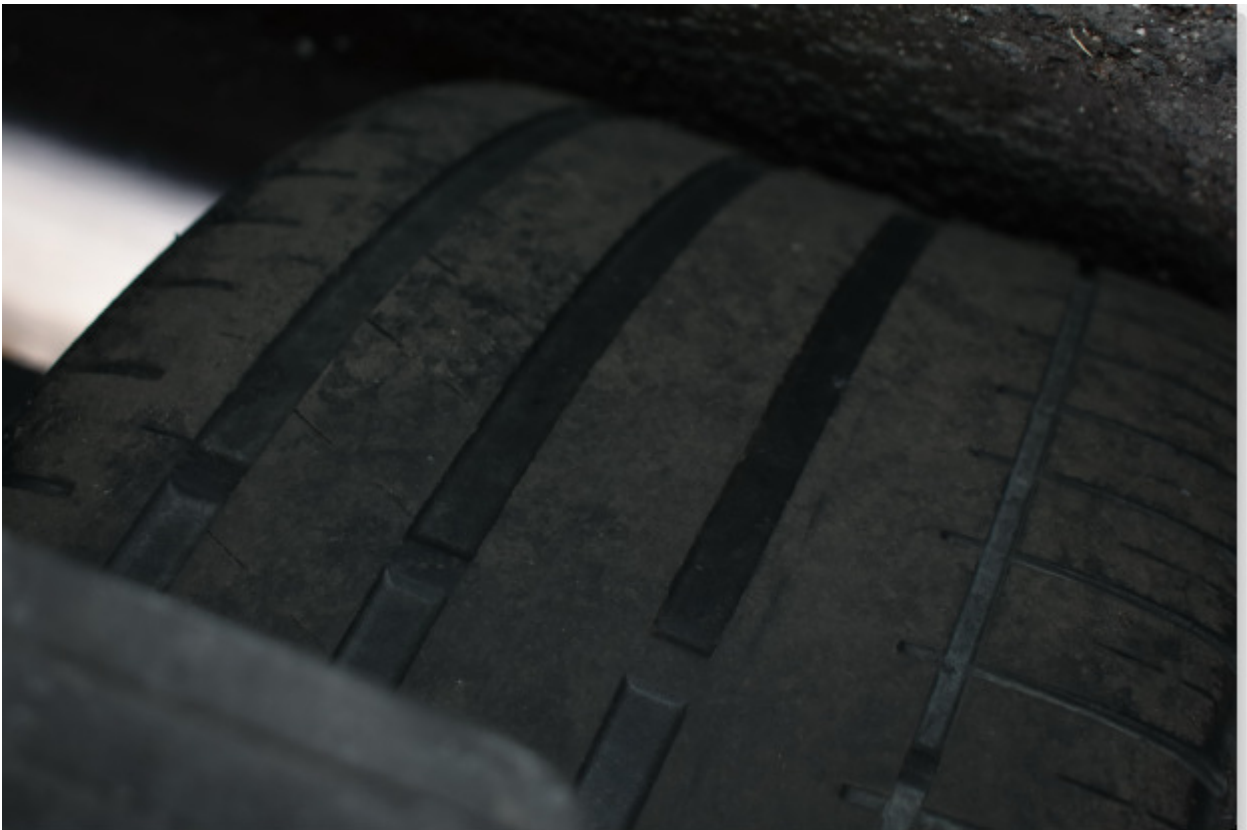
The condition of the rear left tyre does not comply with the legal requirement even though there is still some tread depth left. This is because the inner cords of the tyre were slightly exposed at the inner tread area due to rubber wear.

This **does not** comply with SECTION 109(e) CAP 276 of THE MOTOR VEHICLES (CONSTRUCTION AND USE) RULES, 1974, 1978 OF THE ROAD TRAFFIC ACT. Under this section it states that "*no person shall use, or cause or permit to be used on a road any motor vehicle or trailer, a wheel of which is fitted with a pneumatic tyre where the tyre has any portion of the ply or cord structure exposed*".

Attached herewith the photographs provided by our in house surveyor to shows the tyre excessive wear.

According to surveyor tyres of the insured vehicle with remaining thread depth of approximately Front 3mm and Rear 2mm. The condition of the tyres did not contribute to the accident.
Please see attached photos.
