## 1. Policy Particulars :- THIRD PARTY CLAIM

**ACCIDENT INVOLVING SMB1649H AND SJB7201L ON 6 FEB 2017 ALONG UPPER  
BUKIT TIMAH ROAD.**

THE VEHICLE SUSTAINED DAMAGES AT THE O/S FRONT PORTION. DAMAGES SEE DETAILS.
---

## ADJUSTMENT ON REPAIR COST FOR VEHICLE NO. SMB 1649H

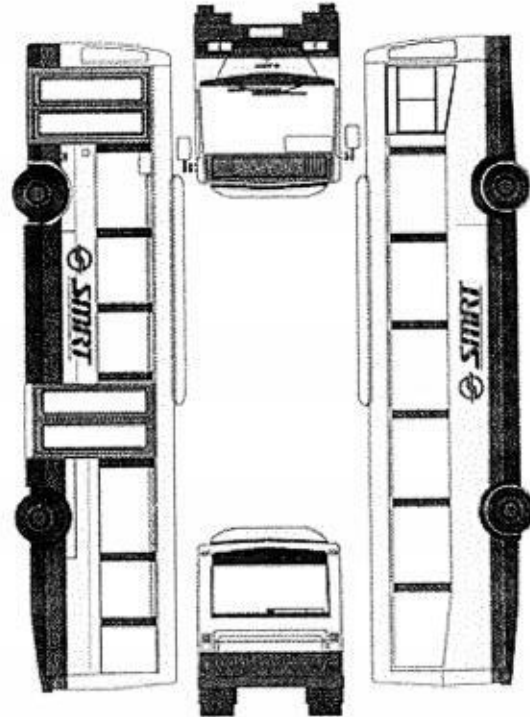
RIGHT FRONT PORTION.

Job Scope	Quotation from ARC	Adjusted by Surveyor, if applicable
TO REPAIR RH FRONT PORTION	795.00	530.00
<b>Total Labour</b>	<b>795.00</b>	<b>530.00</b>

Job Scope	Quotation from ARC	Adjusted by Surveyor, if applicable
PROVIDE LABOUR AND MATERIAL TO PUTTY AND RESPRAY ABOVE REPAIR ITEMS	446.00	300.00
<b>Total Spray Painting &amp; Panel Beating</b>	<b>446.00</b>	<b>300.00</b>

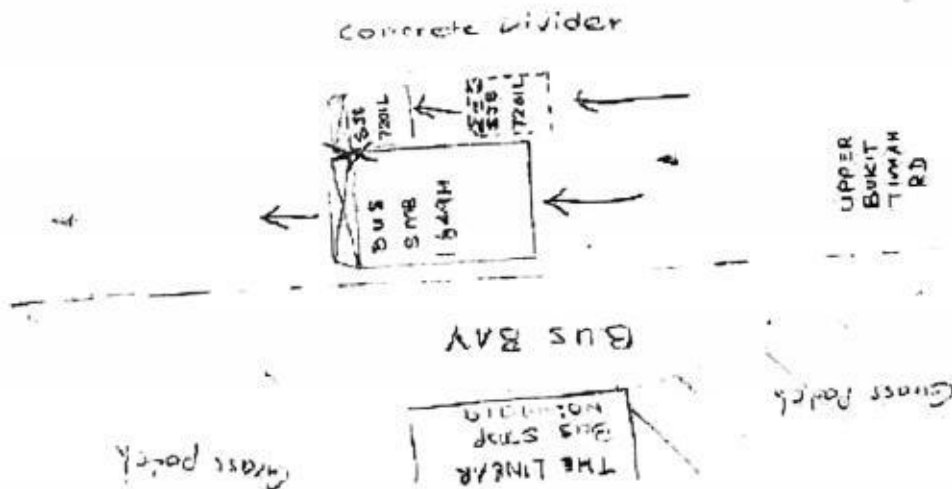
TP reported that he was travelling straight along Upper Bukit Timah Road towards Tampines at extreme left lane, suddenly our insured vehicle trying to overtake his bus and side swipe to his right front portion.

Based on damages sustained to both vehicles, we are of the opinion that at the time of the collision TP vehicle was slanting position. TP bus sustained damages onto right front corner and our insured vehicle sustained long grazed marks along its left side body, it's subjected that one vehicle is slanting position at the time of the collision. If both vehicles side swipe as alleged by Third Party, his bus should not be sustained damage on its right front portion corner only but also should have damages on its right side body.

Therefore, our insured version is more probable and we are intending to reject Third Party claim.

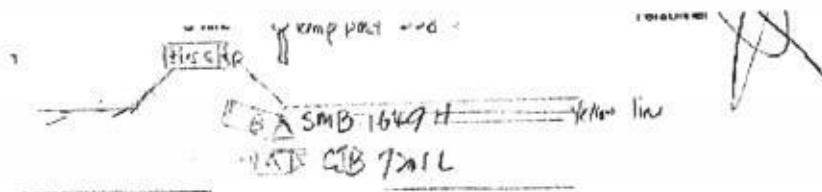
A - SJB 7201L (Insd).  
B - SMB 1649H

OI reported that TP was moving out from bus bay and collided to his vehicle while he passing by the bus stop.
