ASSIGNMENT

OD / TP / WS / TP RES / OD RES / EVA / INV / MVTo Inspect Vehicle No: SKN 8824Hat Workshop m/s. PERFORMANCEof 303, ALEXANDRA RDInsured: CTI

Veh No: SKN 8824H Yr Regn: 2014 JULYType: M. Car / M. Cycle / Bus / Van / Lorry / Taxi / Prime Mover /

Make: B.M.W 316I 1.6 AT c.c. 1598Colour: BLACK A/C: Insured / Std / NI / NASp. Reading: 137209 T/Radio: Insured / Std / NI / NA

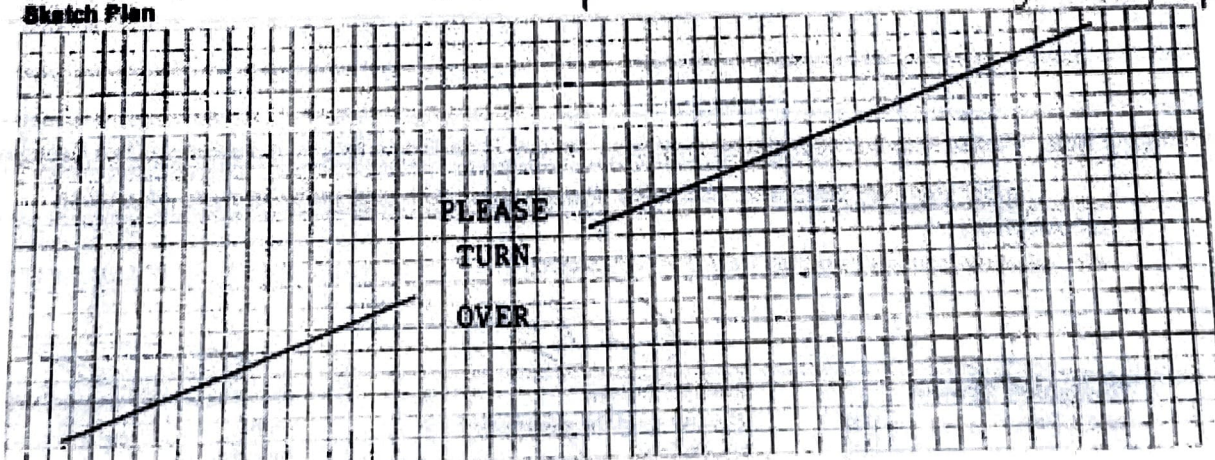
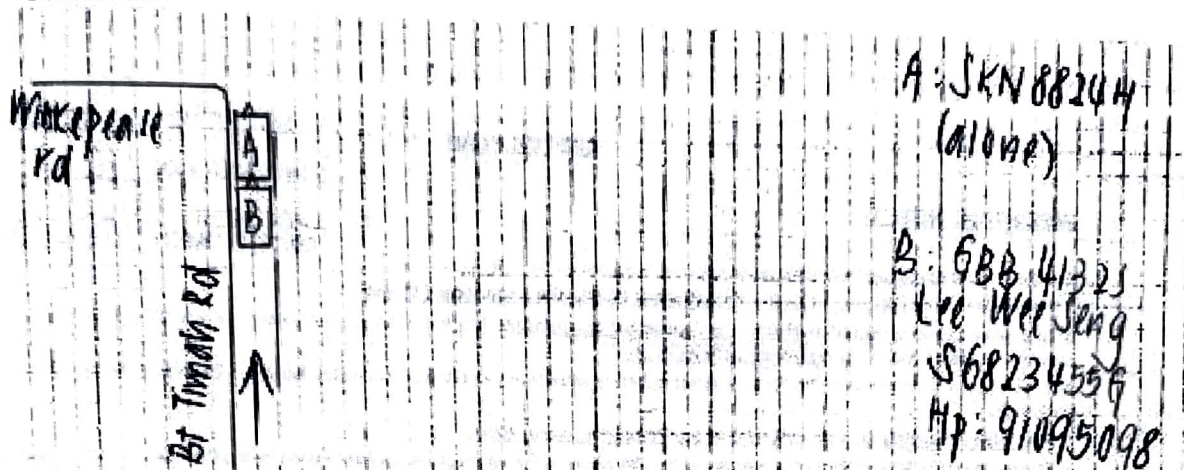
Sketch Plan

I follow front vehicles to slow down & stop. A moment later, felt an impact and realised motor lorry 6BB 41325 had hit onto the back of my stopped vehicle.
