**CLAIMANT: EDMUND VEHICLE RENTAL PTE LTD**  
**ACCIDENT INVOLVING YP5507S & PA7998E ON 13 NOVEMBER 2020 ALONG HOUGANG AVENUE 2 AT ABOUT 0850 HOURS**

**ACCIDENT VEHICLE INSPECTION / ASSESSMENT REPORT**

Our Ref: CL 12243 YP 5507 S

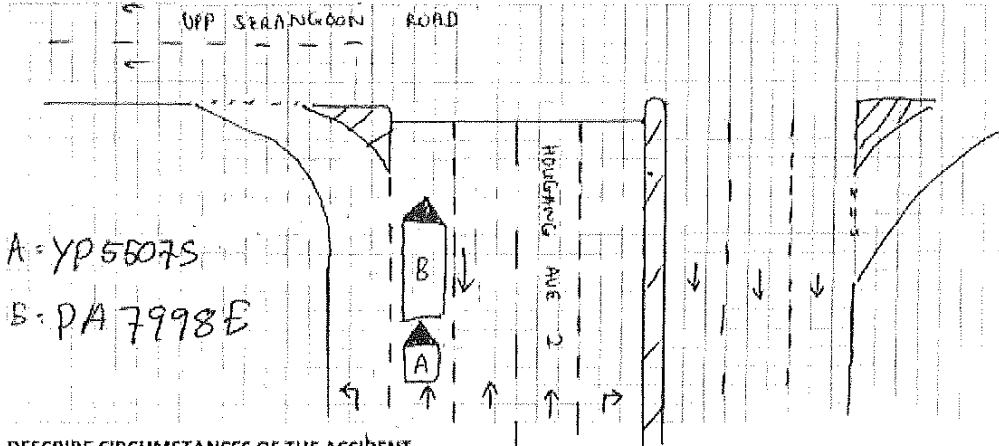
## SKETCH PLAN

REFER TO ATTACHED. VEHICLE B(PA7998E) REVERSED AND HIT FRONT PORTION OF VEHICLE A(YP5507S). PLEASE REFER TO SKETCH, STATEMENT AND VIDEO FOR TYPE OF ACCIDENT.

I WAS DRIVING YP5607S TOWARDS HOUGANG  
AVENUE 2, AT THE TRAFFIC LIGHT I PA7998E  
REVERSE AND HIT MY VEHICLE. *[Signature]*
