## LKK Auto Consultants Pte Ltd

## ADJUSTMENT ON REPAIR COST FOR VEHICLE NO. CB 8803B

### PHOTOGRAPHS FOR VEHICLE NO. CB 8803B

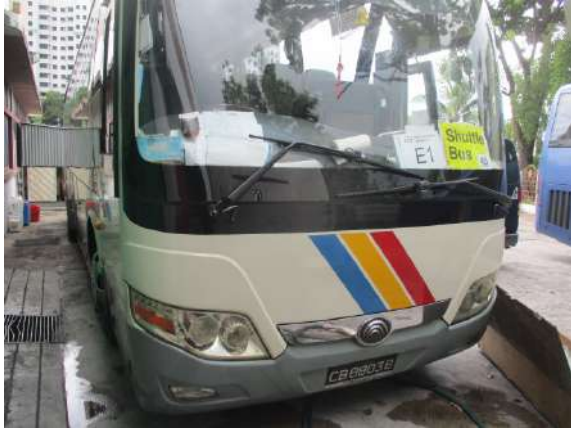
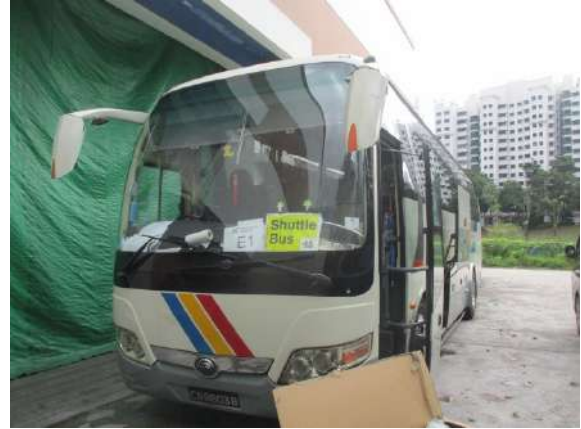
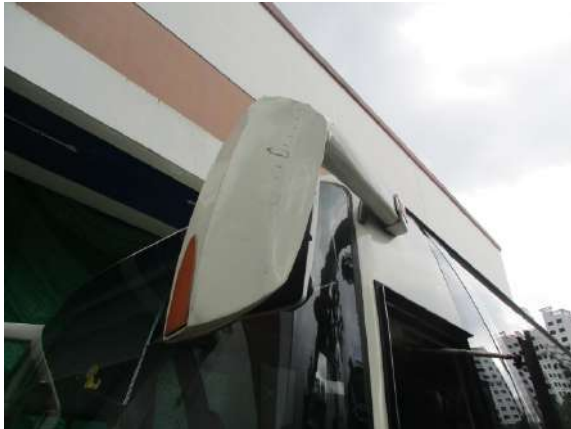
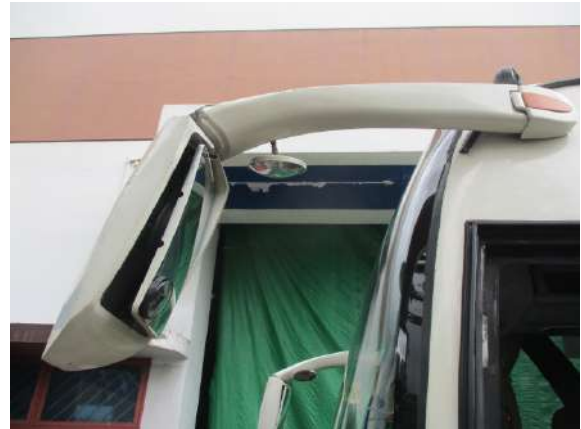
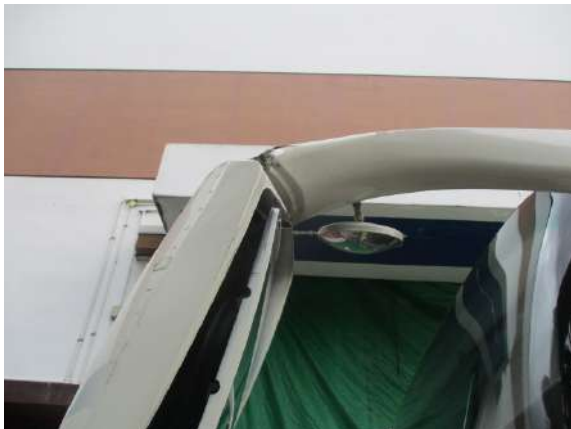
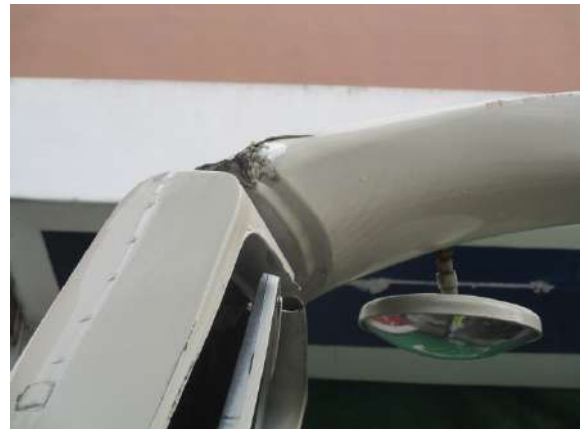
### INSPECTION

| Affiliated to Federation Internationale Des Experts En Automobile | | | | |
|---|---|---|---|---|
| | THE VEHICLE SUSTAINED DAMAGES AT THE N/S BODY.<br><br>DAMAGES SEE DETAILS. | | | |

| Qty | Description of Parts | Condition | Estimate By Workshop (\$) | Our Adjusted (\$) |
|---|---|---|---|---|
| | FRONT AUTO SIDE MIRROR WITH WARMER L/H (SN) | | 1,860.00 | 1,660.00 |
