ASSIGNMENT

To Inspect Vehicle No: SKT9574R

ESTIMATE : ACCIDENT REPAIRS
WORKSHOP : UBI ROAD 1
CONTACT NO : 6366 2323
FAX NO : 6841 1183
REFERENCE : PA/OD/0277/2021/HR
DATE : 1-Apr-21
WIP : 21811

ESTIMATED LABOUR CHARGES FOR ACCIDENT VEHICLE SKT 9574 R

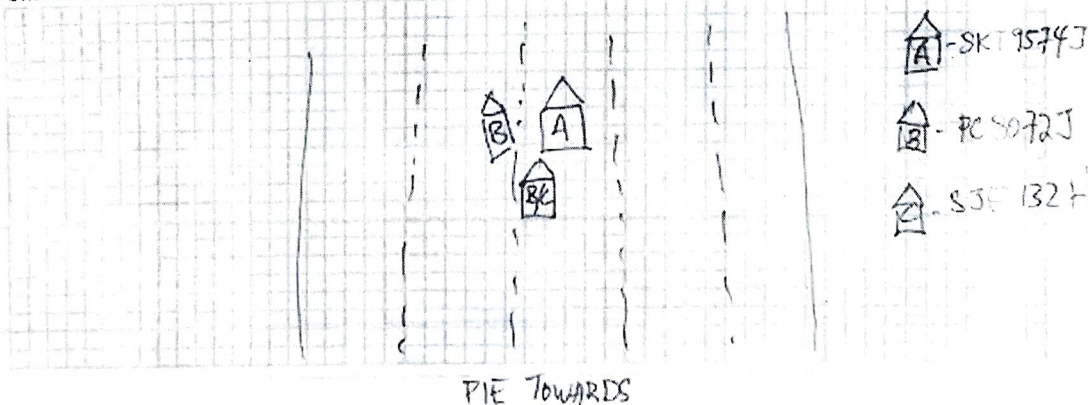
Sketch Plan

I was driving on the PIE towards Changi and just passed the Jln Bahar exit. I was on the 3rd lane heading towards the KJE (BKE) exit when the cars in front of me slowed down and came to a stop so I also slowed down and stopped behind the car in front of me. I saw from my rear view mirror that a white van was coming towards me very fast, and in order for it to try to avoid hitting directly into my rear, it swerved to the left. Unfortunately, it still hit the rear left side of my car. The van then came to a stop on the lane next to me on my left. Soon after that, another car behind the white van - a Toyota car - also hit into my rear on the left side.
