## ASSIGNMENT

Veh No: GBD 3339J Yr Regn: 2014 / SEP  
 Type: M.Car / M.Cycle / Bus / Van / Lorry / Taxi / Prime Mover /  
 Truck / Trailer or \_\_\_\_\_  
 Make: Nissan NV350 9.V 2.5 SAT C.C. 2489  
 Colour: GREY A/C: Insured / Std / NI / NA  
 Sp. Reading: \_\_\_\_\_ T/Radio: Insured / Std / NI / NA  
 Eng/No: \_\_\_\_\_  
 C/No: INIM C2E2620003024  
 Gen. Cond: Good / Fair / Poor / Burnt  
 Steering: Order / Jammed / Leaked / Burnt or  
 Brake: Order / Jammed / Leaked / Burnt or  
 Modi: Nil / S/Rim / STD A/Rim or  
 Tyre Size: F: 195R15C  
 R: \_\_\_\_\_  
 BS / DUN / EXNOVA / GY / FS / LIZA / MIC / OHTSU / PIR / SUMI /  
 TOYO / YOKO or \_\_\_\_\_  
 Front \_\_\_\_\_ Rear \_\_\_\_\_  
 R/Bal. 6 mm R/Bal. 6 mm  
 L/Bal. 6 mm L/Bal. 6 mm  
 D.O.A. 22/03/21 D.O.I. 09/04/21  
 Survey held at YONG SING MOTOR  
 Des. of Damages: Front / Rear / O/S / N/S / U/C / Rooftop or

### Yong Sing Estimate Repair

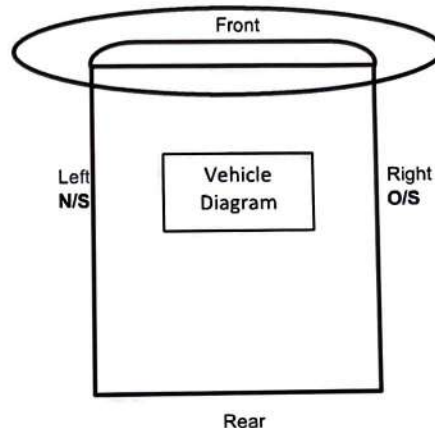
The U/C / Chassis frame / Body Structure affected due to collision.

The damages on the vehicle are as indicated in the following diagram :

| Job Scope | Yong Sing Estimate | Surveyor Adjustment |
|---|---|---|
| REMOVE AND REFIT DAMAGED ITEMS, PULL AND REALIGN VEHICLE FRAME. WELD AND REFIT NEW PARTS. | \$3,500.00 | 2000 |

| Job Scope | Yong Sing Estimate | Surveyor Adjustment |
|---|---|---|
| PULL AND REALIGN FRONT CHASSIS. | \$400.00 | 200 |

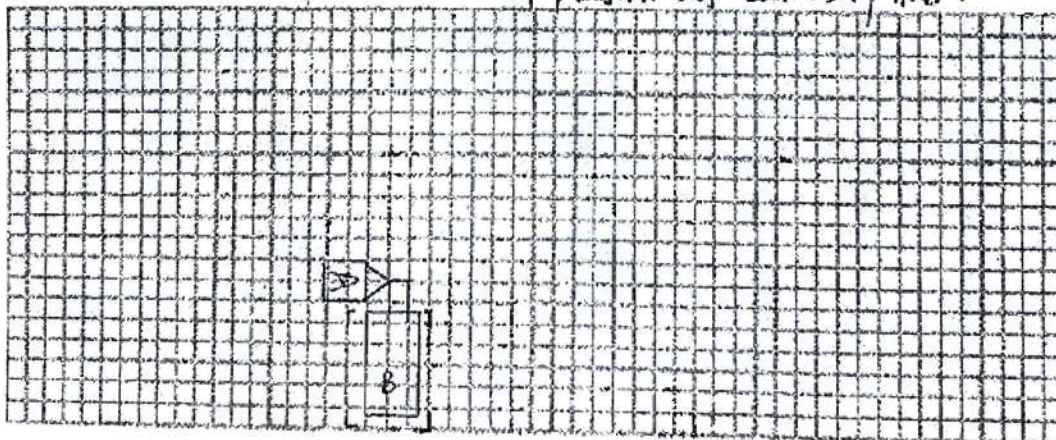
Sketch Plan

I WAS TRAVELLING TO 24 PENJURU CWT COMMODITY HUB TO COLLECT MY PARCELS FOR MY DELIVERY. I DROVE TO THE LOADING / UNLOADING BAY AS USUAL. ALL OUT OF SUDDEN MY VEHICLE COLLIDED ONTO AN OBJECT WHICH PARKED OUT OF THE PARKING LOT.

A : GBD3339 ]  
B : container
