VEHICLE INSPECTION REPORT

Name of Workshop : Lush Automotive Pte Ltd
Place of inspection : 8 Kaki Bukit Ave 4 #03-47, Premier @ Kaki Bukit, Singapore 415875
Date of Accident : 08 April 2021
Date of Inspection : 14 April 2021

Registration No.	: SLM 868C	Chassis Frame No.	: WP1ZZZ95ZFLB66995
Make / Model	: Porsche Macan S 3.0 AT 4WD	Engine No.	: 018245
Year of Registration	: 2015	Odometer Reading	: 68,744 KM
Class / Type	: SUV	Colour	: Blue

ASSESSMENT SUMMARY

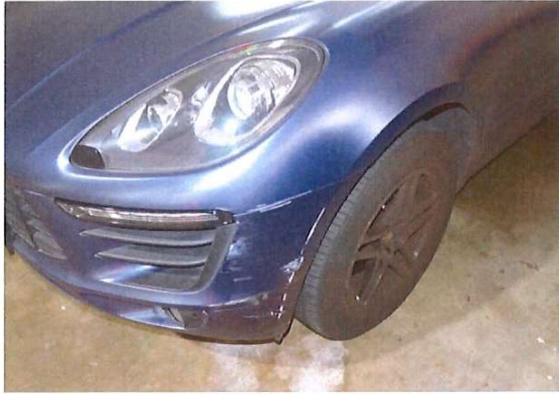
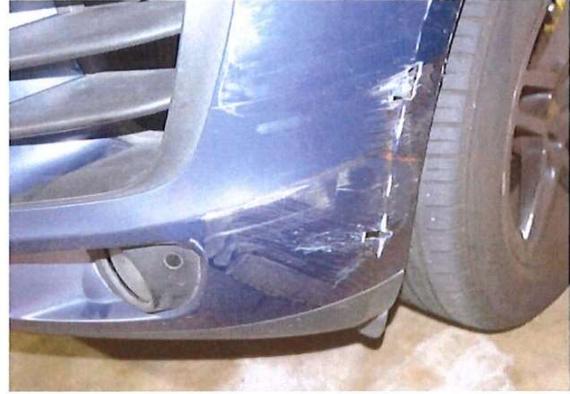
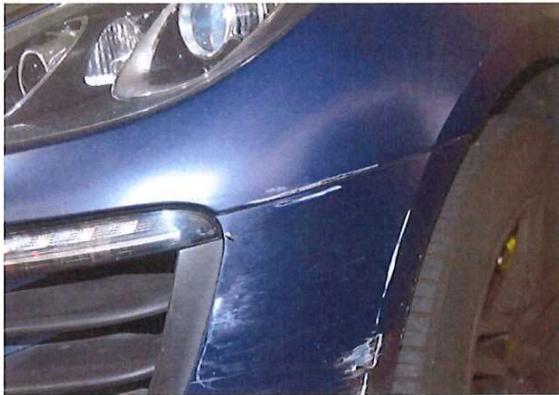
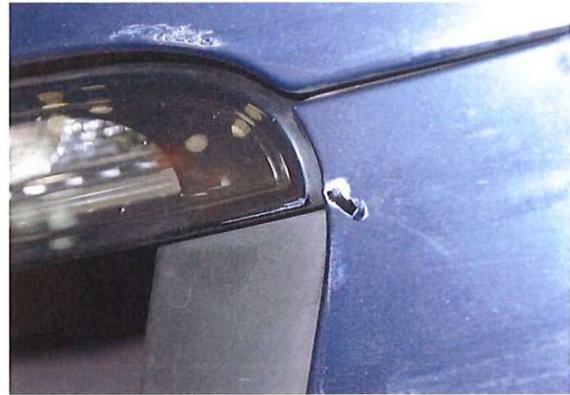
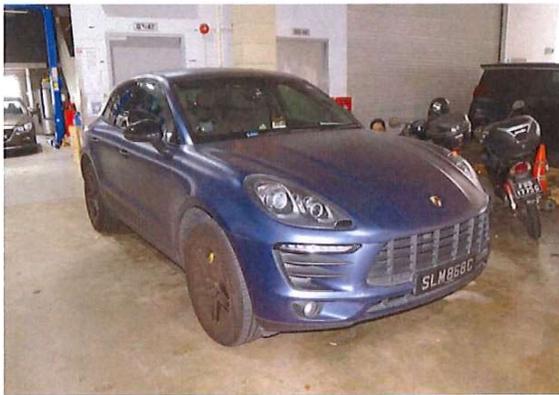
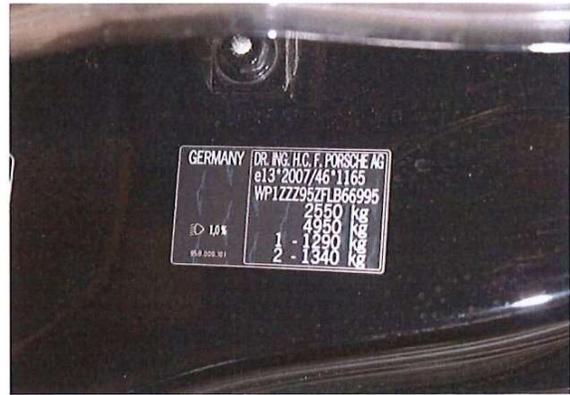
Damages sustained were consistent with the subject vehicle being involved in a collision with another vehicle and the impact of the collision was delivered **Diagonally to the LH Side from rear to front; left to right;** portion of the vehicle.

(Please refer to the list and survey photographs as attached for more information)

Enclosed No. Of Photograph : 28
(at the time of static inspection)

Our attached assessment schedule has been checked throughly by us against the actual damages sustained on the vehicle, and we recommend the replacement of parts and repair accordingly. We have adjusted the cost and the repairer has agreed to undertake the repair at the recommended sum to a acceptable quality and standards. We have not given authorization and instruction to the repairer to proceed with the repairs.

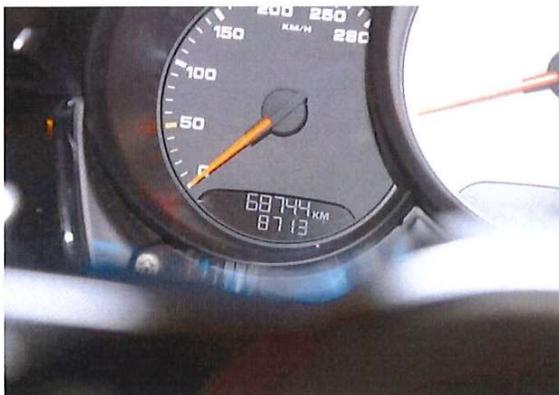
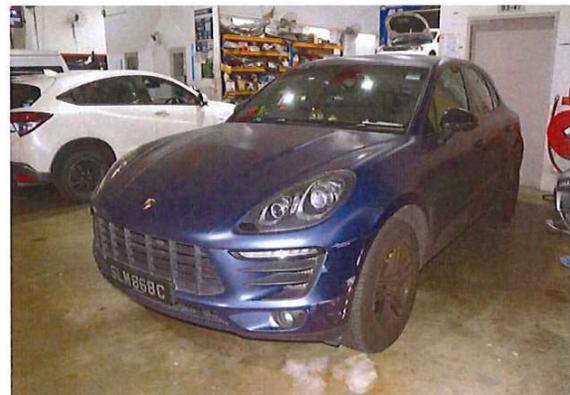
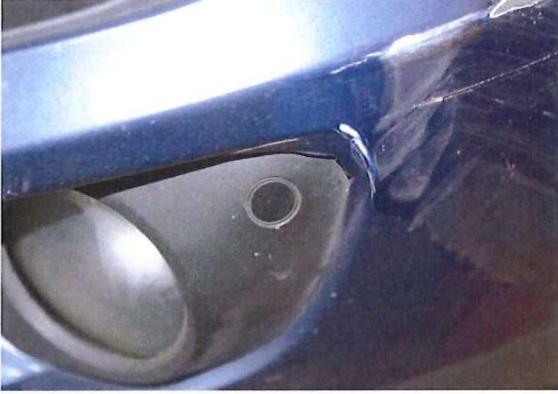
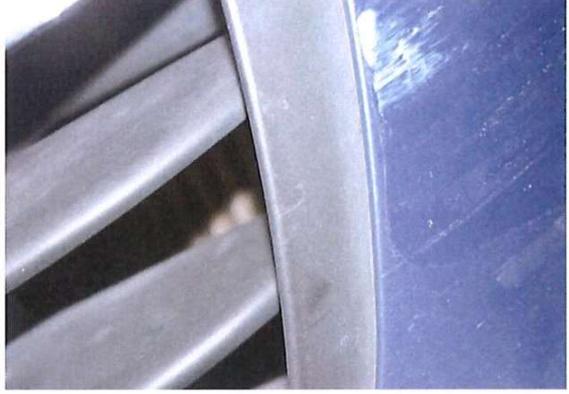
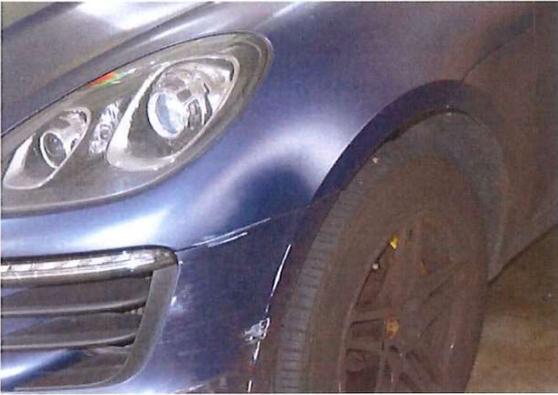
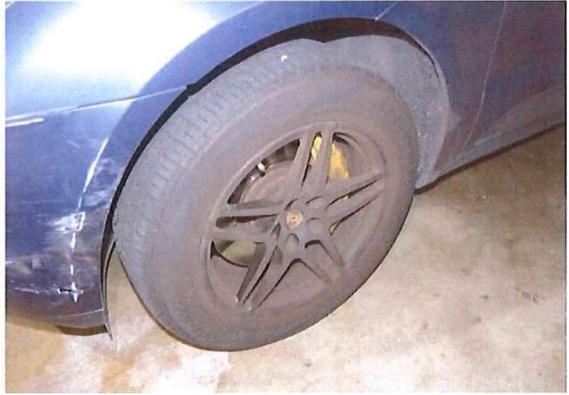
<u>SN</u>	<u>Qty</u>	<u>Descriptions</u>	<u>Conditions</u>	<u>Repairer's Estimate</u>	<u>Surveyor's Revised</u>
LIST ITEMS:-					
1	1 pc	front bumper	deformed	\$ 2,920.00	\$ 2,920.00
2	1 pc	front bumper l/h side grille	scratched	\$ 259.00	\$ 259.00
3	1 pc	front bumper l/h fog lamp	scratched	\$ 647.00	\$ 647.00
4	1 pc	front bumper l/h side retainer	necessary	\$ 290.00	\$ 290.00
5	1 pc	front bumper r/h side retainer	necessary	\$ 290.00	\$ 290.00
6	1 pc	l/h front fender	damaged	repair	repair
				\$ 4,406.00	\$ 4,406.00
Less 10%					\$ 440.60
				\$ 4,406.00	\$ 3,965.40
