Affiliated to Federation Internationale Des Experts En Automobile							
	QBE INSURANCE	(S) PTE LTD		Ref:	CC4/QBE21005044/Aea3q2			
	1 RAFFLES QUAY TOWERSINGAPOR			Date:	05/05/2022			
				Code:	QBE

ADJUSTMENT ON REPAIR COST FOR VEHICLE NO. SMP 7909U

PHOTOGRAPHS FOR VEHICLE NO. SMP 7909U

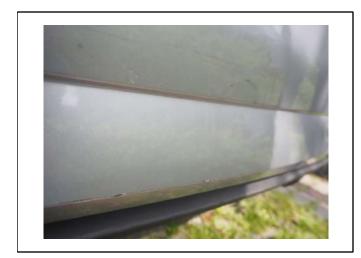
4.		Description	on of Damages					
	THE VEHICLE SUS	STAINED DAMAGES AT THE REA	AR PORTION.					
	DAMAGES SEE DETAILS.							
5.		General	Information					
	Accident Date	19/04/2021	Inspection Dat	e	22/04/2021			
	Survey held at	PREMIUM AUTOMOBILES PTE	LTD					
		55 UBI ROAD 1 . SINGAPORE 408699						
5a.		Re	emarks					
	A)THE INSPECTION WAS CONDUCTED ON A"WITHOUT PREJUDICE" BASIS. B)IN ACCORDANCE TO YOUR INSTRUCTIONS, WE HAVE NOT AUTHORISED REPAIRS.							
5b.	Estimate Days of Repair							
	ESTIMATED NORM	MAL PERIOD FOR REPAIR:		3 Worki	ng Days

Qty	Description of Parts	Condition	Estimate By Workshop (\$))	Our Adjusted (\$)
	REPLACEMENT OF PARTS			
1	REAR BUMPER (SN)	DEFORMED	1,944.00	1,944.00
1	REAR BUMPER FIXING PARTS (SN)	NOT NECESSARY	193.00	-
2	REAR BUMPER GUIDE SECTION -LH/RH (SN)	NOT NECESSARY	32.00	-
1	REAR BUMPER SPOILER (SN)	NOT NECESSARY	237.00	-
1	REAR BUMPER REINFORCEMENT BEAM (SN)	NOT NECESSARY	603.00	-
2	REAR BUMPER BRACKET -LH/RH (SN)	NOT NECESSARY	56.00	-
1	SUNDRIES (SN)	NOT NECESSARY	200.00	-
			3,265.00	1,944.00
	<u>LABOUR</u>			
	TO REMOVE AND RENEW REAR PARKING AND CHECK FUNCTION.		280.00	280.00
	TO DISMANTLE AND RENEW BUMPER RE-ORGANISE CRASH MANAGEMENT COMPONENTS REINSTALL ALL PARTS REMOVED.		1,050.00	700.00
	TO RESPRAY REAR BUMPER .		900.00	700.00
	TO CARRY OUT DIAGNOSTIC CHECK.		192.00	192.00
			2,422.00	1,872.00
	GRAND TOTAL		5,687.00	3,816.00
