PROPERTY DAMAGES CLAIMS AS A RESULT OF A ROAD TRAFFIC ACCIDENT INVOLVING MOTOR VEHICLES NO. SKR2592U AND SMA7978Z ALONG GAMBAS AVE ON 23.12.2020.

#### ACCIDENT DAMAGED VEHICLE INSPECTION REPORT

Our Ref : WG/TP/2021-32

VEHICLE NO: SKR2592U MODEL: COOPER'S COUNTRYMAN FWD SR DSC HID

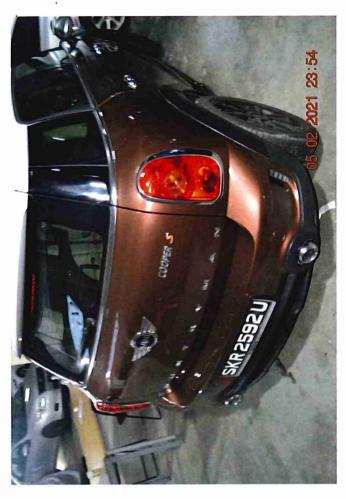
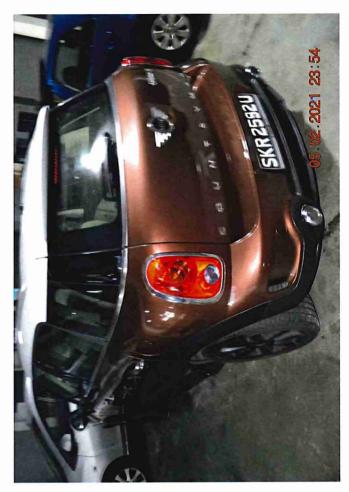
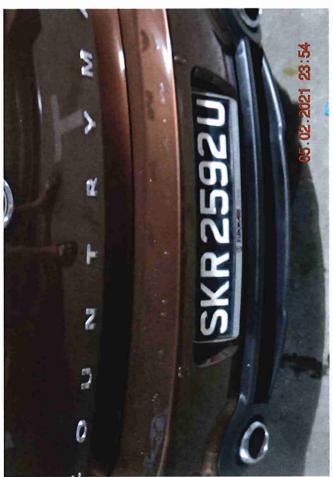
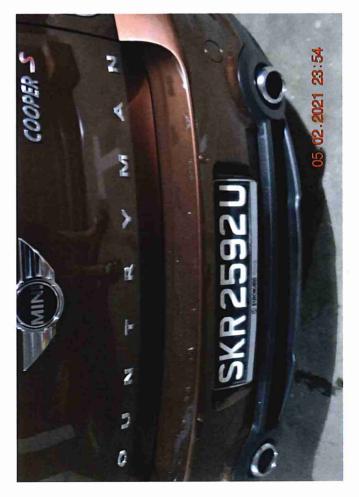
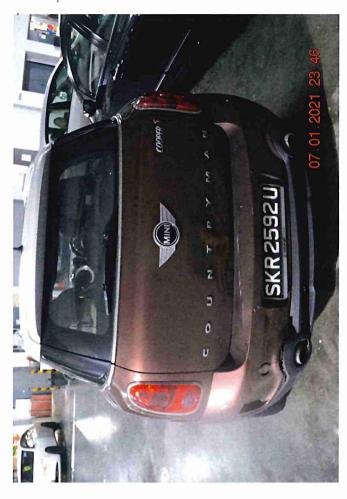
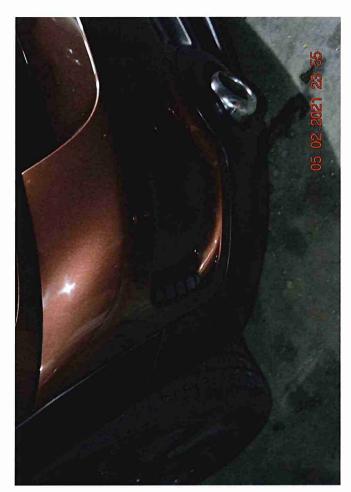
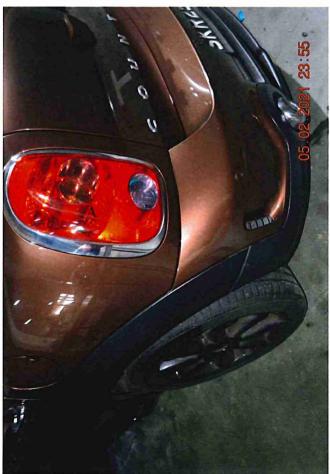
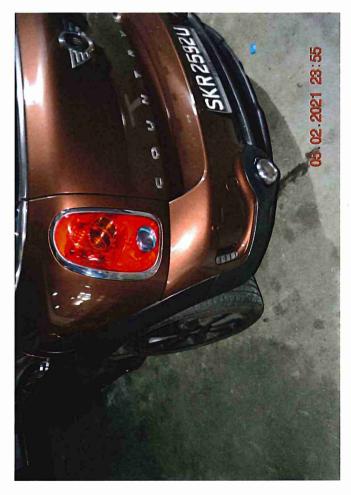
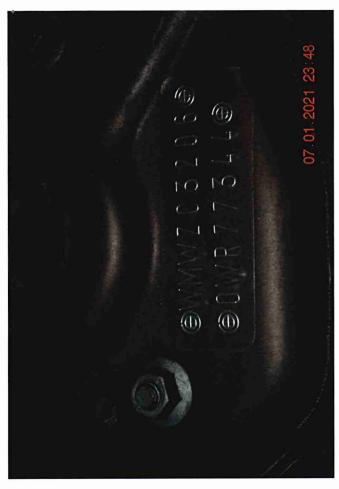
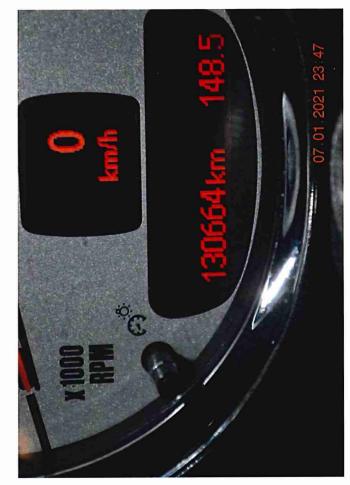
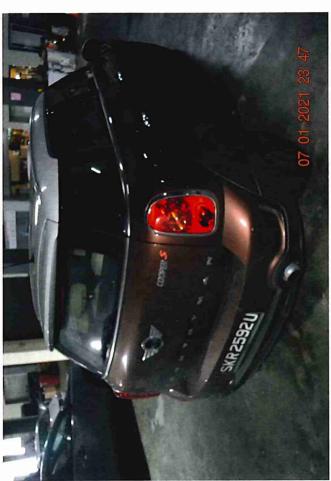
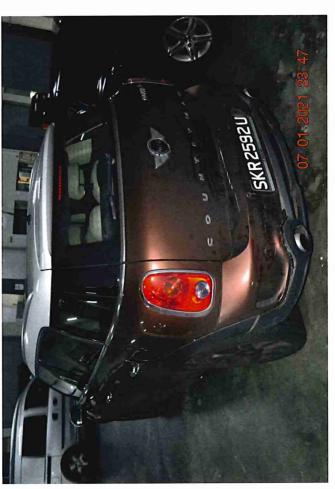
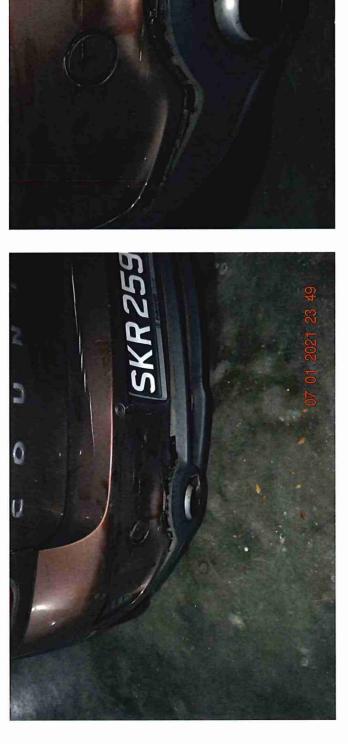
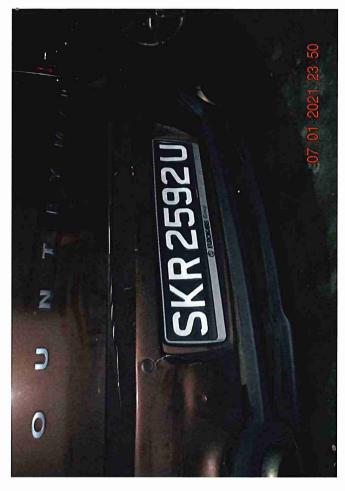
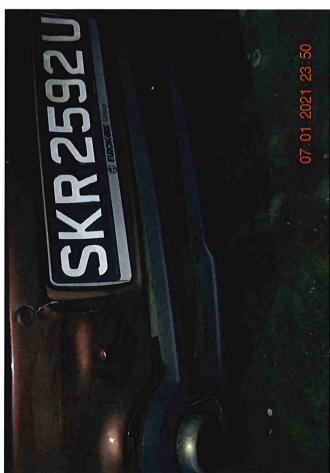
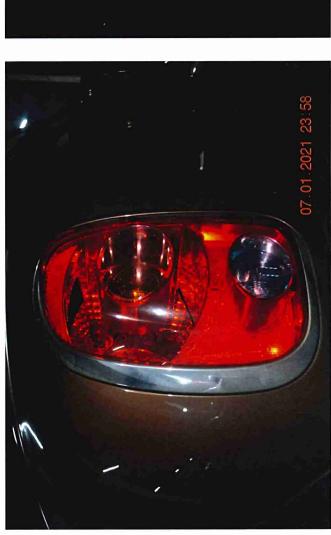
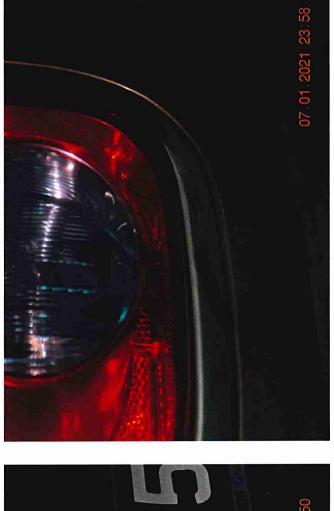
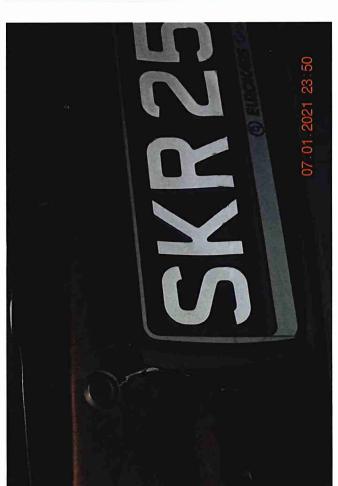
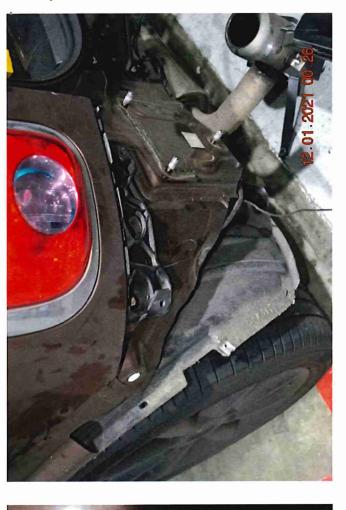
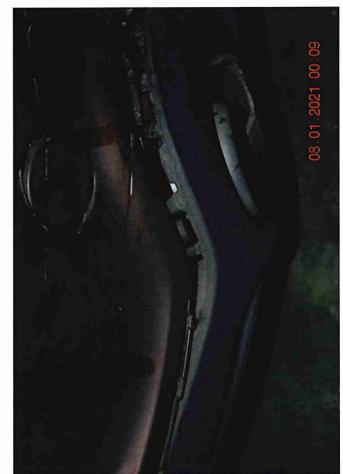
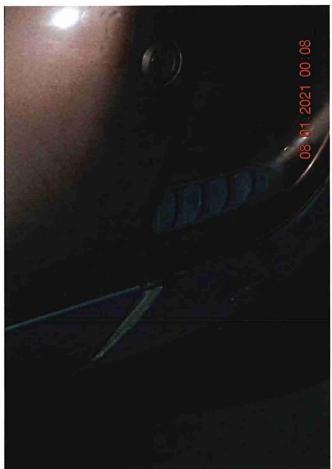
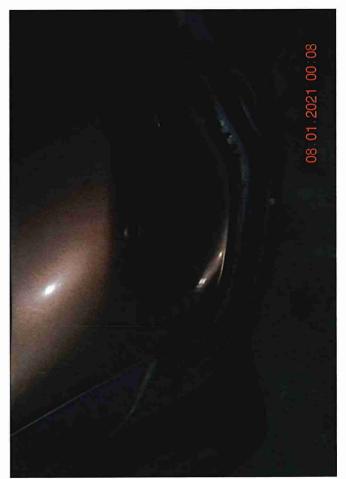
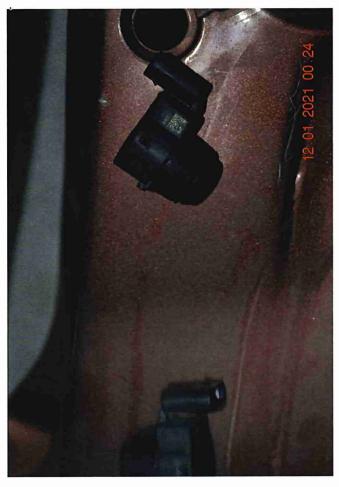
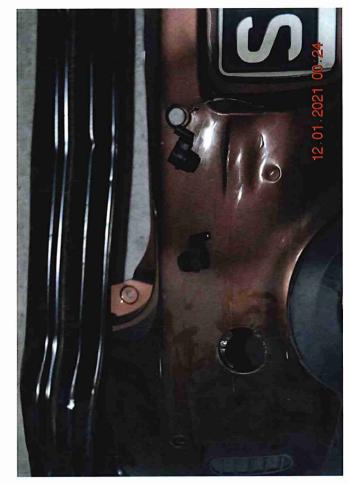
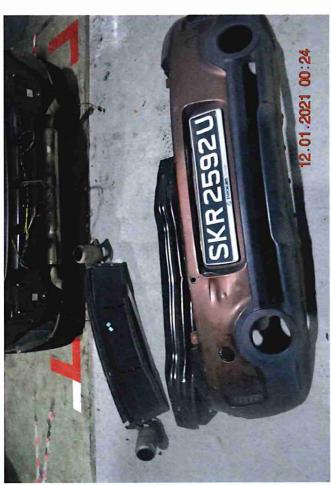
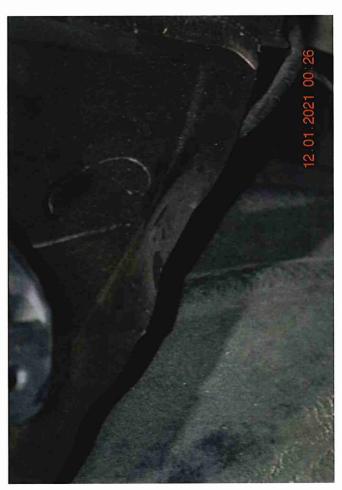
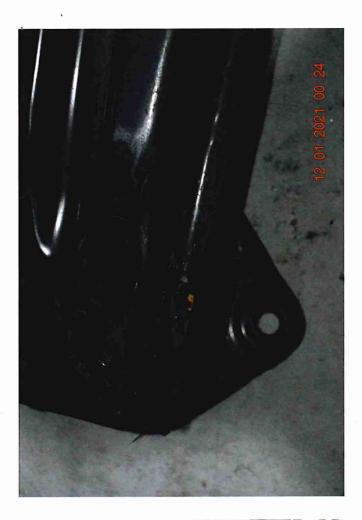
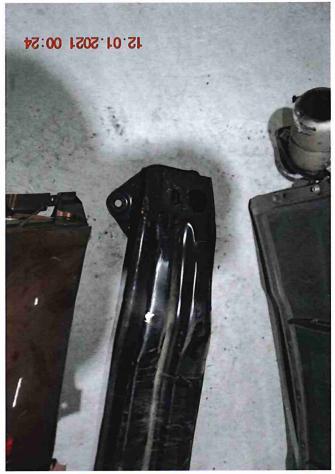
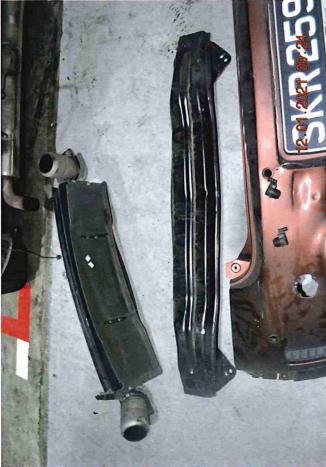
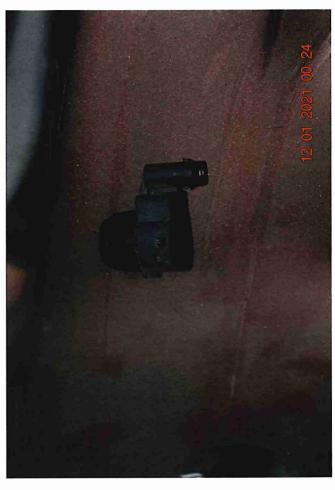
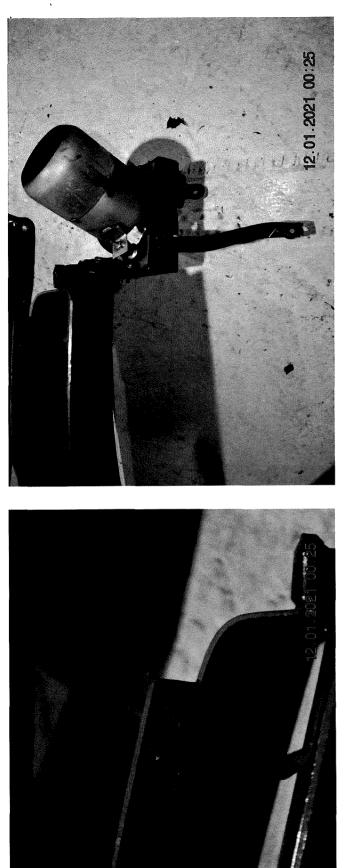
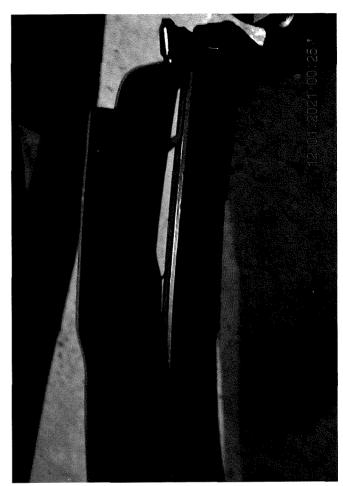
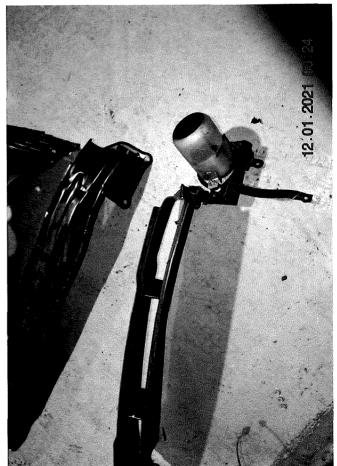
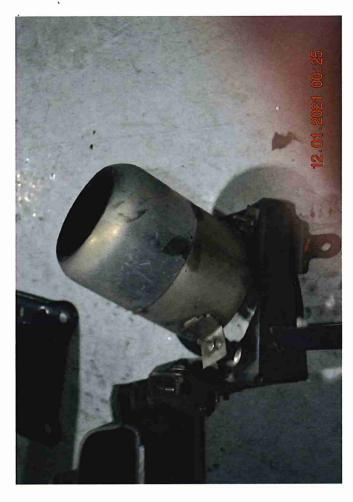
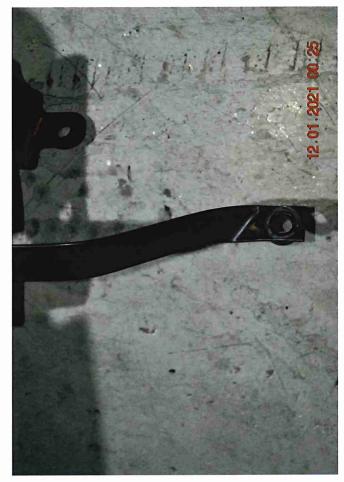
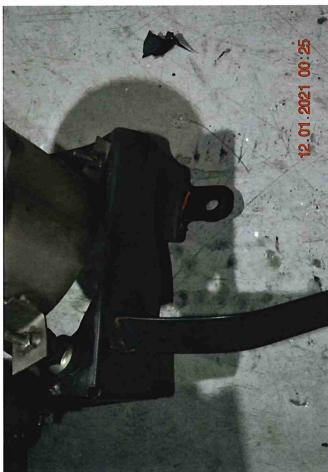
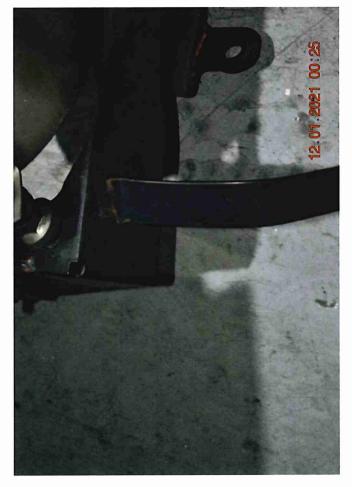
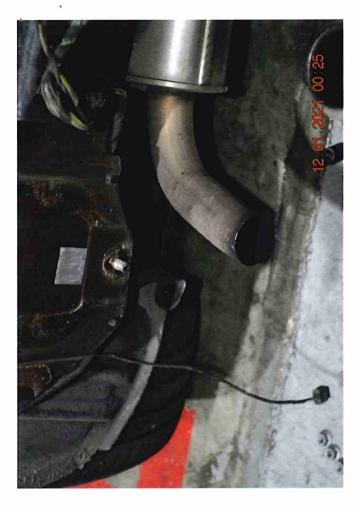
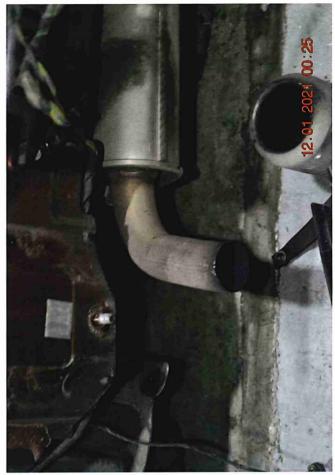
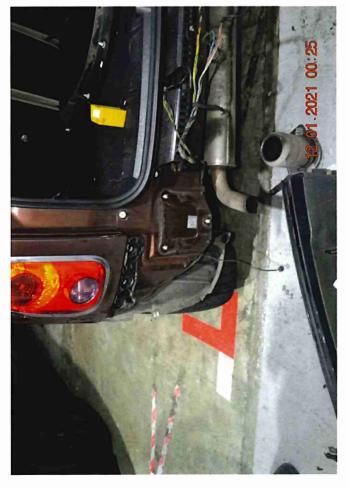
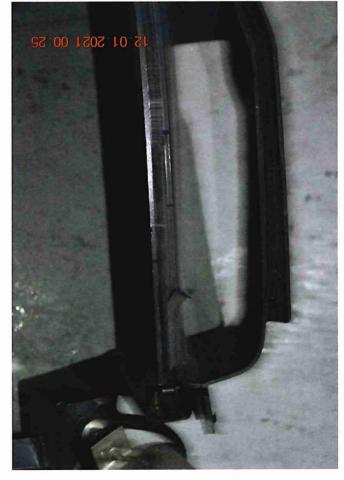
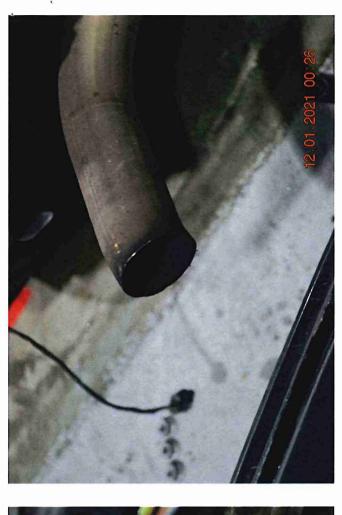
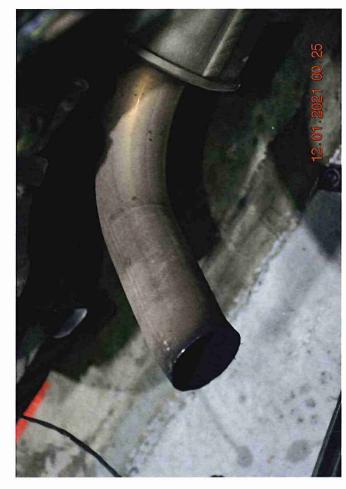
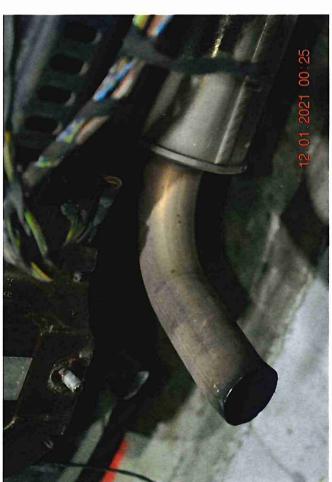
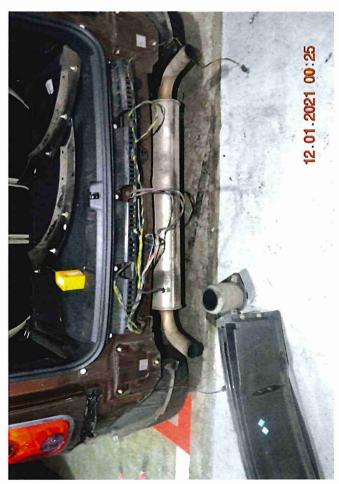
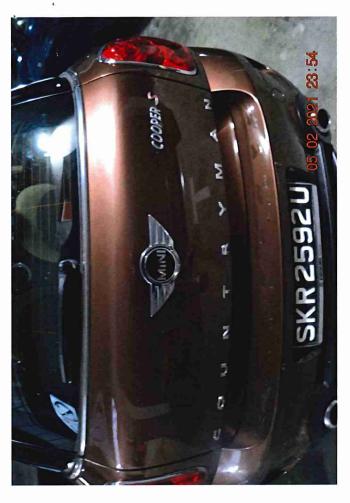
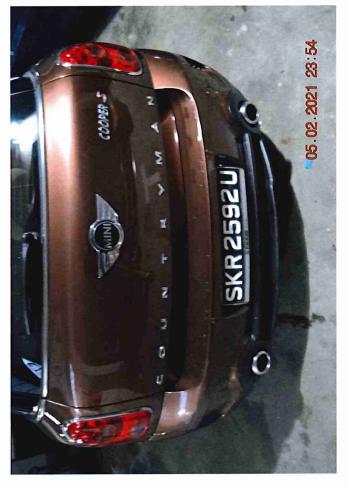
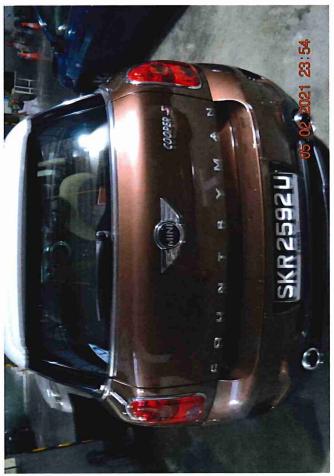
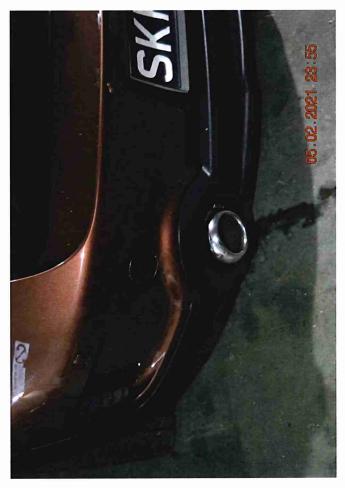
The vehicle sustained damage at the rear right portion.

Enclosed Sixty (60) photographs depicting damage to the vehicle.

QTY	ASSESSED		ORIGINAL		REVISEI
)_	SPARE PARTS	PC/SET	CONDITION		QUOTATION	Q	UOTATION
	REAR BUMPER	1	CRACKED	\$	1,195.00	-\$	1,195.00
	REAR BUMPER RETAINER	2	NECESSARY	\$	158.00	\$	158.00
	REAR BUMPER GARNISH	1	DEFORMED/CRACKED	\$	780.00	\$	780.00
	REAR BUMPER TOW COVER	1	CRACKED	\$	78.00	\$	78.00
	REAR BUMPER REINFORCEMENT	1	DENTED	\$	558.00	\$	558.00
	REAR BUMPER INNER BRACKET	1	CRACKED	\$	240.00	\$	240.00
	REAR BUMPER UNDER GARNISH	1	DEFORMED	\$	1,450.00	\$	1,450.00
	END PANEL	1	DENTED	\$	788.00	\$	788.00
	END PANEL TOP GANRISH	1	CRACKED	\$	219.00	\$	219.00
	PDC SENSOR	2	MALFUNCTION	\$	715.00	\$	715.00
	SENSOR HOLDER	2	NECESSARY	\$	40.00	\$	40.00
	SENSOR WIRE HARNESS	1	MALFUNCTION	\$	589.00	\$	589.00
	REAR EXHAUST SILLENCER	1	BENT	\$	1,044.00	\$	1,044.00
	EXHAUST MOUNTING	2	NECESSARY	\$	42.00	\$	42.00
	EXHAUST CHROME TIP	1	GRAZED	\$	180.00	\$	180.00
	EXHAUSY BRACKET	2	BENT	\$	170.00	\$	170.00
	REAR FENDER COWLING RH	1	CRACKED	\$	286.00	\$	286.00

The impact was confined to the rear right portion of the vehicle. The damages appeared to be consistent as per the accident report statement. Please refer the attached schedule and photographs for details.

Our assessment of the repair costs to pre-accident condition was \$\$8,800.00 nett at lump sum basis.(Subject to GST if applicable)

The repairer has agreed to undertake repair the vehicle at a lump sum basis of \$8,800.00 nett corresponding to replacement of parts, spray painting and labour charges. We now revert for your decision on the above claim.
