CS / SMR 21005133 / Day 3

ASSIGNMENT

To Insp Vehicle No: SHD 3846R

REPAIR ESTIMATE

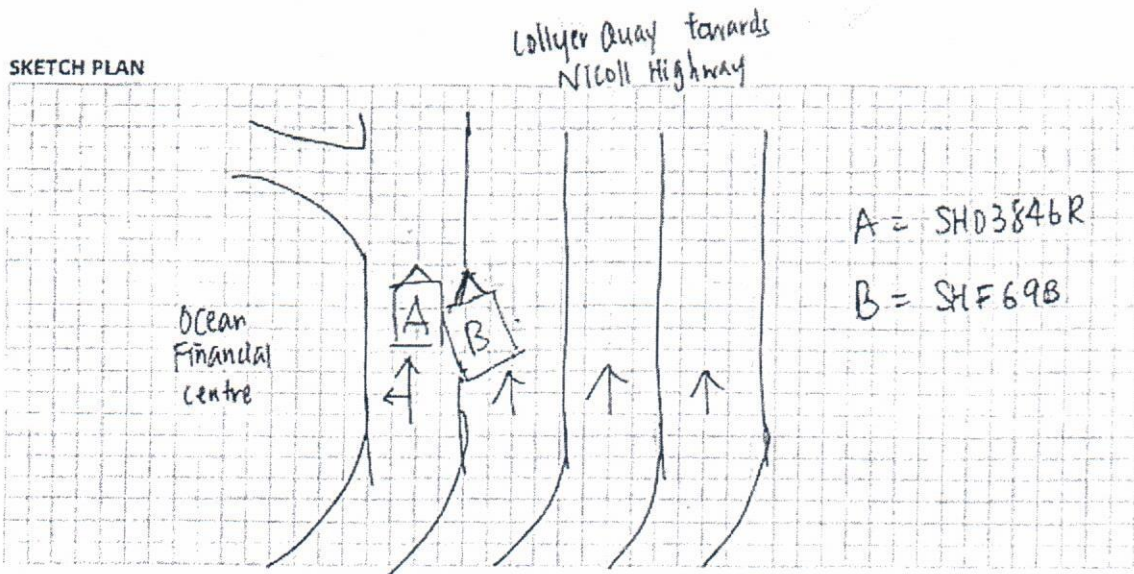
SKETCH PLAN

On 22 Apr 2021 at about 2140 hours, I was travelling along Collyer Quay towards Nicoll Highway. Suddenly, I felt an impact on my vehicle and realised that another vehicle, SHF69B, had crashed into the right side of my vehicle. After the accident happened, the other vehicle's driver and I stepped out of our vehicles. The other vehicle's driver told me that he received a barking at Ocean Financial Centre and needed to turn left into the driveway for pick up.
