**CLAIMANT: LIN YUN**
**PROPERTY DAMAGES CLAIMS AS A RESULT OF A ROAD TRAFFIC ACCIDENT INVOLVING  
 MOTOR VEHICLES NO. SMV2861Z AND SDW7373J ALONG PIE TOWARDS JURONG NEAR EXIT  
 12 ON 24.10.2020.**

**SYNOPSIS OF DAMAGES RESULTANT FROM THE ACCIDENT**

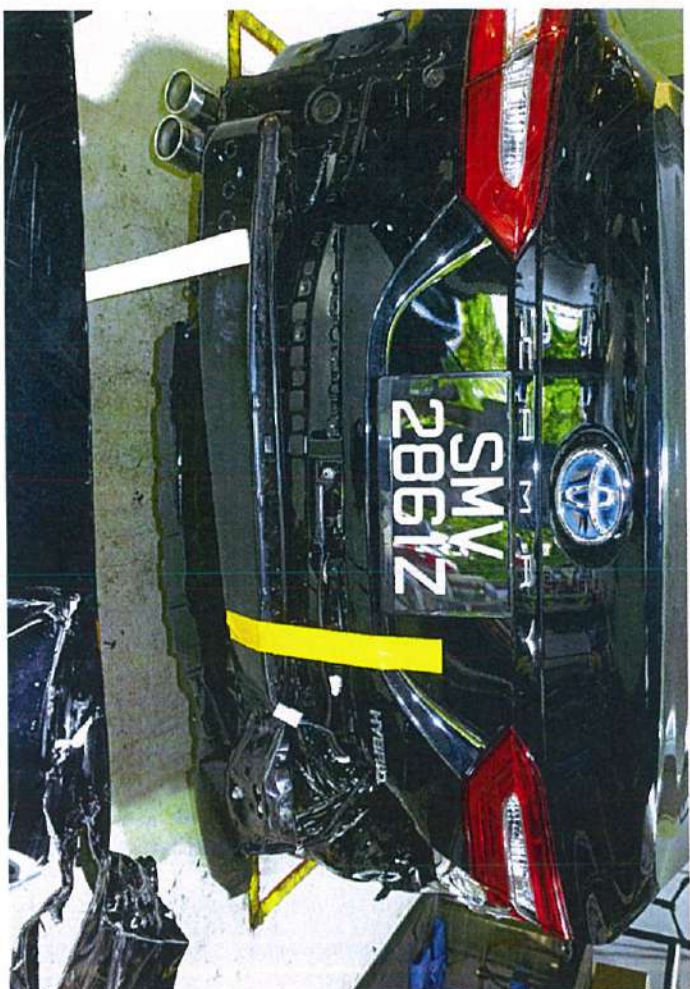
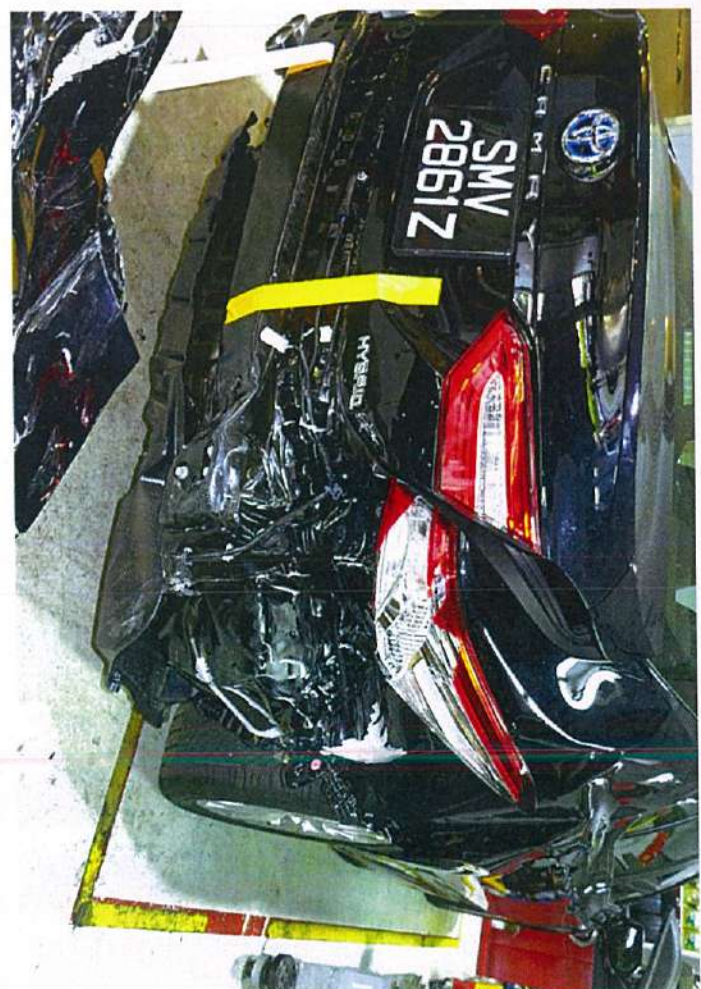
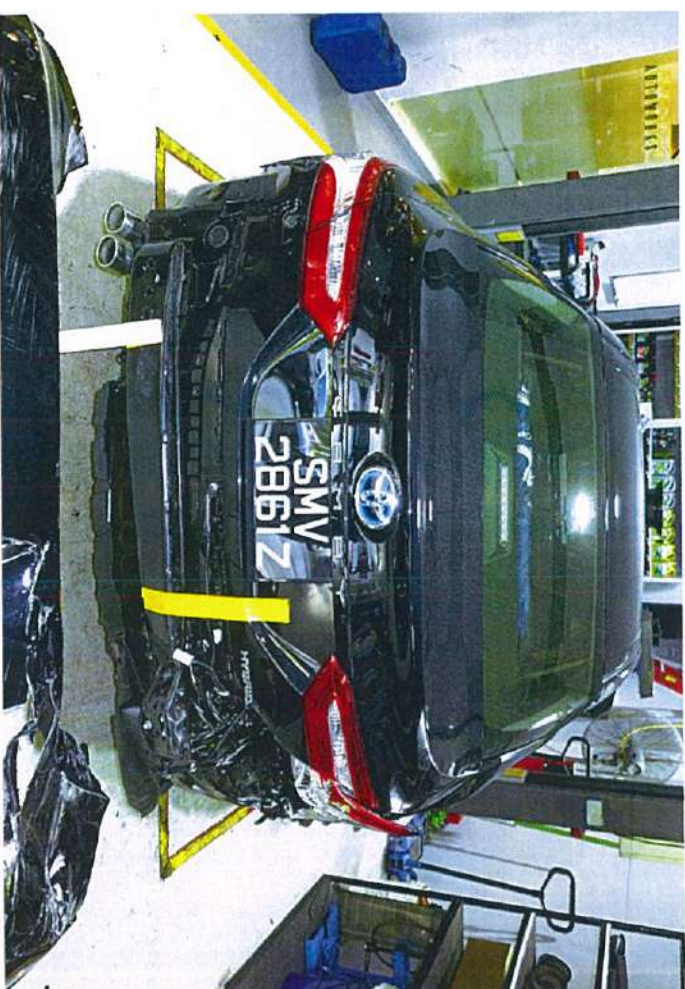
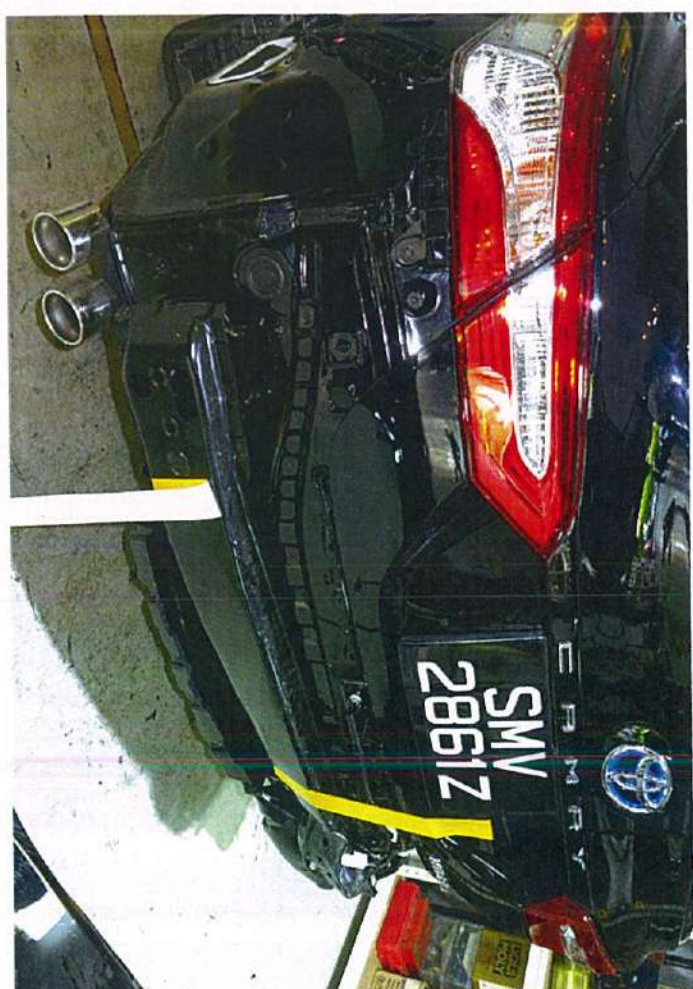
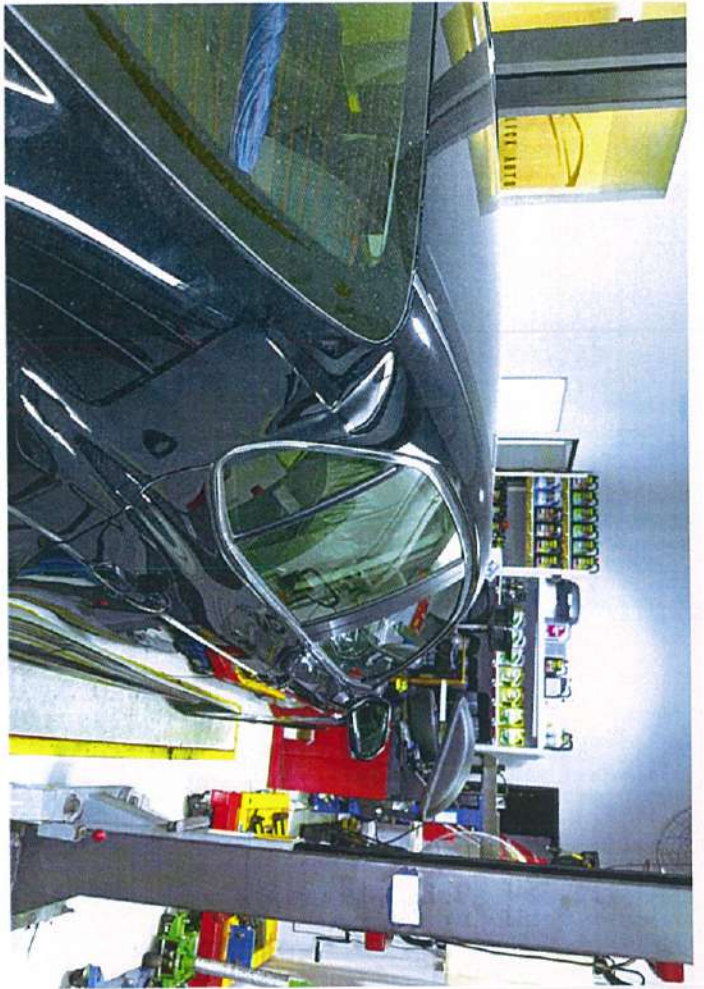
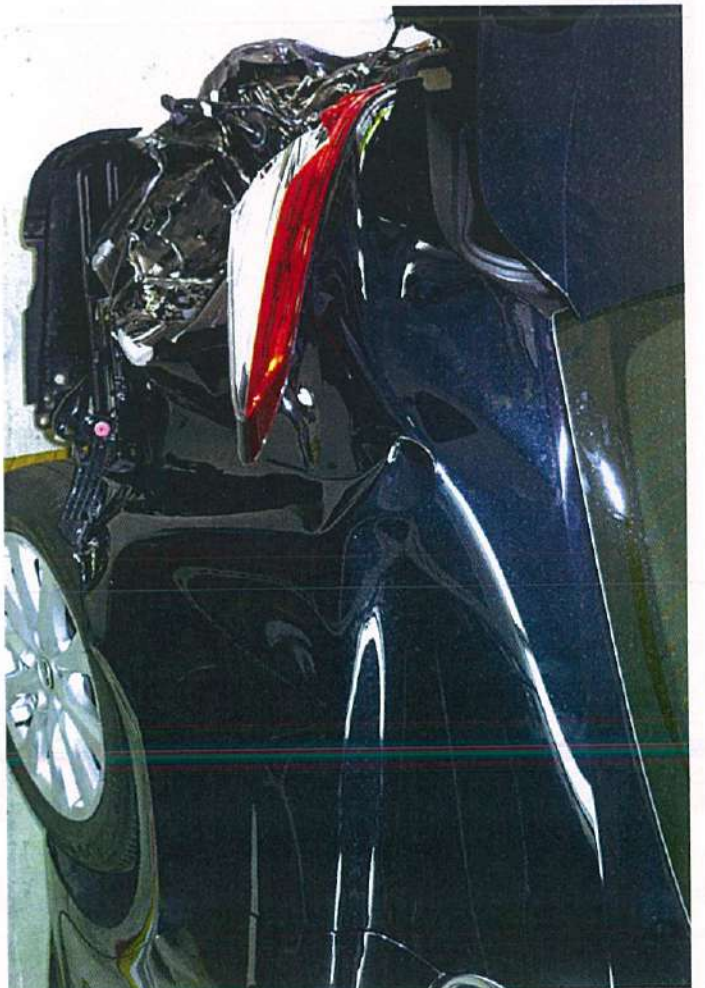
The impact of the collision has damaged / affected the bootlid, taillamps, rear bumper, rear end panel, spare tyre panel, o/s rear fender, rear door and etc...

Please refer to Annex A (Appraisement Schedule) for a detailed account of the damages and photographs taken.

The estimate cost of repair submitted by Messrs Right Click Autoworks Pte Ltd as per schedule attached has been revised and scrutinised, and in our opinion, we consider it to be fair and reasonable. The repairers have agreed to undertake the repairs to the owner's satisfaction at our revision. We have not authorised the repairs.

Our adjusted cost of repair is SGD 20,827.47 to carry out the repairs. Please refer to Annex A (Appraisement Schedule) for a detailed account of the cost estimates.
