**CLAIMANT: LIN YUN**
**PROPERTY DAMAGES CLAIMS AS A RESULT OF A ROAD TRAFFIC ACCIDENT INVOLVING  
 MOTOR VEHICLES NO. SMV2861Z AND SDW7373J ALONG PIE TOWARDS JURONG NEAR EXIT  
 12 ON 24.10.2020.**

**SYNOPSIS OF DAMAGES RESULTANT FROM THE ACCIDENT**

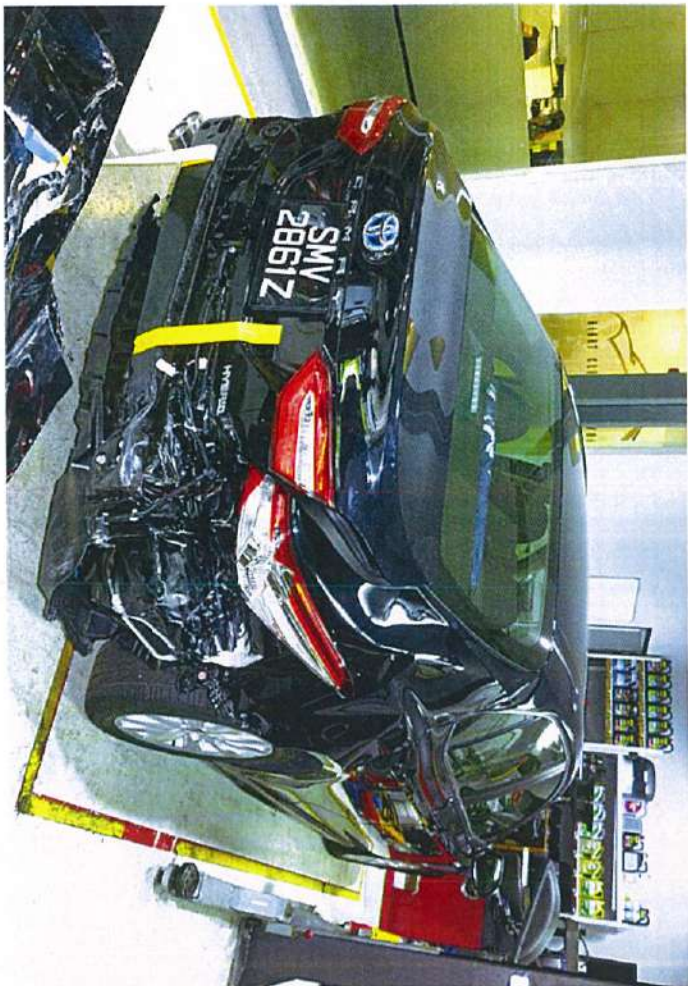
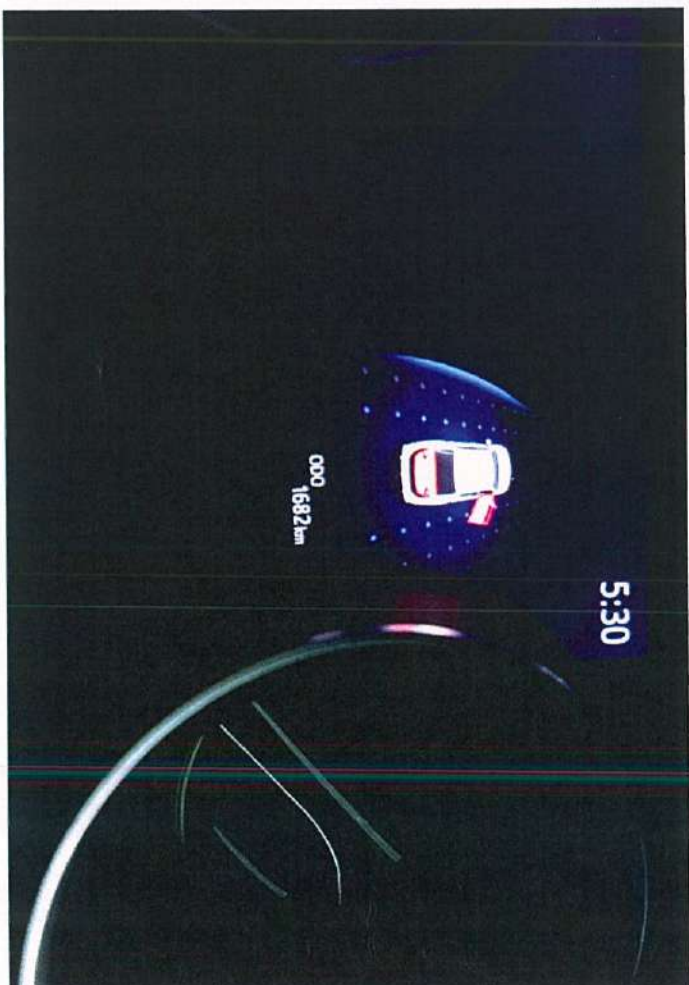
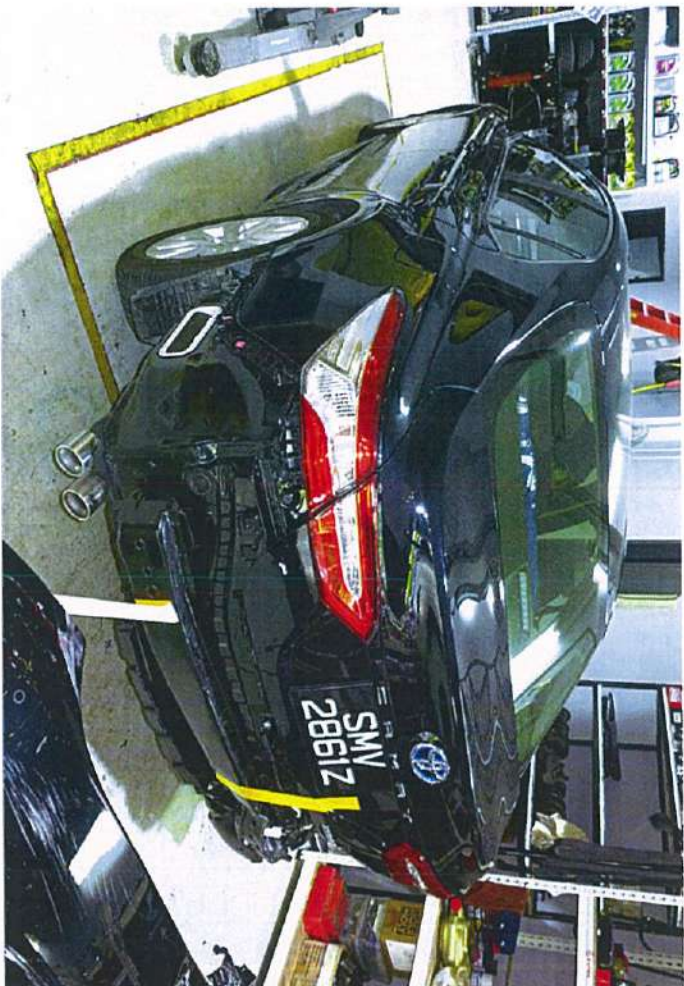
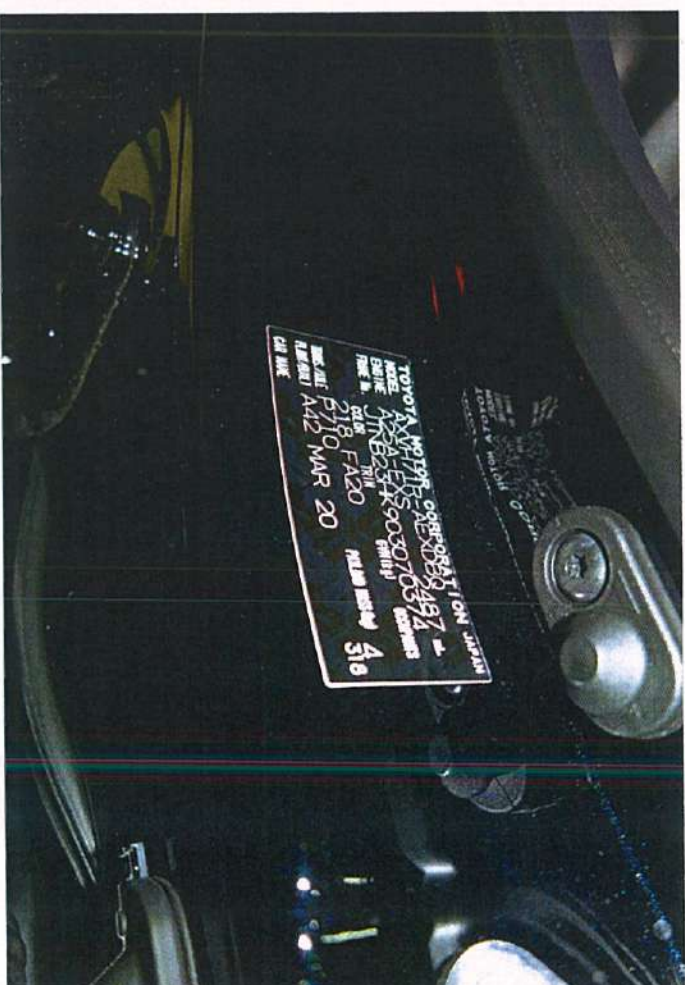
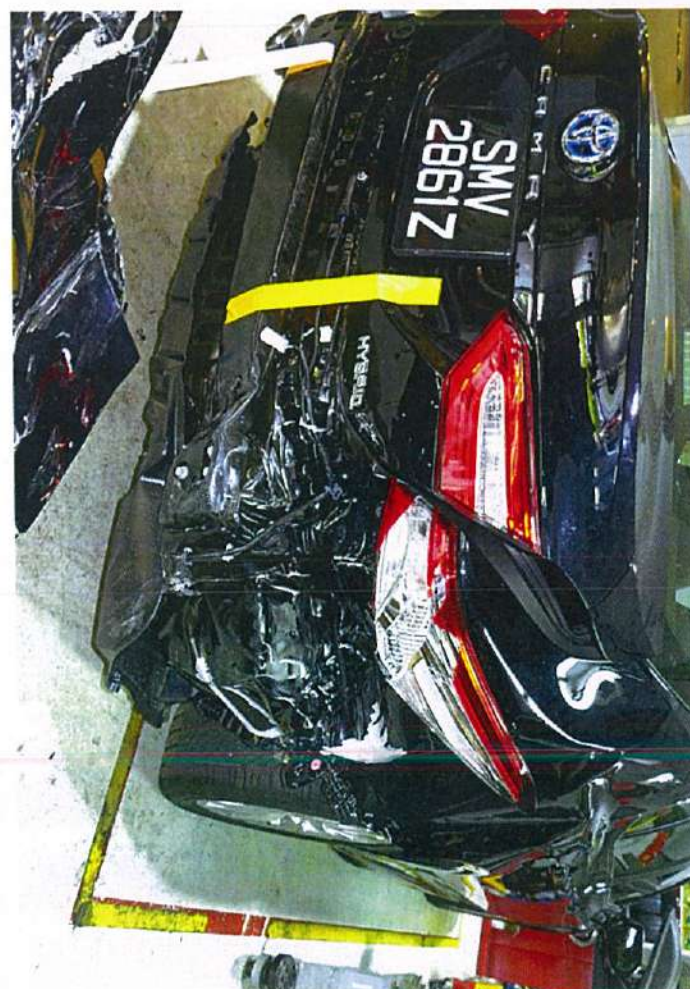
The impact of the collision has damaged / affected the bootlid, taillamps, rear bumper, rear end panel, spare tyre panel, o/s rear fender, rear door and etc...

Please refer to Annex A (Appraisement Schedule) for a detailed account of the damages and photographs taken.

The estimate cost of repair submitted by Messrs Right Click Autoworks Pte Ltd as per schedule attached has been revised and scrutinised, and in our opinion, we consider it to be fair and reasonable. The repairers have agreed to undertake the repairs to the owner's satisfaction at our revision. We have not authorised the repairs.

Our adjusted cost of repair is SGD 20,827.47 to carry out the repairs. Please refer to Annex A (Appraisement Schedule) for a detailed account of the cost estimates.
