From: Loh, Chee-Heng <Chee-Heng.Loh@aig.com>
Sent: Thursday, 1 July 2021 5:34 PM
To: Hsiao Tong (LKKAUTO)
Cc: Admin A
Subject: RE: 0916446613SG *** LKK REF: CC4/AIG21005382/Upa3

From: Hsiao Tong (LKKAUTO) <chewht@lkkauto.com>
Sent: Thursday, 1 July 2021 5:14 PM
To: Loh, Chee-Heng <Chee-Heng.Loh@aig.com>
Cc: Admin A <admin-a@lkkauto.com>
Subject: [EXTERNAL] RE: 0916446613SG *** LKK REF: CC4/AIG21005382/Upa3

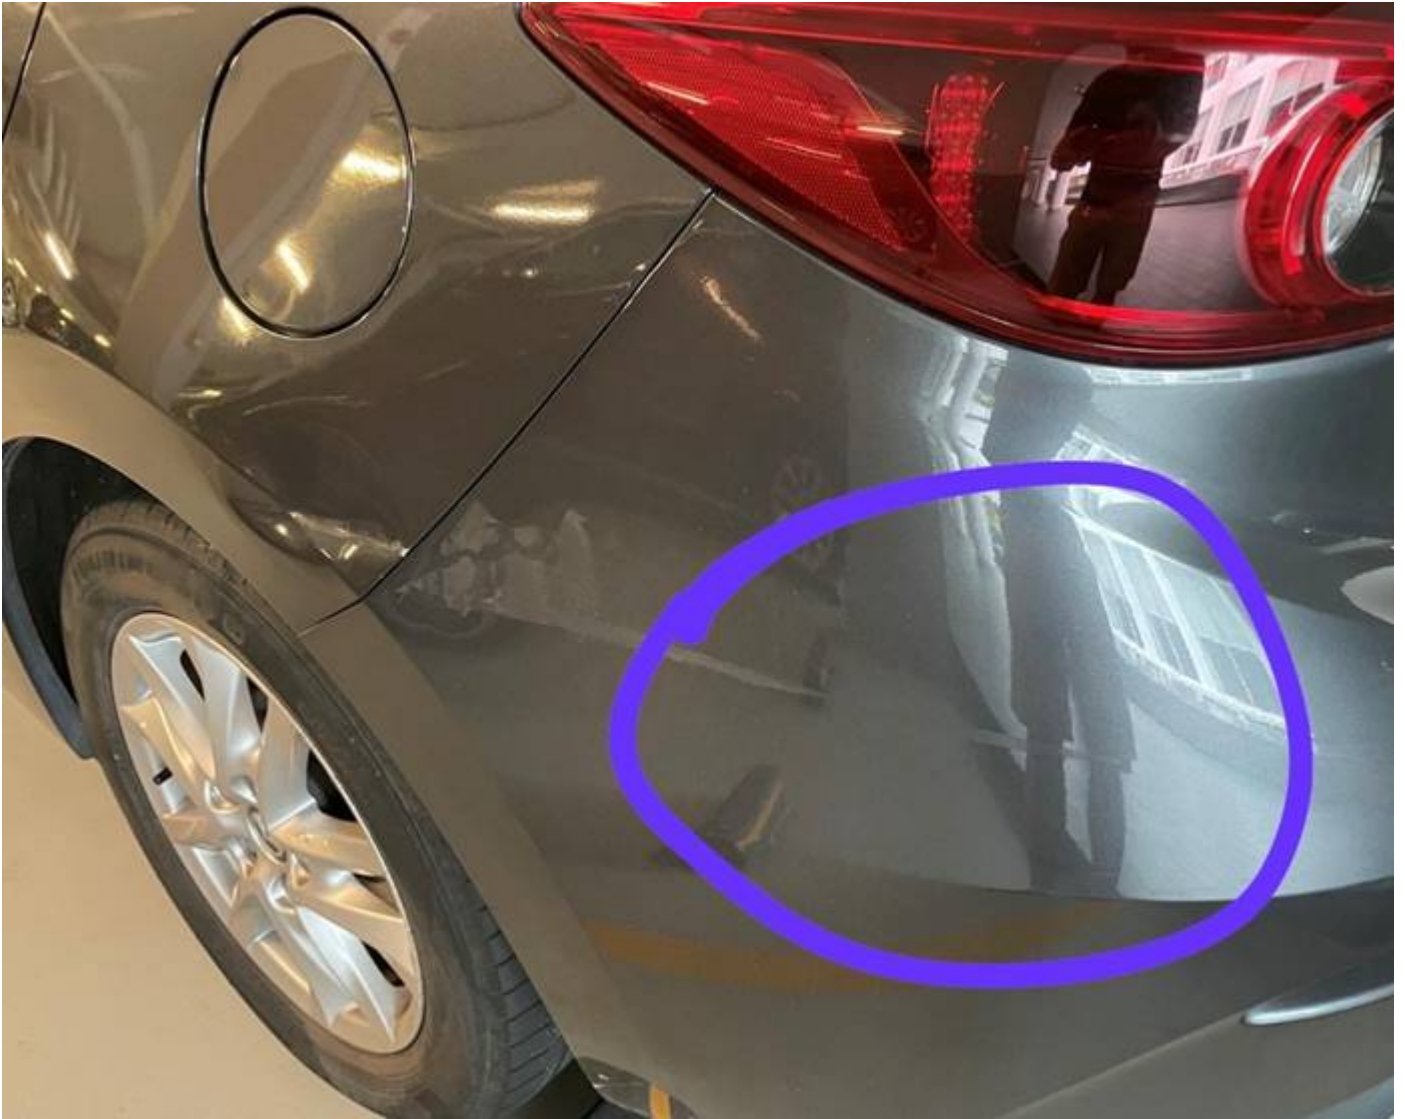
We have spoken to our driver Mr Chua on this matter. During our tele-conversation, he adamant that he was driving within his lane and he slowed down his car due to the front car slowed down. Third party was unable to stop and swerved left to avoid collision but still hit onto OI's vehicle. OI is of the view that if he changed lane and hit by third party, the damages sustained to his car will be more on the side door and more serious. The damages sustained to OI's vehicle was on the left rear bumper and fender. OI did not pursue the claim as liability is unclear at that point of time. OI did not repair his car till date and the damages is still on his car.
Kindly refer to the below photos submitted by OI on 28/06/2021 for your reference.

OI would like to highlight that the purple circle is the 1st point of impact that third party swerve and scratching his left rear bumper, then third party stopped his lorry and caused a dent on the fender(below the petrol pump cover).

Based on damages profile, if OI stopped stationary without moving, damage to OI vehicle should have focus on rear left corner, but the damage appear to be on left rear bumper corner which indicating that OI attempting to swerve left also when third party lorry is swerving to left simultaneously resulted in the collision. Without concrete evidence like video footage, we are of the view it is 50/50 case.

You may engage OI on 50/50 based on contradictory versions between both parties. Damage pattern showed TP's sketch plan to be more probable.
