SINGAPORE ACCIDENT STATEMENT

ACCIDENT STATEMENT

Date Of Report	24/09/2020 16:10
Date Of Accident	24/09/2020 12:30
Exact Location Of Accident	DUNEARN ROAD
Country/State of Loss	SINGAPORE

Vehicle Make & Model: BMW 116I
Vehicle Registration Number: SLP2421D
Date of Accident:24-Sept-2020

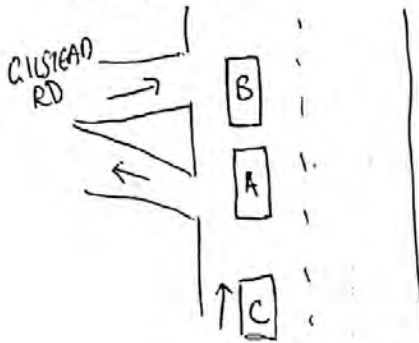
SKETCH PLAN

LOCATION: DUNGARN RD TOWARDS NEWTON CIRCUS.

AA B stopped already.
Stopped for quite awhile.

- A) Complaint car
B) Van
C) Car behind that hit A

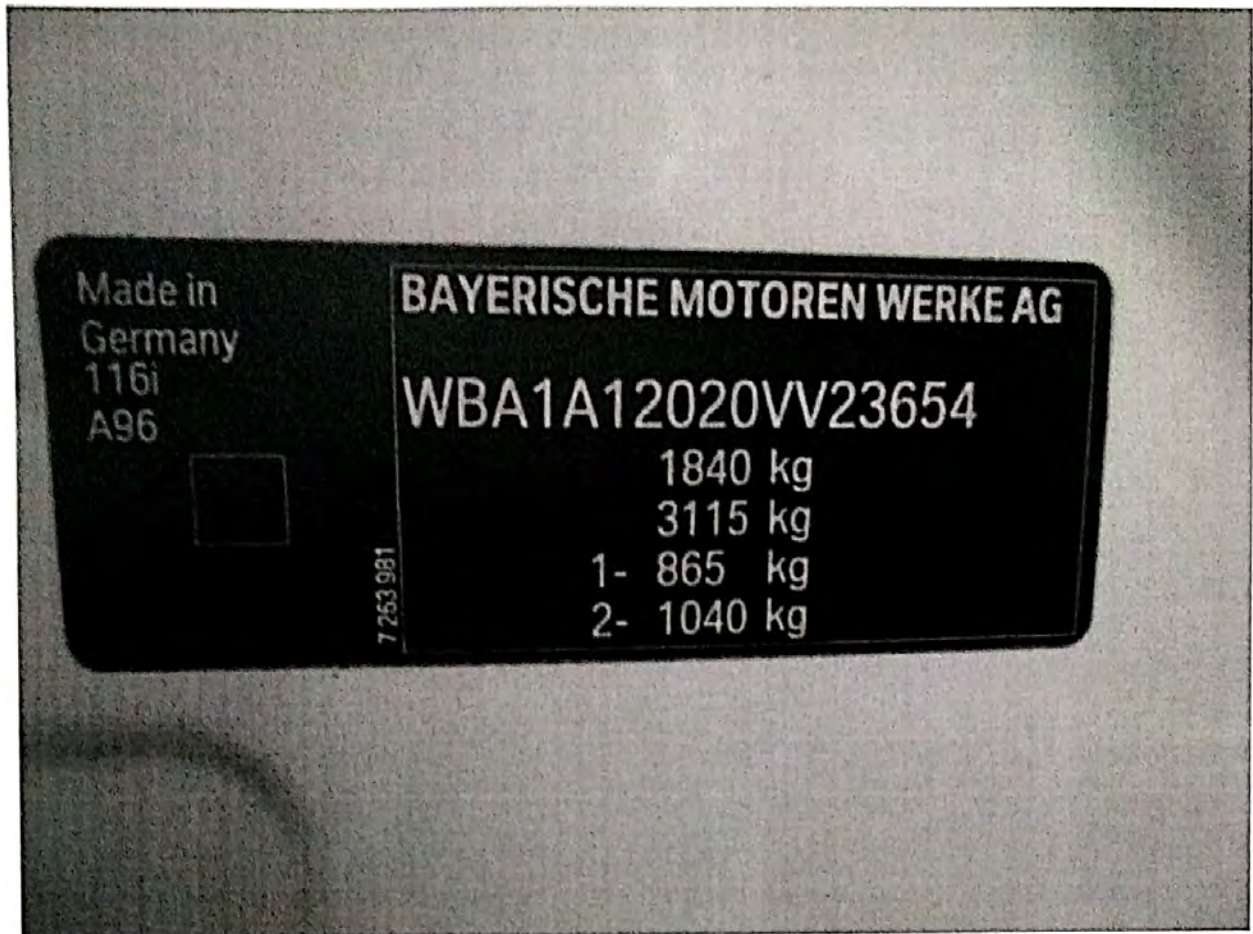
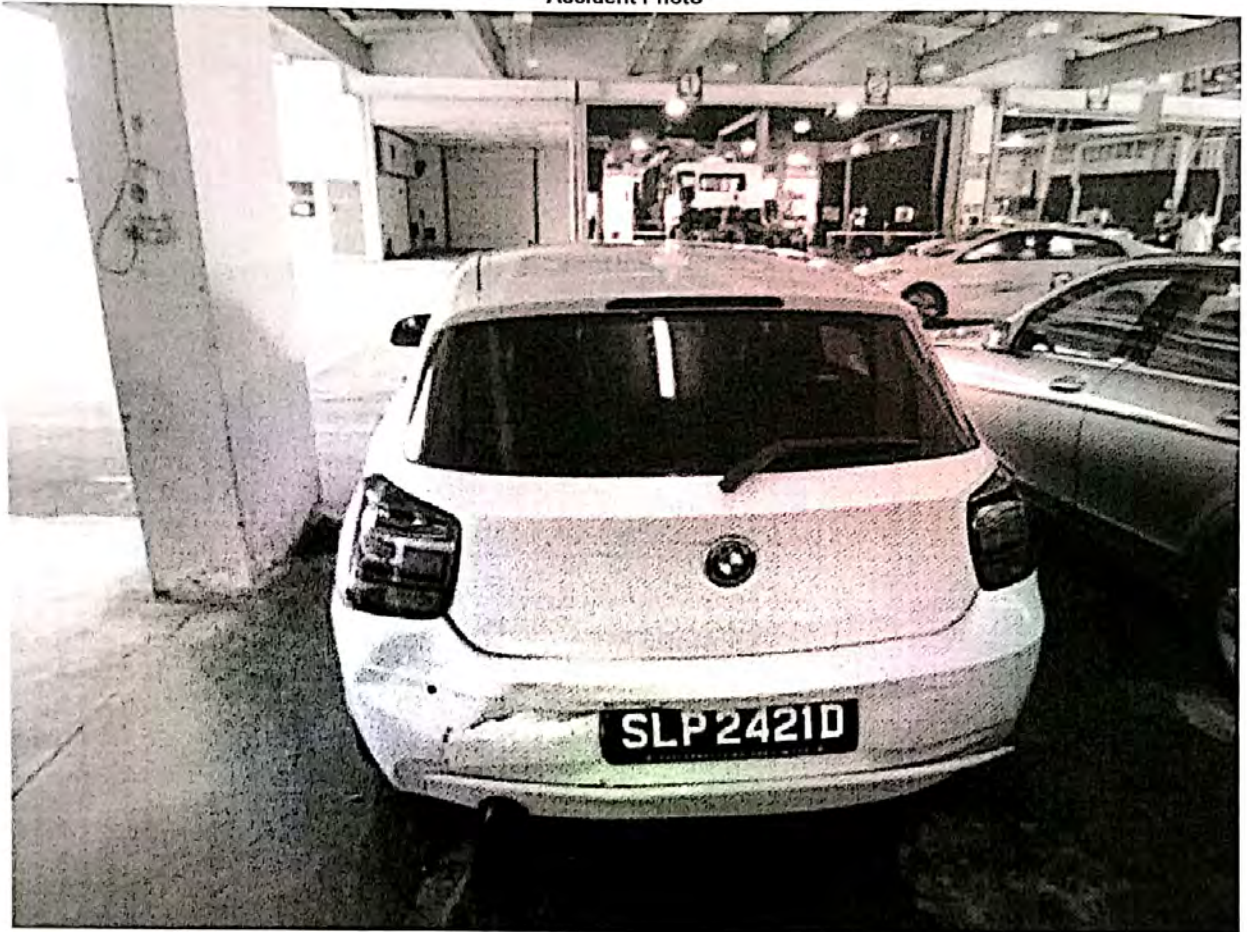
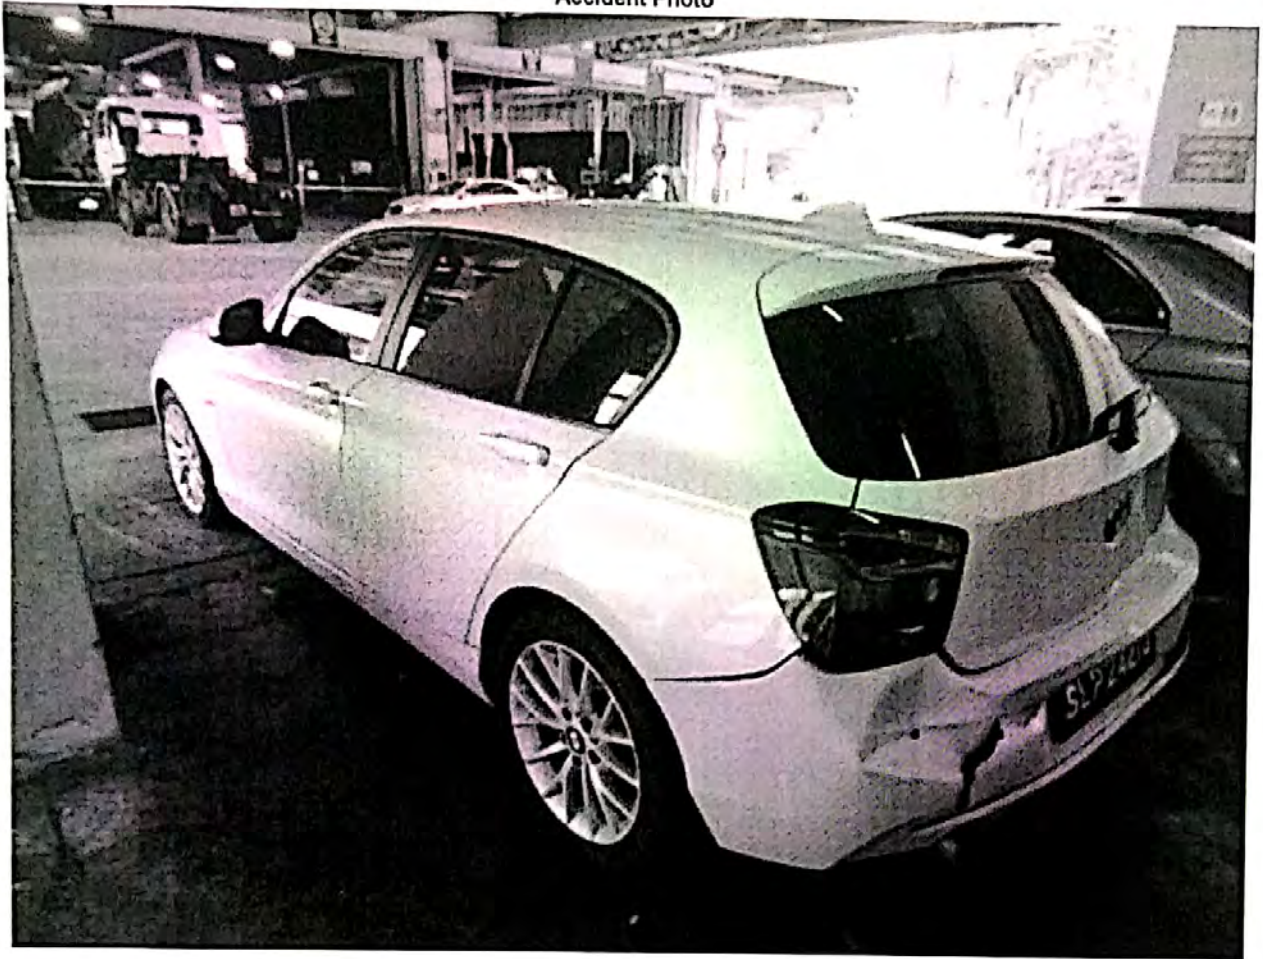
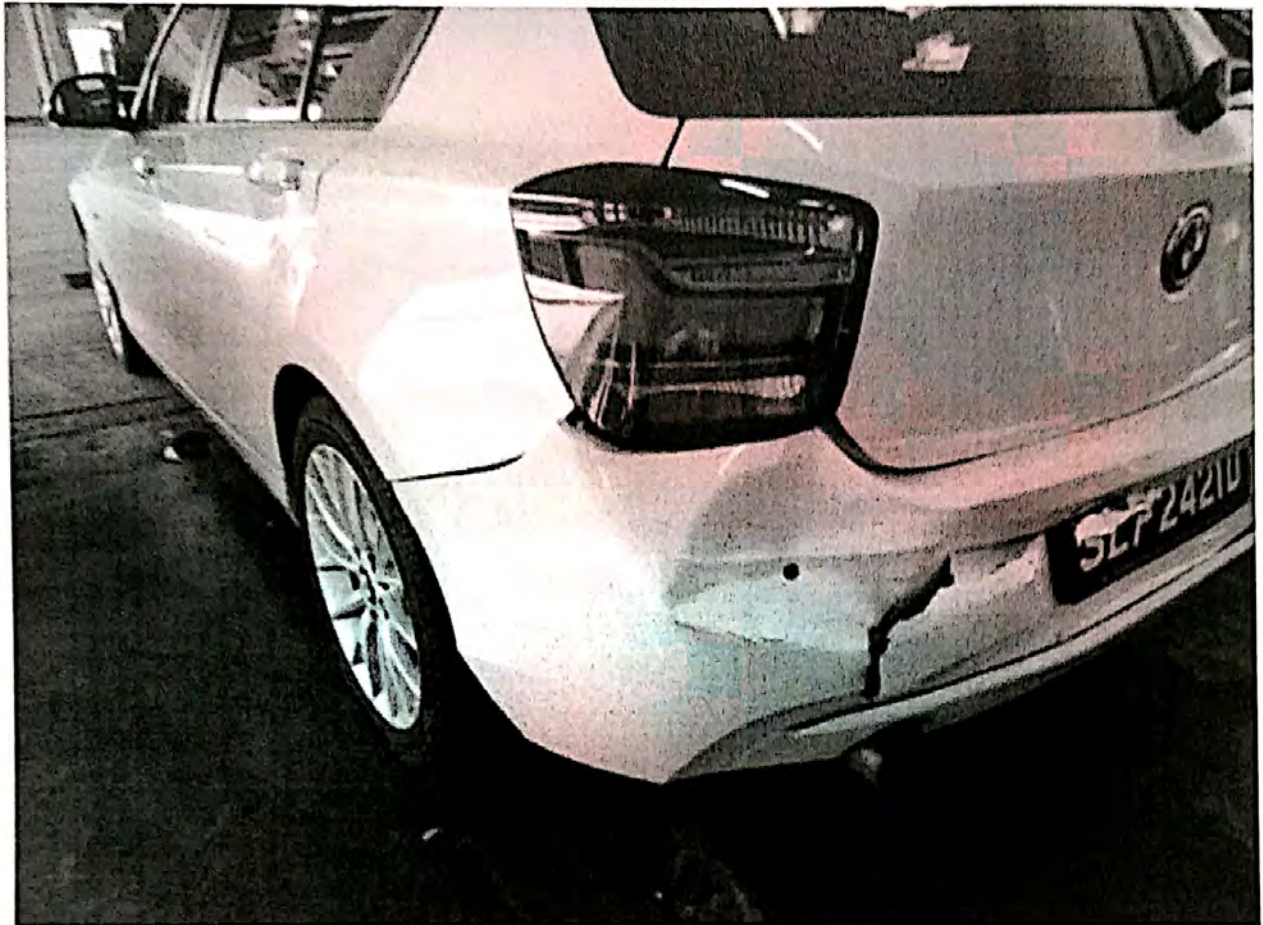
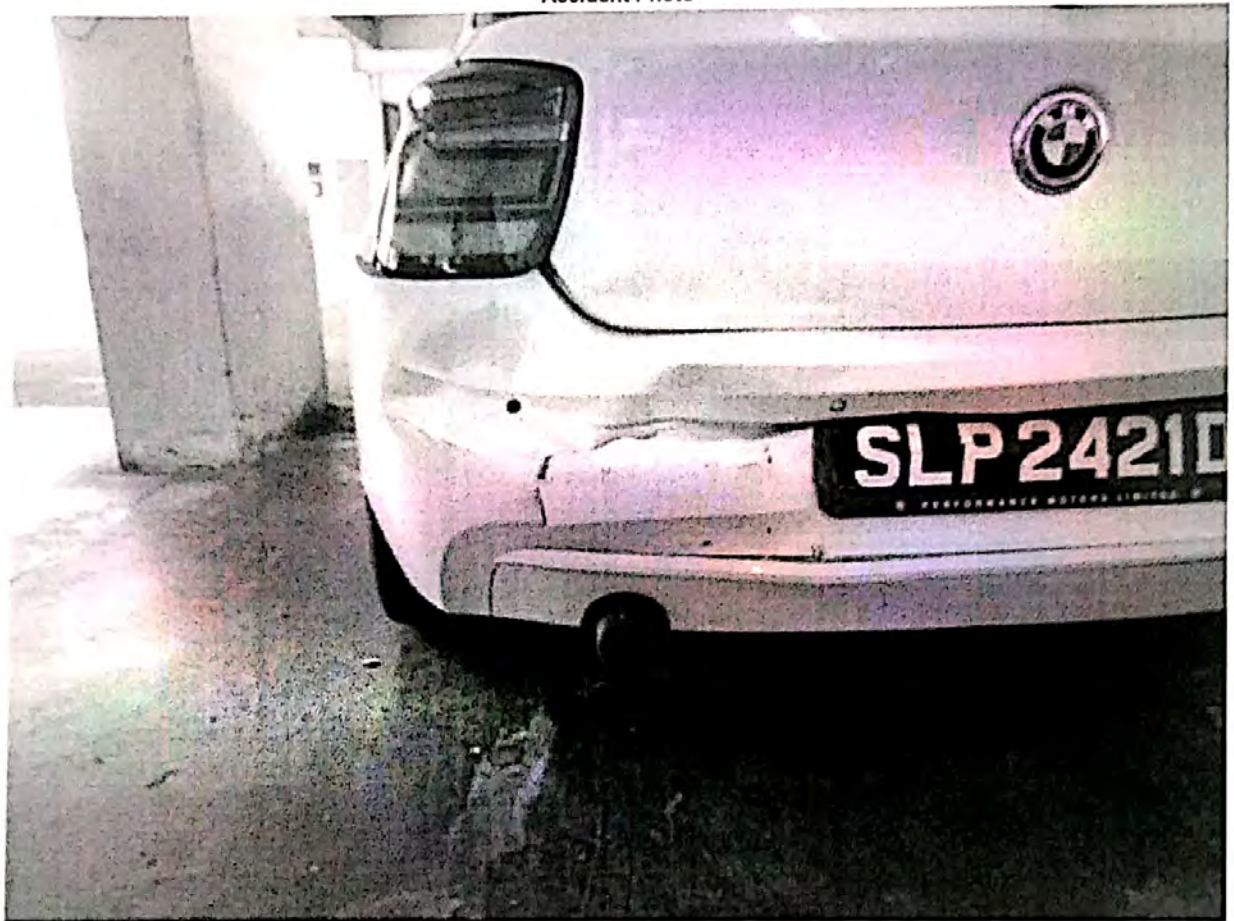
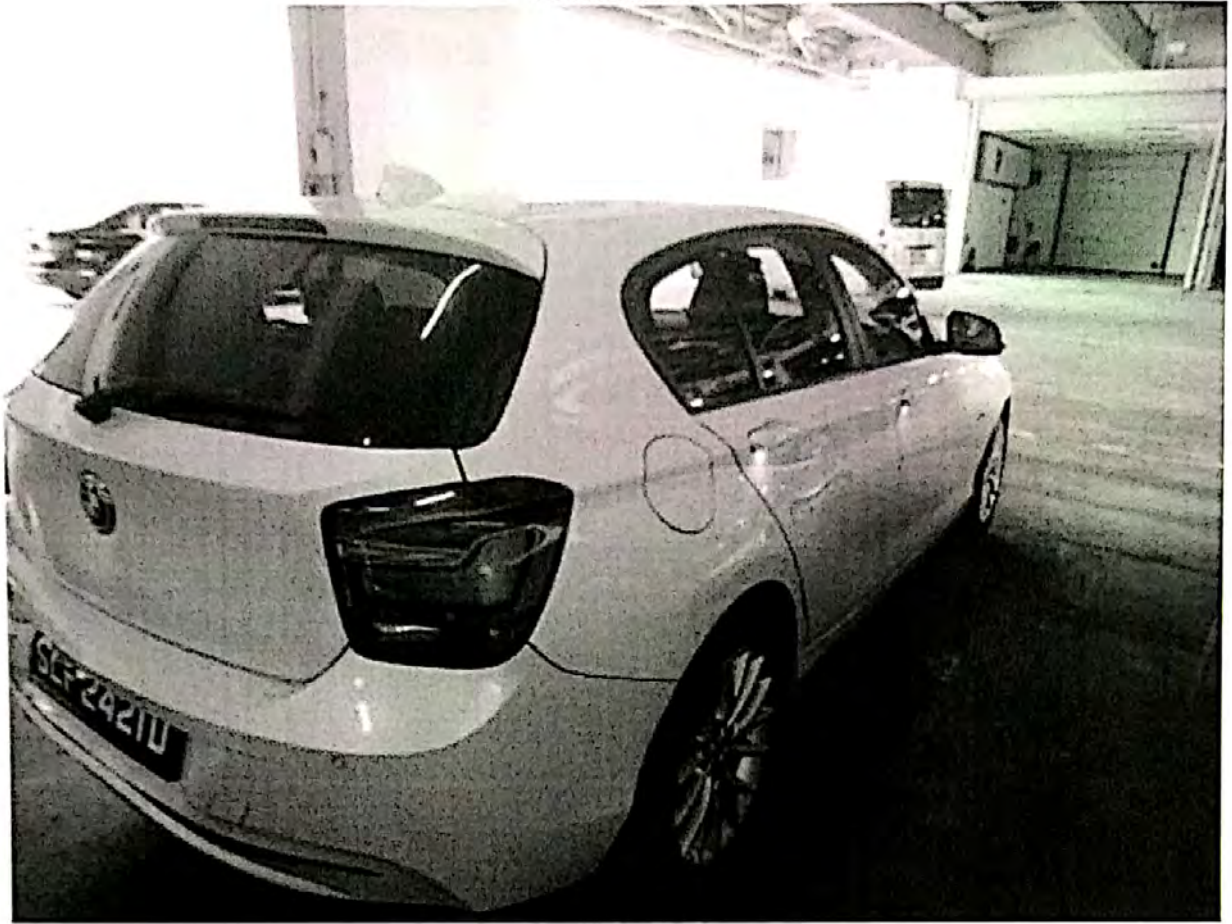
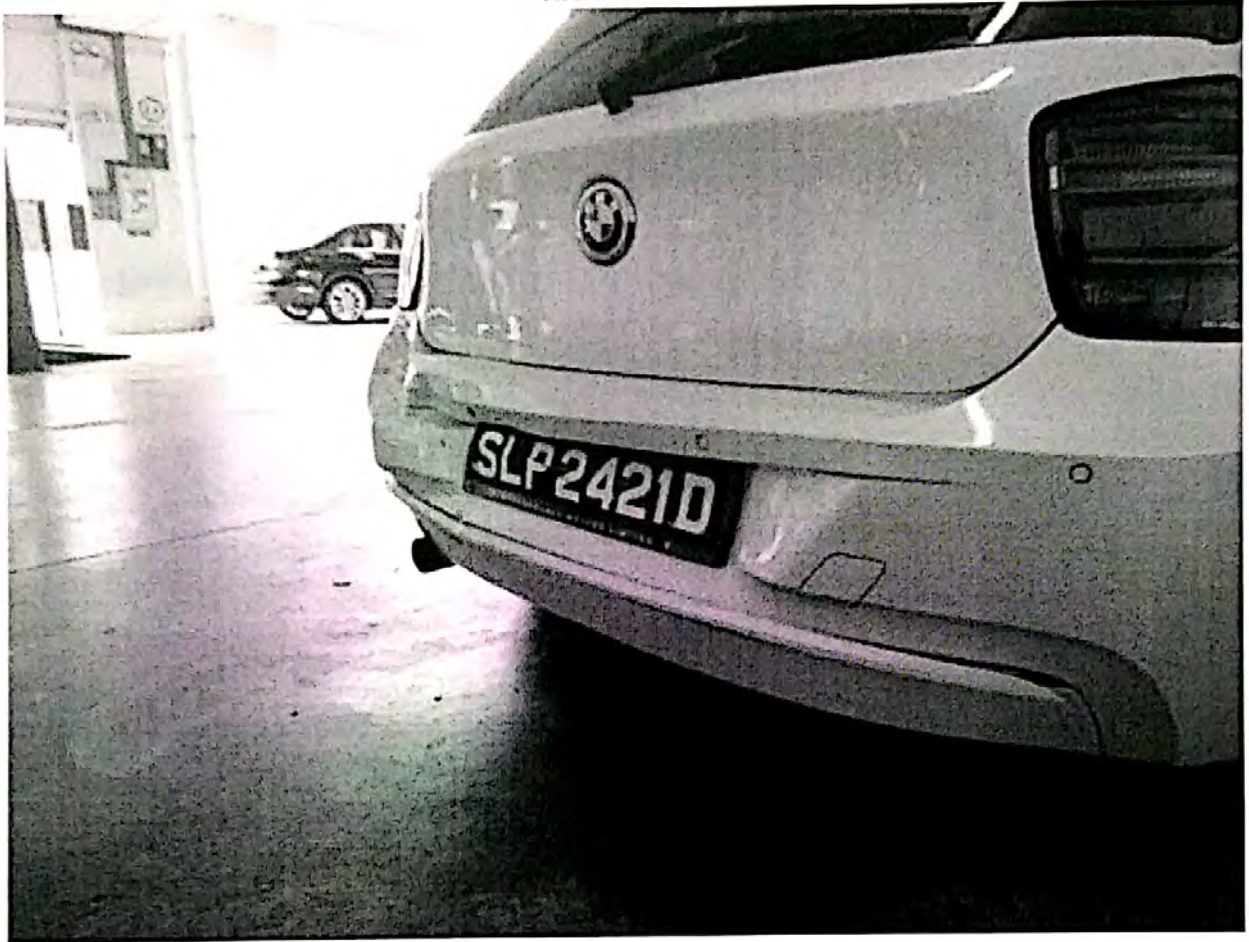
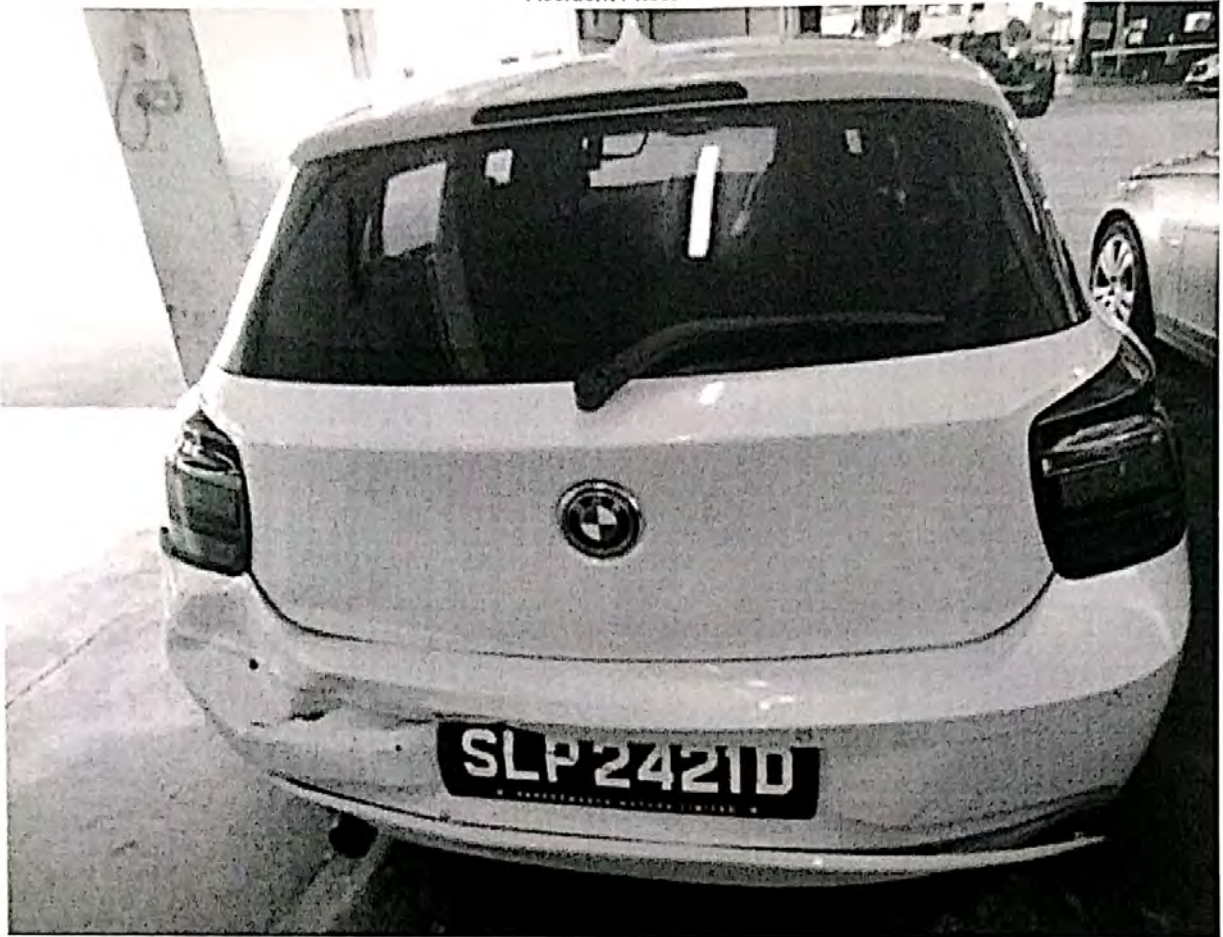
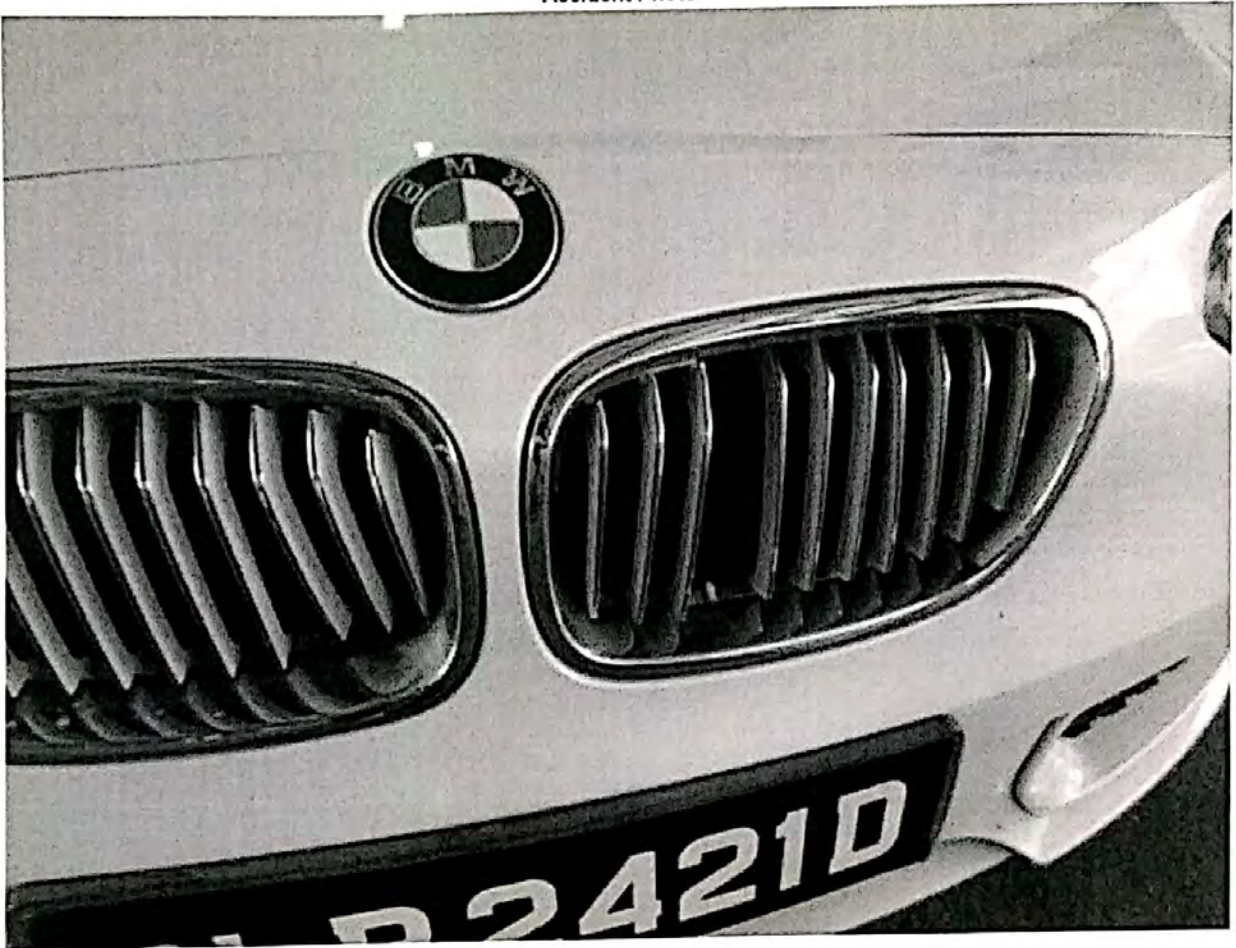
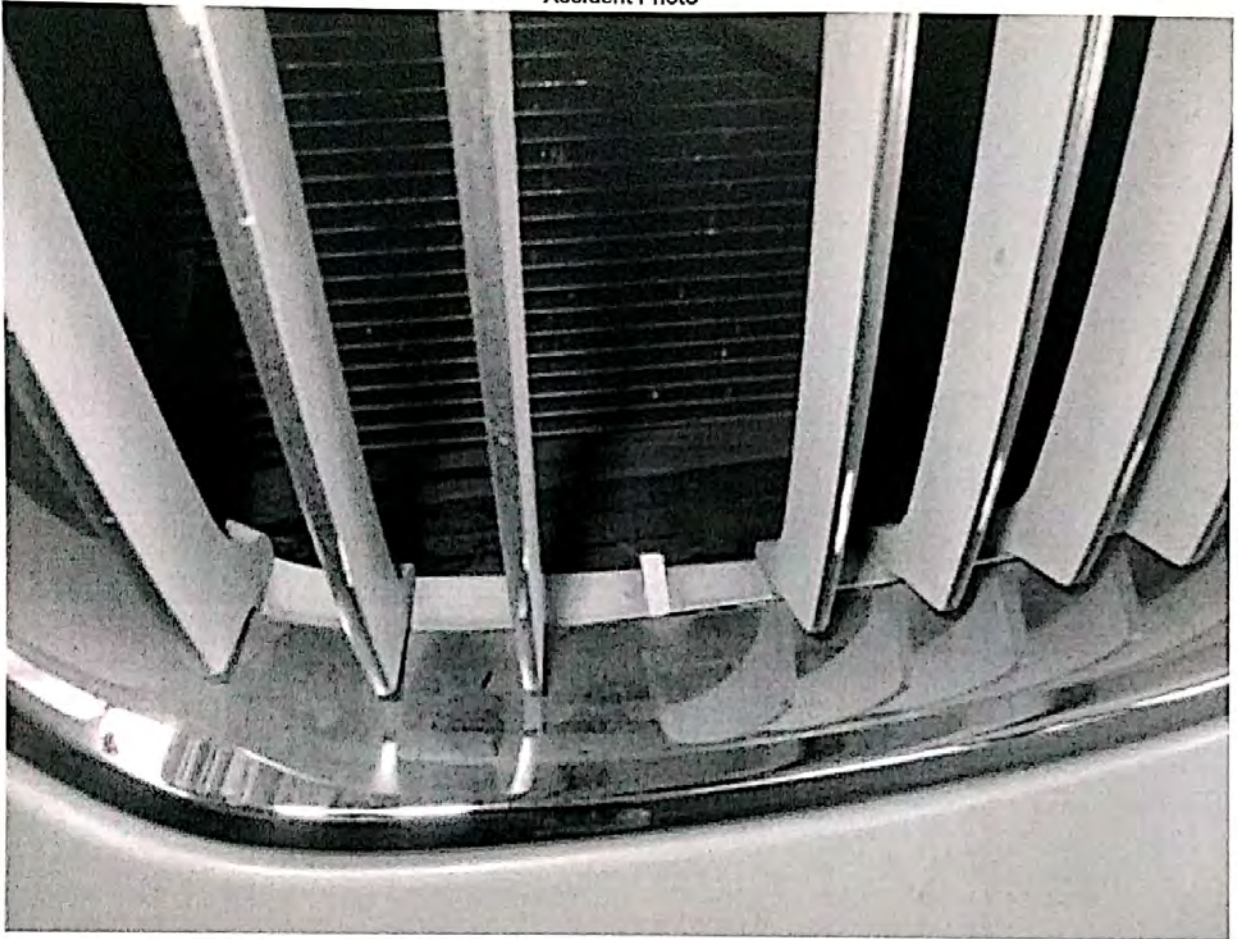
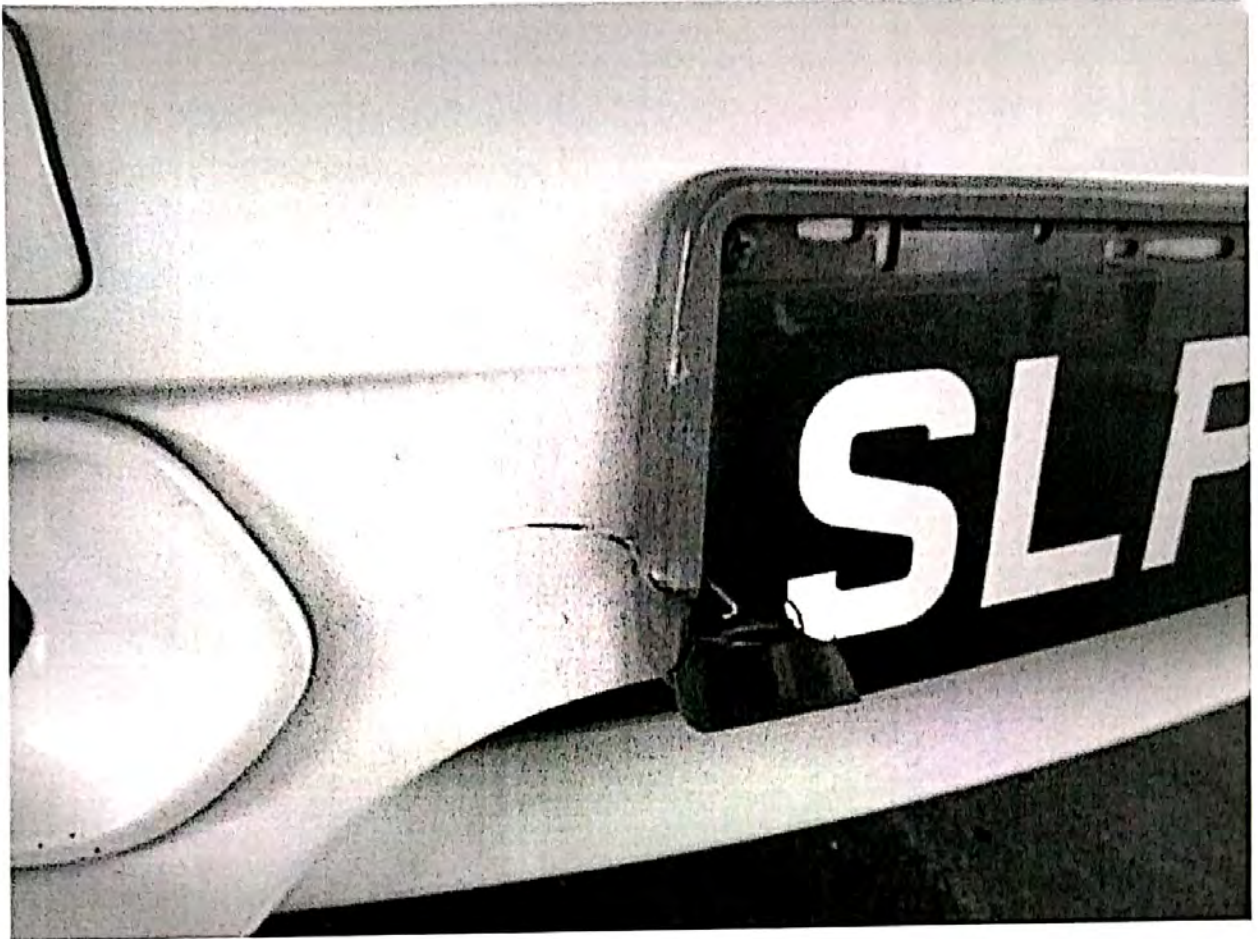
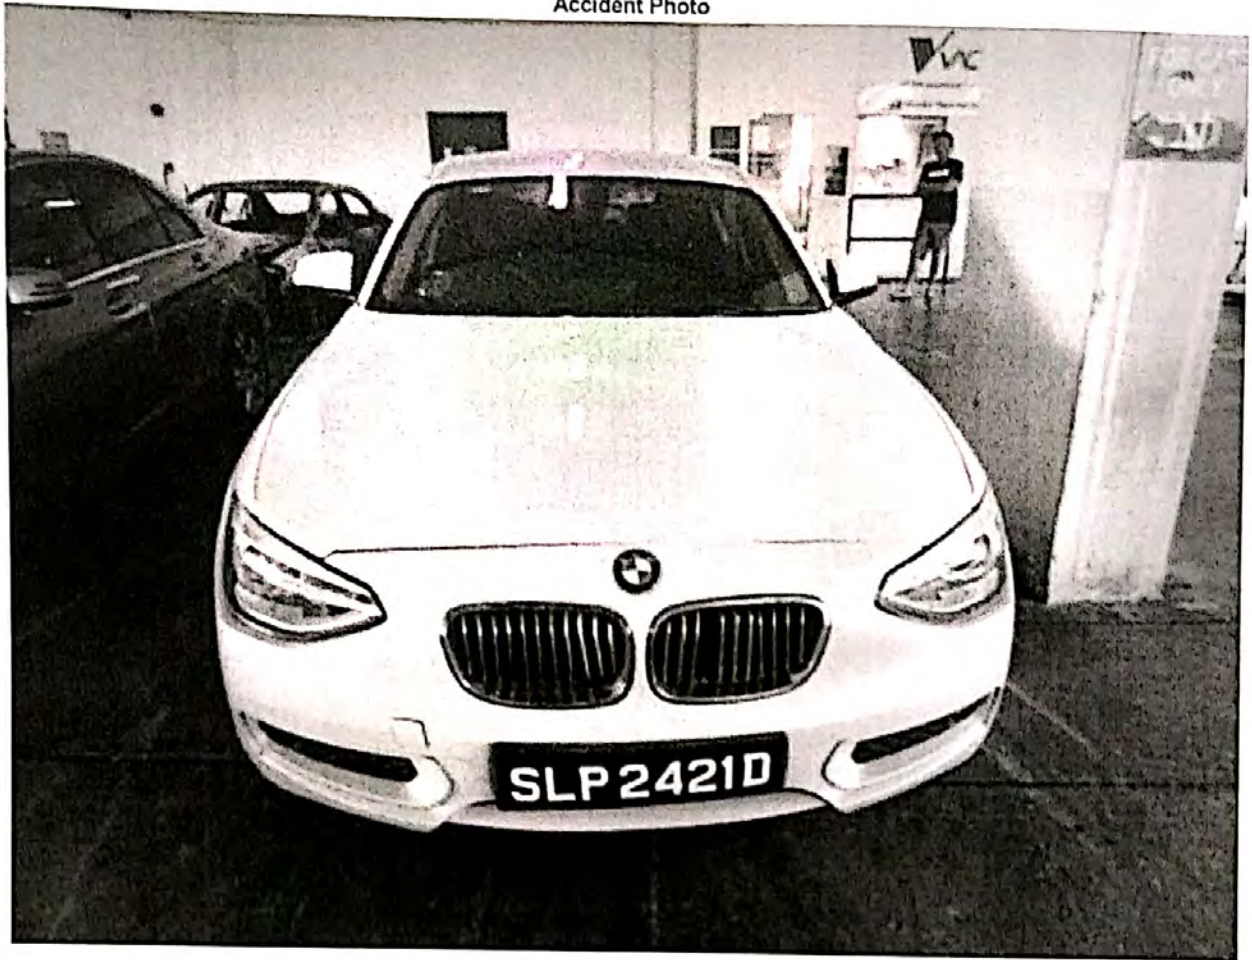
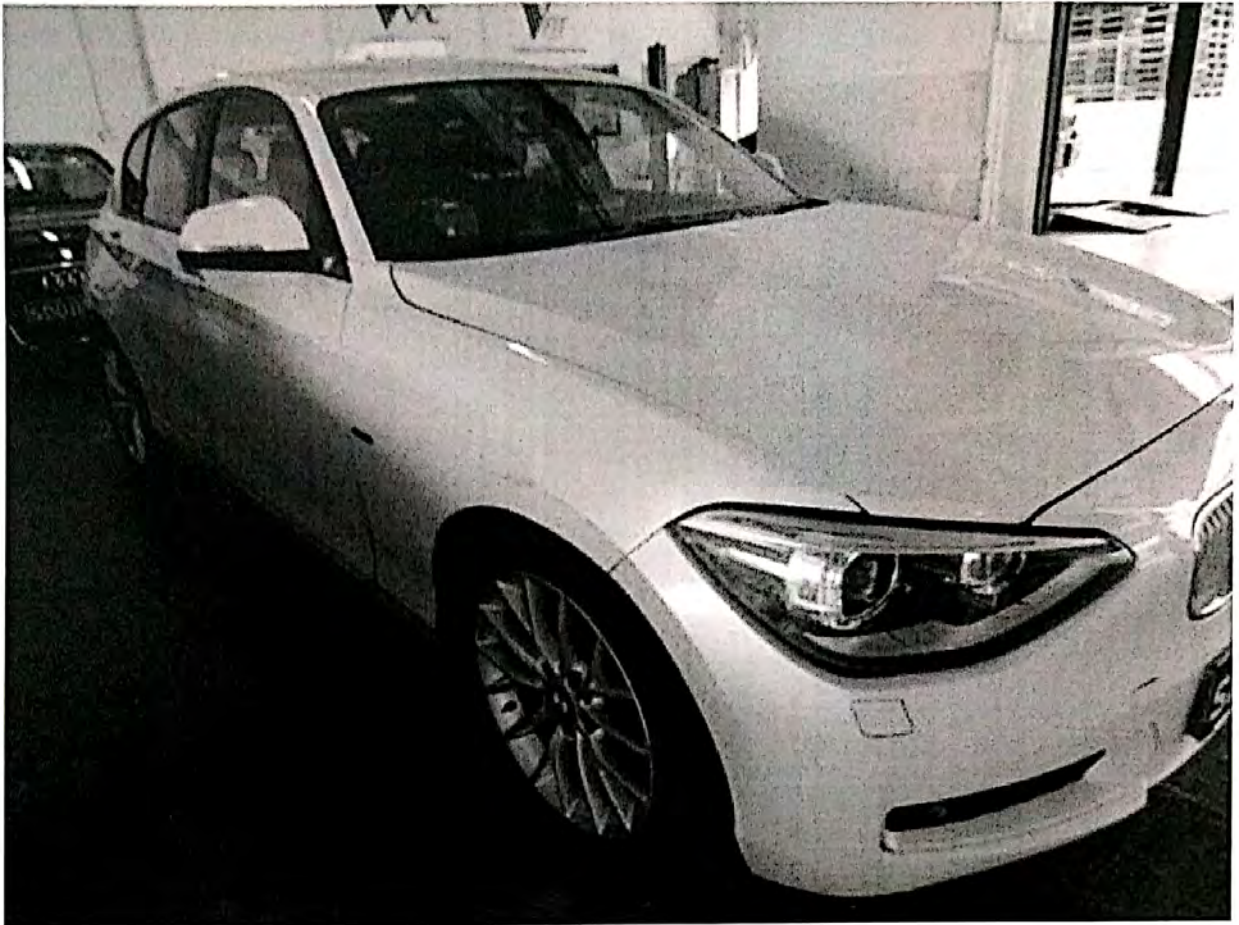
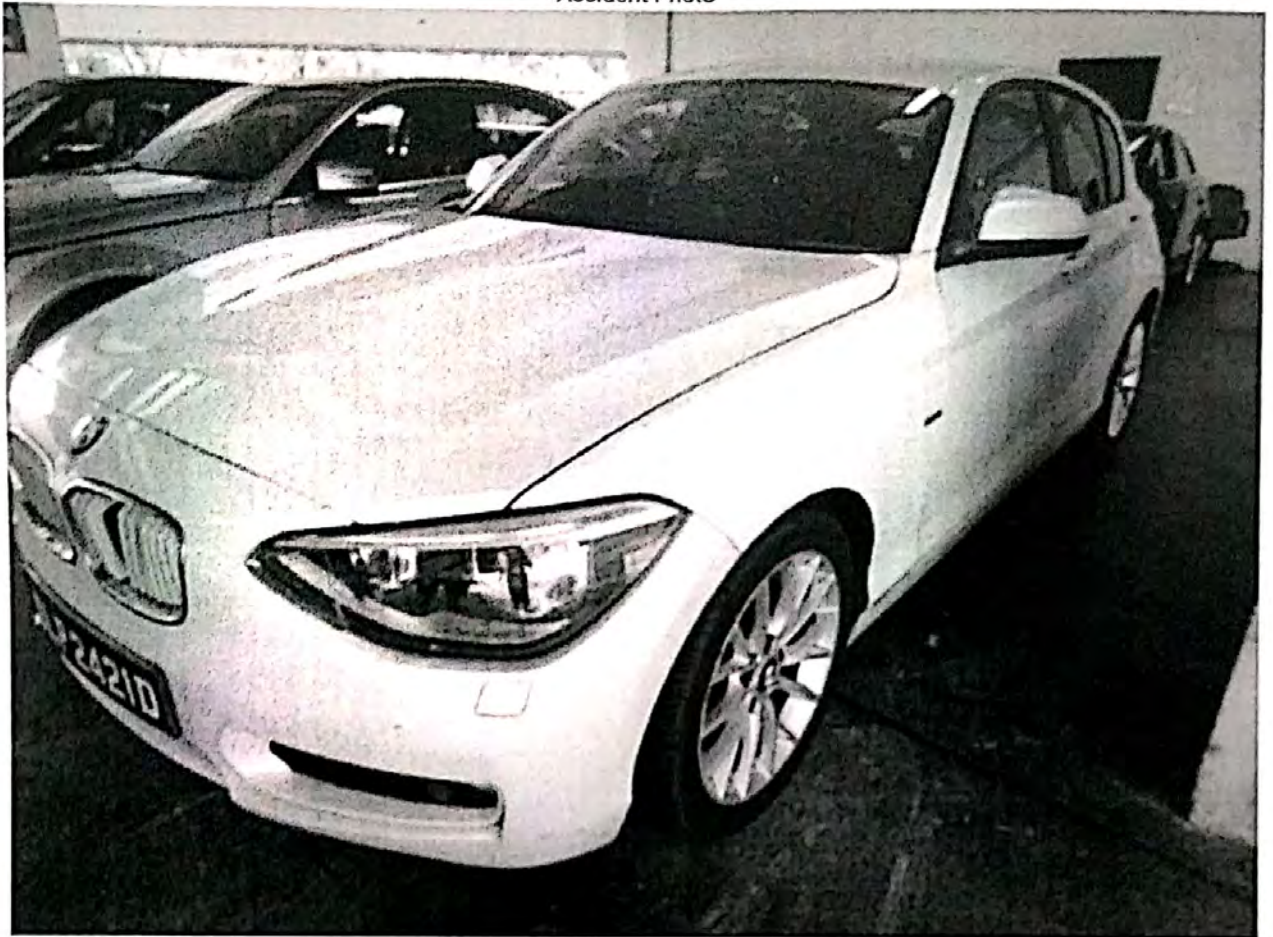
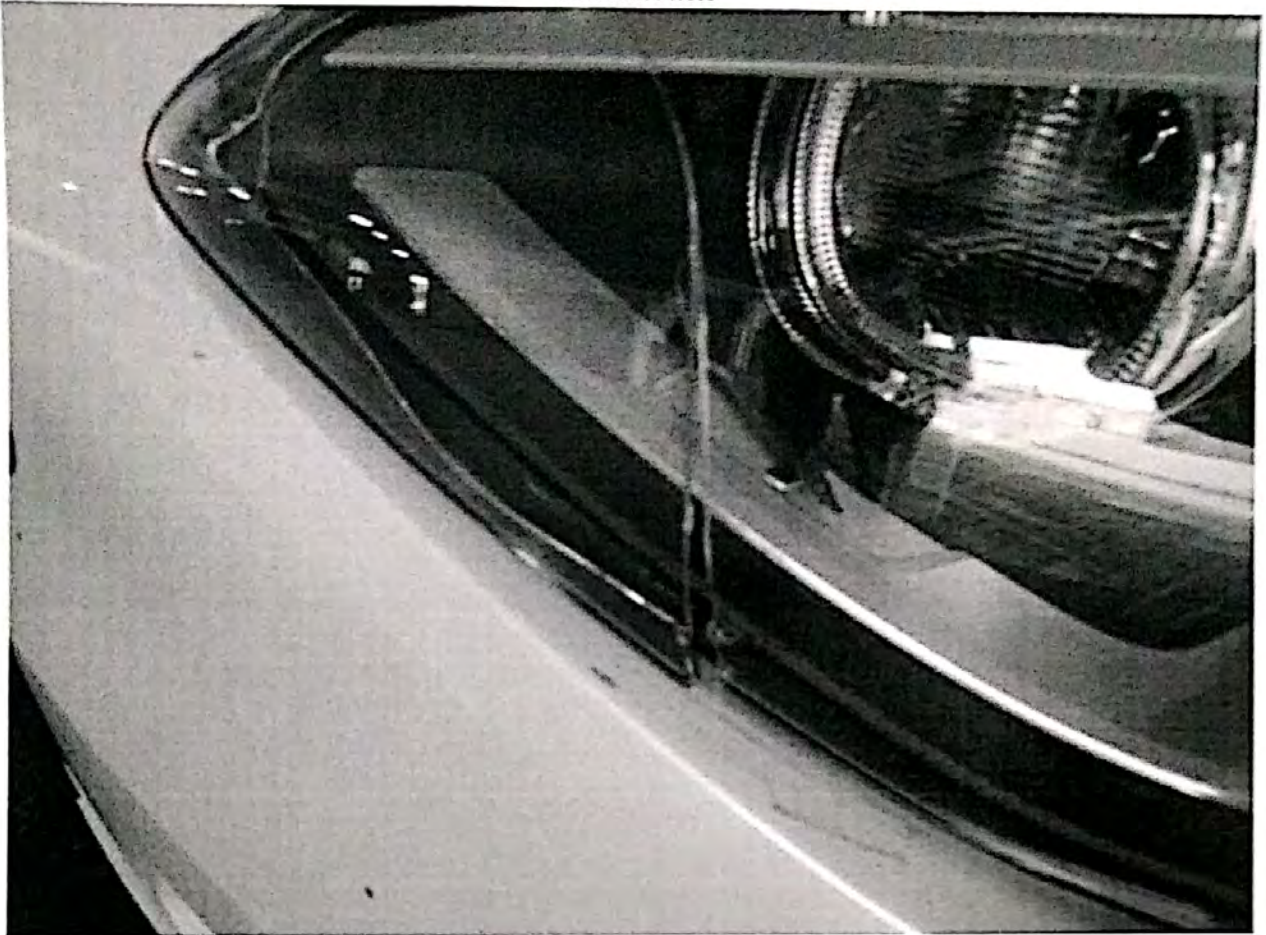
Accident Photo

Damages sustained were consistent with the subject vehicle being involved in a collision with another vehicle at its rear. Invariably, the impact resulted in the vehicle to surge forward and collided with another vehicle at its front, sustaining damages at its frontal & rear portions.

Damages sustained were the bonnet & its inner reinforcement - bent, bonnet inner lock/catch - shifted, front bumper assembly, front support panel - thrust inwards/buckled resulting in the air conditioner condenser & radiator assemblies - shifted inwards, bootlid & its inner reinforcement - dented/bent/buckled/warped over an extensive area, bootlid/inner lock/striker - bent inwards/shifted, rear end panel/taillamp panel n/s - thrust inwards/buckled, rear bumper assembly, rear fender n/s - buckled, rear door lock pillar/dog leg n/s - buckled/sandwiched with n/s rear door assembly resulting in its inner locks - shifted/misaligned, exhaust muffler/tailpipe - bent/resonant, rear compartment floor/tyre well panel - buckled, etc.

We have negotiated with the repairer and they have agreed to repair this vehicle for **S\$8,890.00 NETT** which, in our opinion is fair and reasonable.
