Vehicle No. SLB 5538E

## ADJUSTMENT ON REPAIR COST FOR VEHICLE NO. SLB 5538E

### PHOTOGRAPHS FOR VEHICLE NO. SLB 5538E

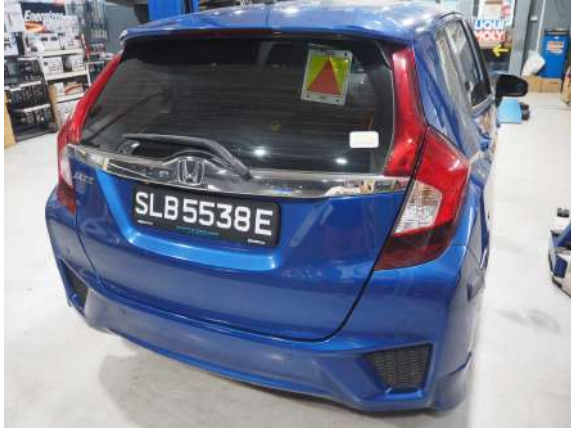
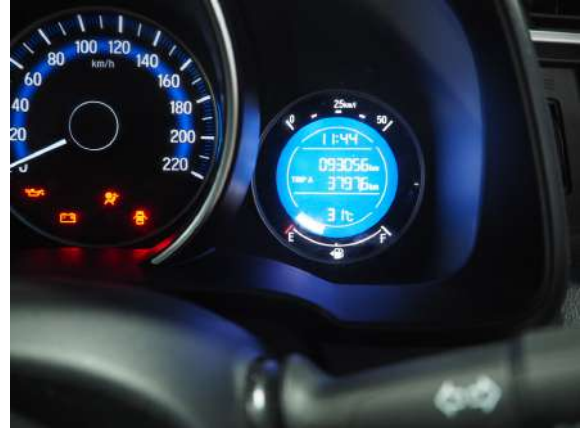
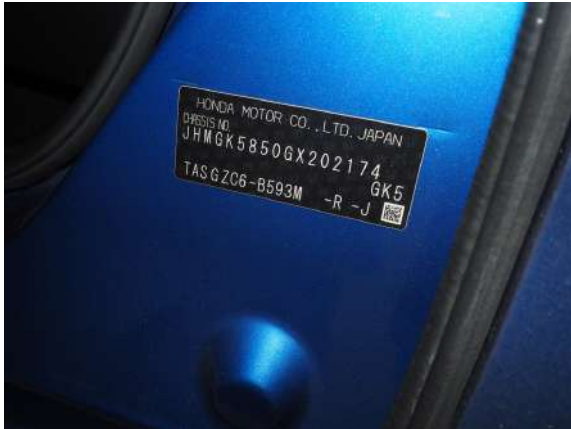
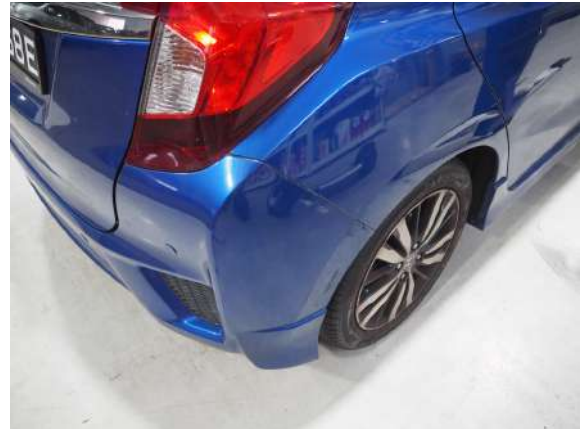
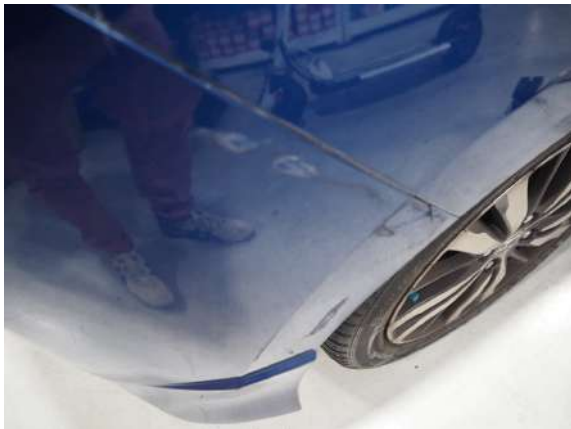
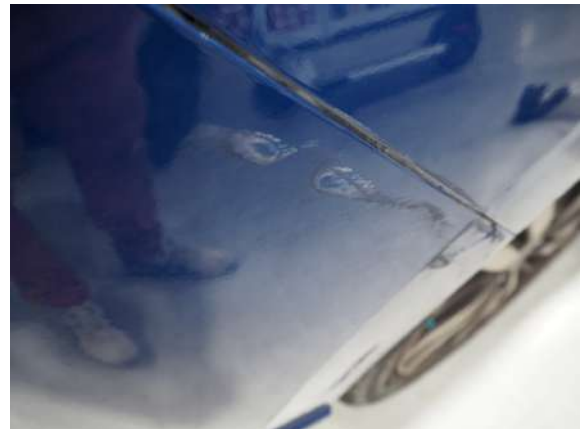
### INSPECTION

<b>4. Description of Damages</b>				
THE VEHICLE SUSTAINED DAMAGES AT THE REAR O/S PORTION.  DAMAGES SEE DETAILS.				
<b>5. General Information</b>				
Accident Date	06/05/2021	Inspection Date	27/05/2021	
Survey held at	EXCLUSIVE ENTERPRISE PTE LTD 8 KAKI BUKIT AVENUE 4 #03-49 PREMIER @ KAKI BUKIT SINGAPORE 415875			
<b>5a. Remarks</b>				
A)THE INSPECTION WAS CONDUCTED ON A"WITHOUT PREJUDICE" BASIS. B)IN ACCORDANCE TO YOUR INSTRUCTIONS, WE HAVE NOT AUTHORISED REPAIRS.				
<b>5b. Estimate Days of Repair</b>				
ESTIMATED NORMAL PERIOD FOR REPAIR:			<b>3 Working Days</b>

150.00	30.00
	<b><u>LABOUR</u></b>			
	WIRE CHECK .		50.00	30.00
	R/R REAR REVERSE SENSOR .		80.00	50.00
	R/R REAR FENDER QUARTER GLASS .	NOT NECESSARY	120.00	-
	TUFF COAT.		100.00	30.00
	LABOUR .INCLUSIVE OF THE REPAIR OF REAR FENDER RH .		500.00	250.00
	PAINTING .		500.00	400.00
			1,350.00	760.00
	<b>GRAND TOTAL</b>		<b>2,621.84</b>	<b>1,255.60</b>
	<b>RECOMMENDED COST OF LUMP SUM REPAIRS (TO ITS PRE-ACCIDENT CONDITION)</b>			<b>1,000.00</b>
