**PROPERTY DAMAGE CLAIM ARISING FROM ACCIDENT INVOLVING
VEHICLES SJM5327M & YQ530B AT 375 BUKIT BATOK STREET 31 ON
29/3/2021**

AUTOMOBILE INSPECTION REPORT

VEHICLE INSPECTION
SJM 5327M

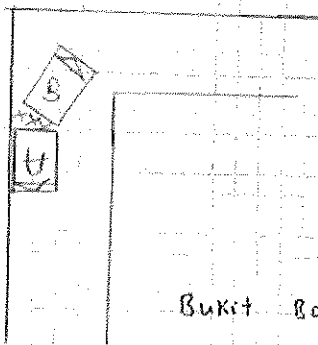
SKETCH PLAN

A) SJM 5327M

B) YQ 5308

Bukit Batok St 31

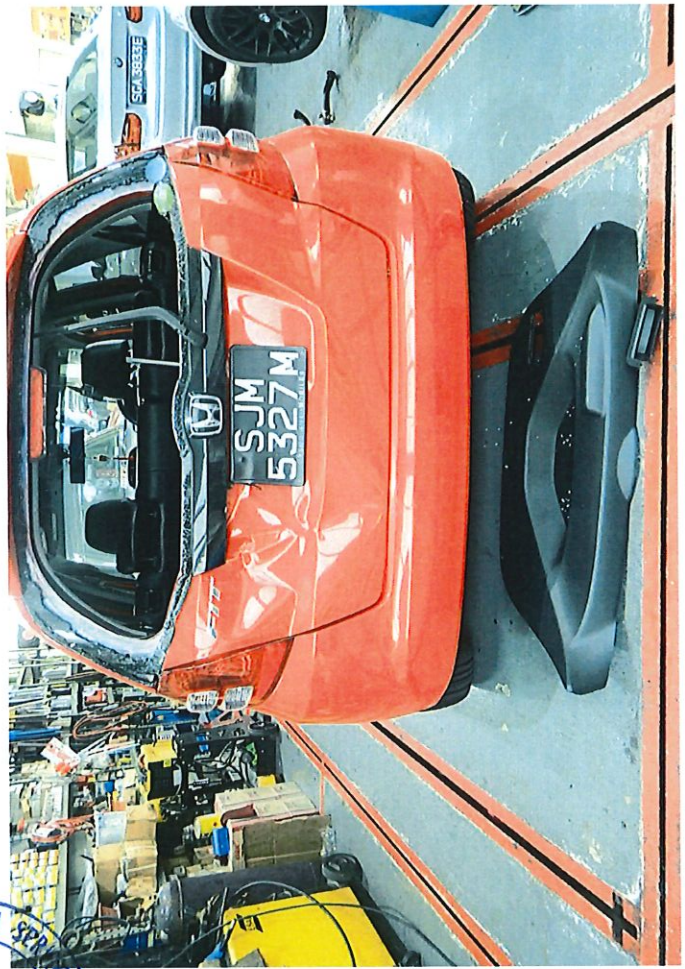
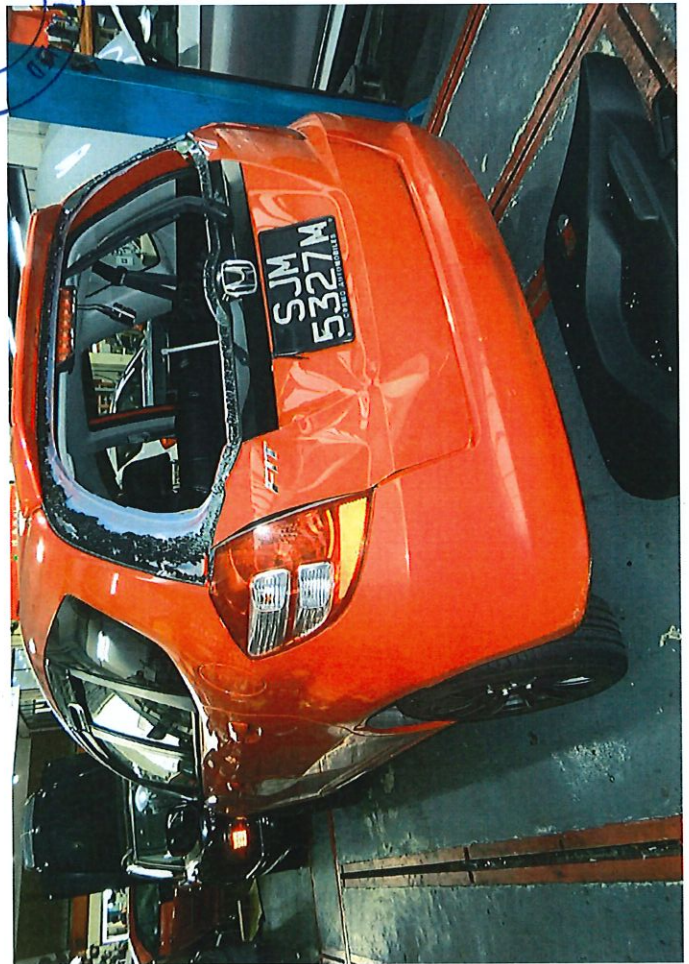
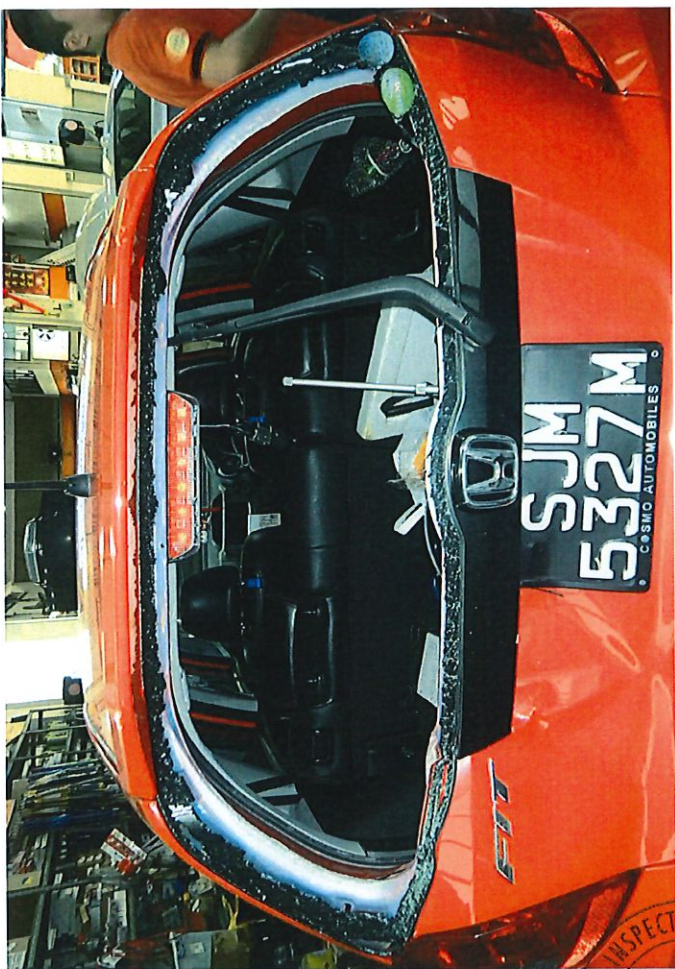
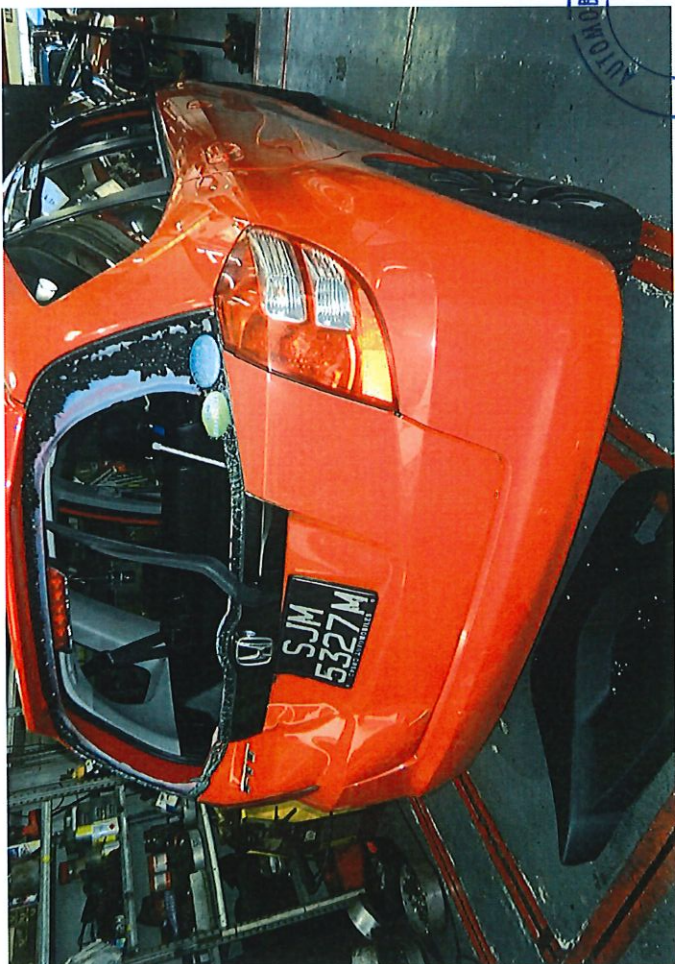
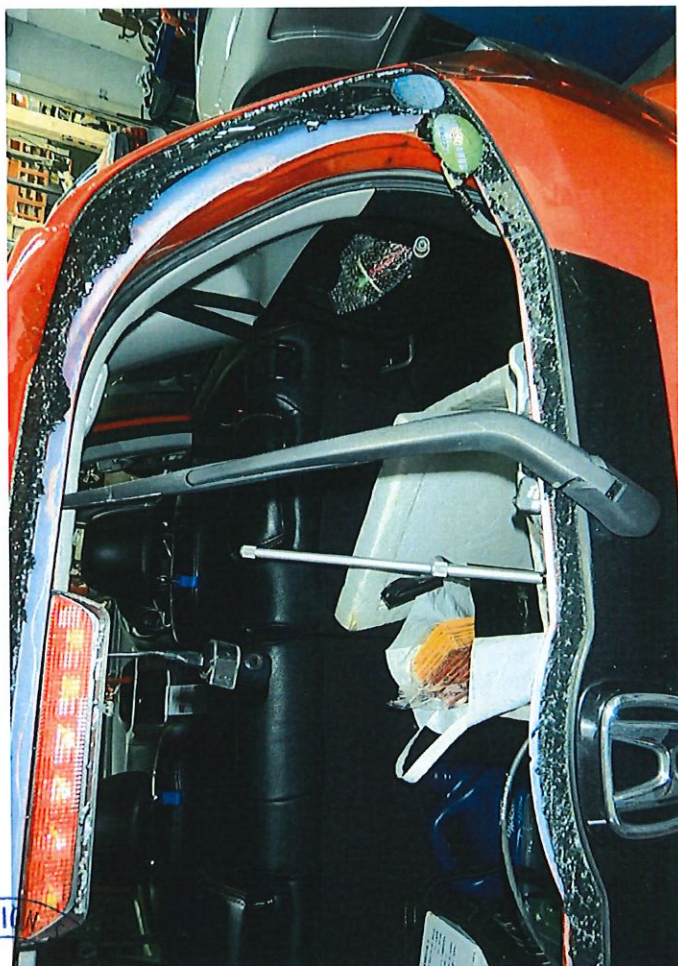
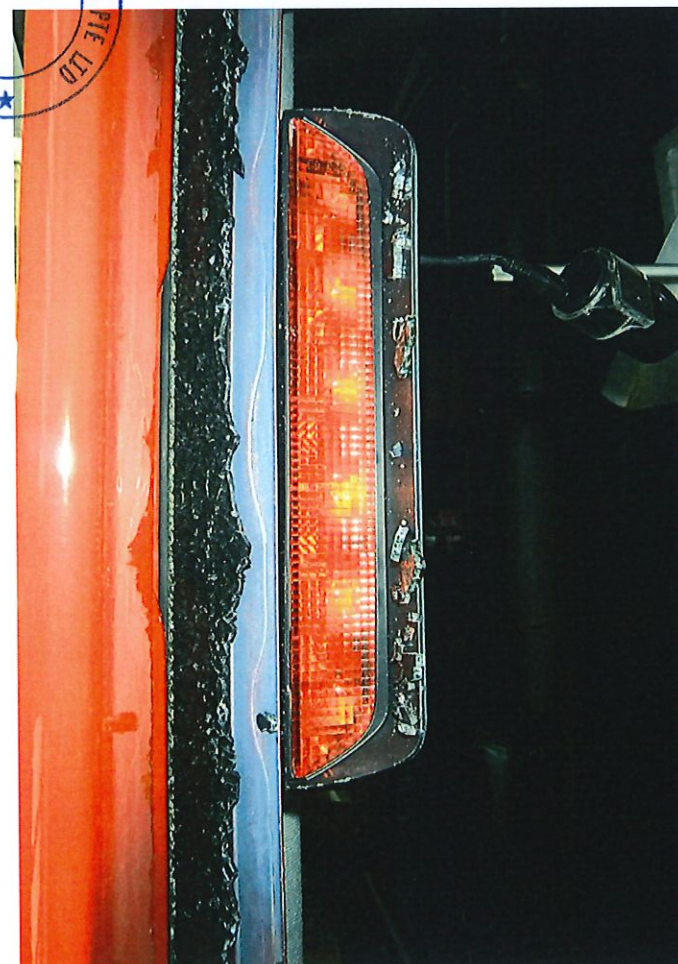
DAMAGE TO THE REAR PORTION. FOR FURTHER DETAILS, PLEASE REFER TO OVERLEAF.

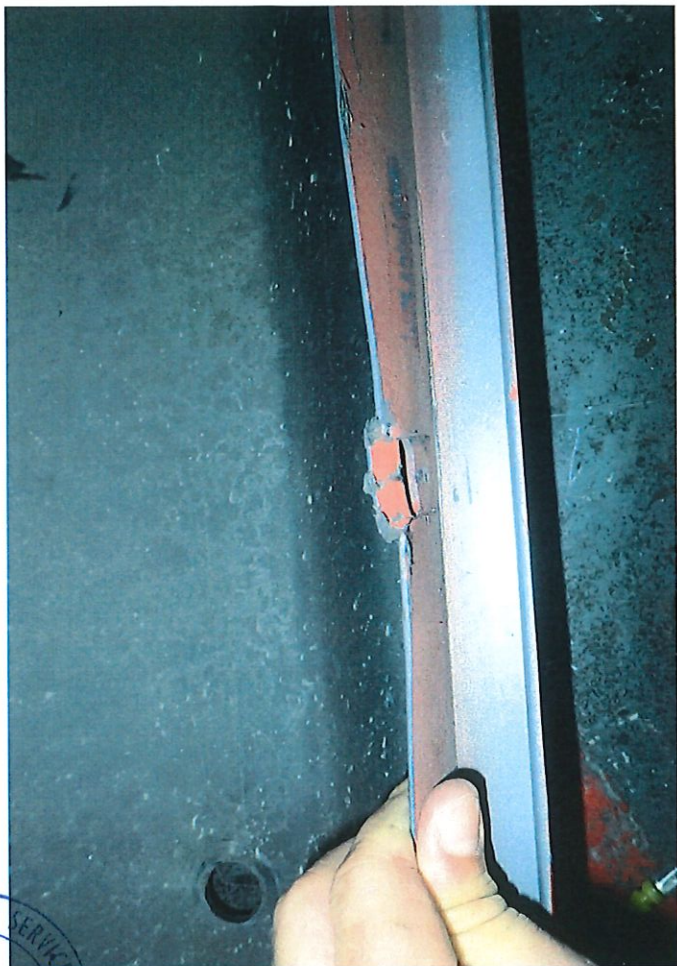
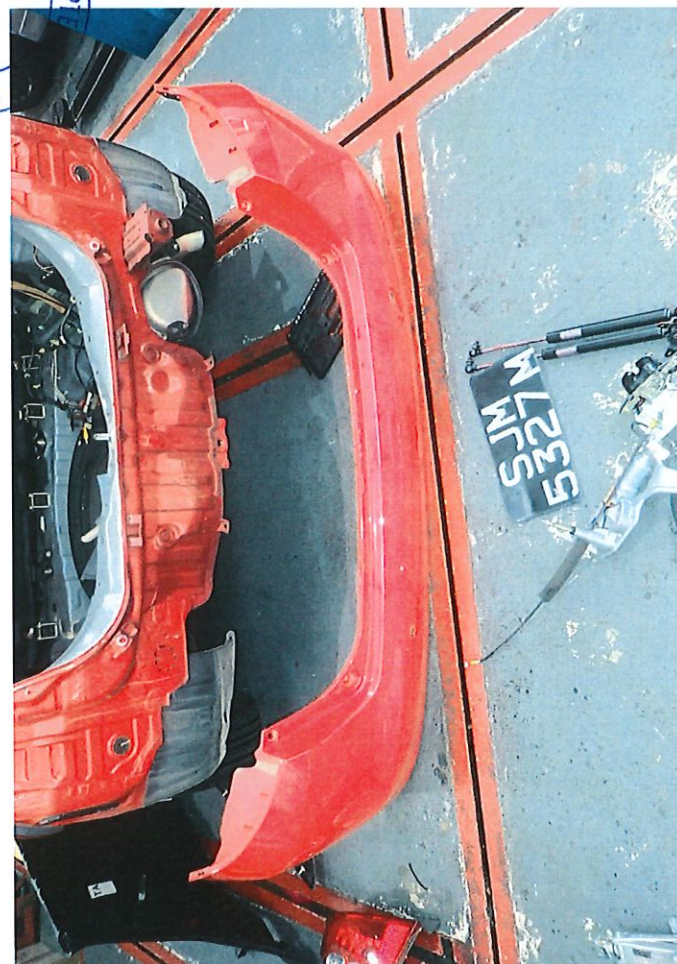
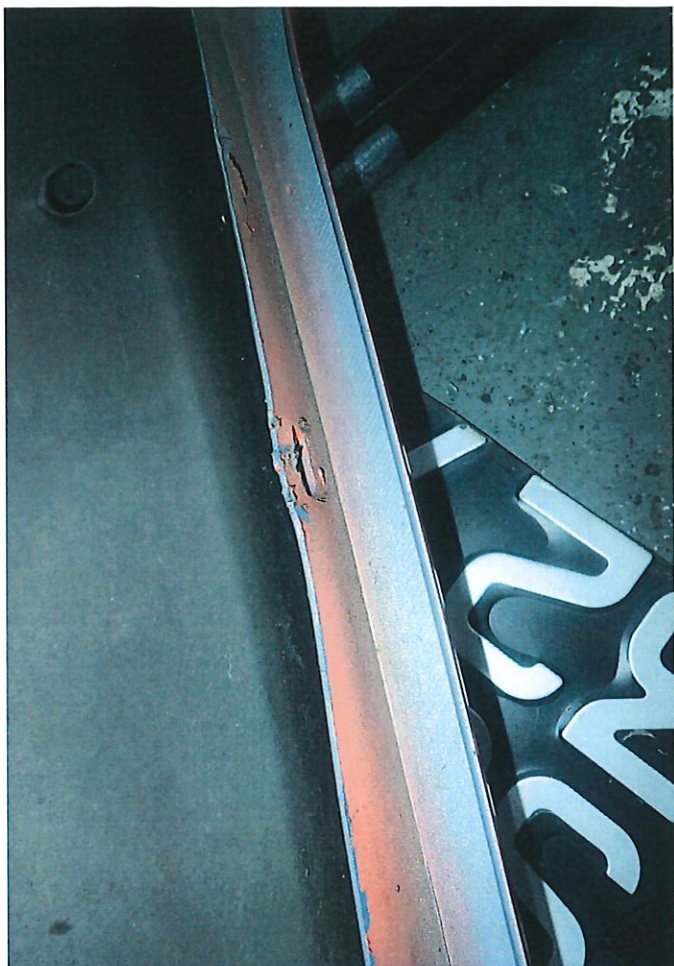
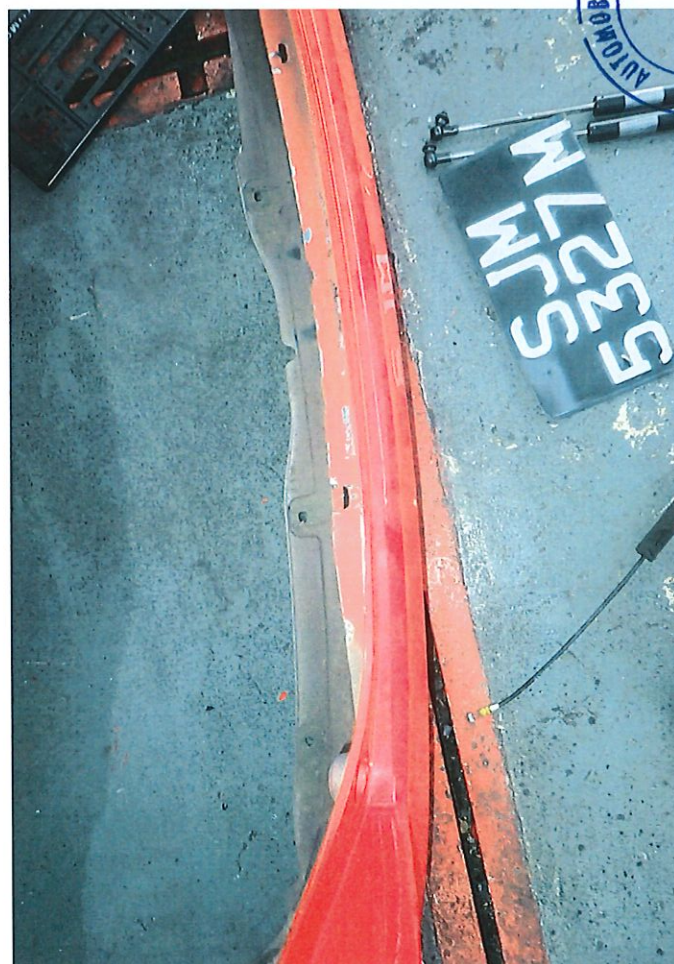
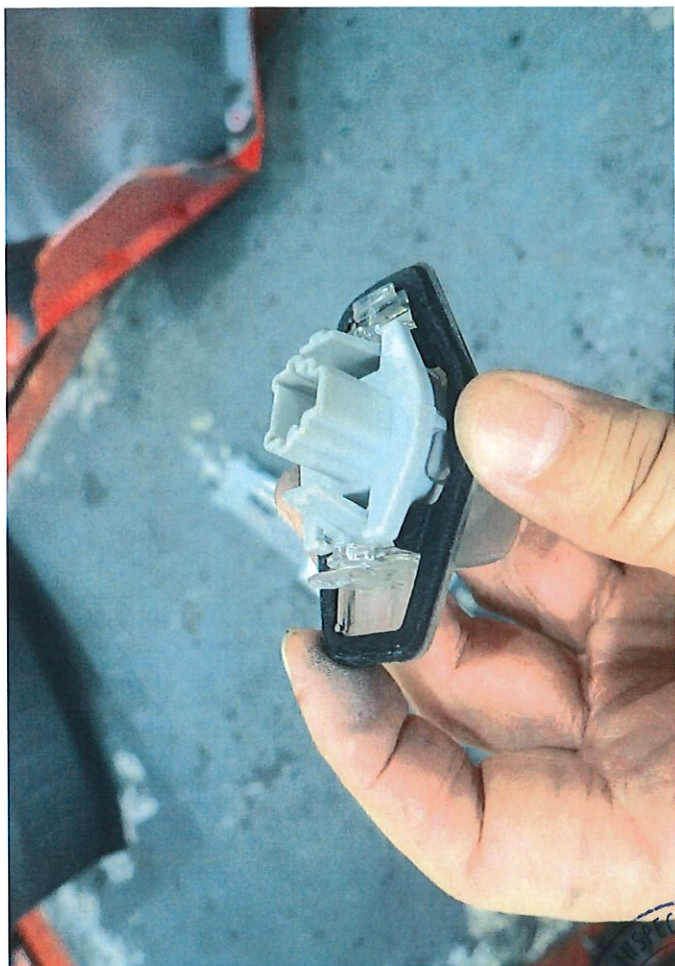
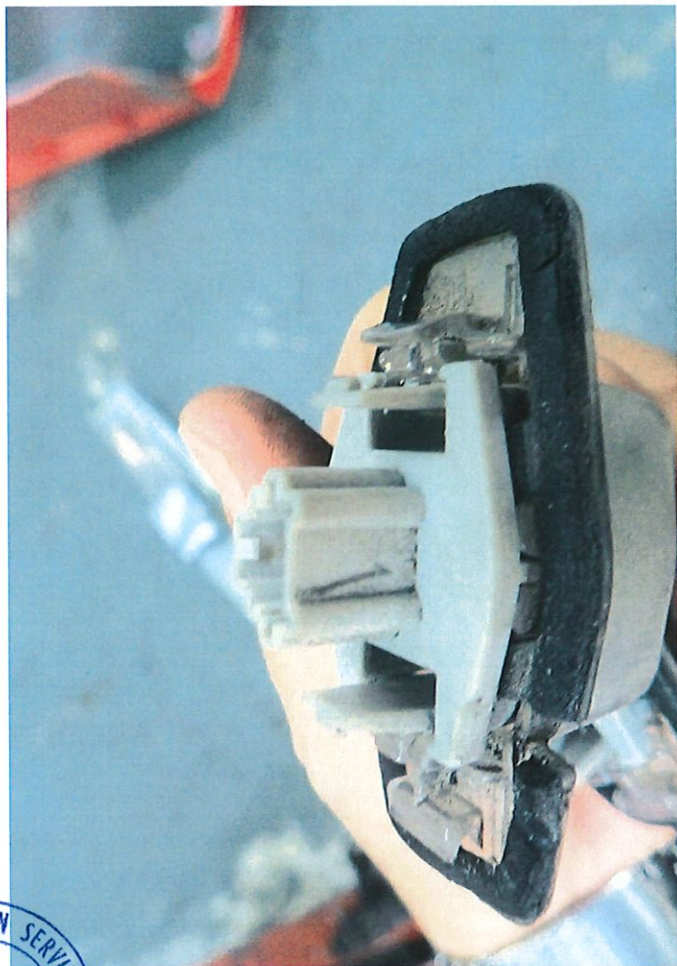
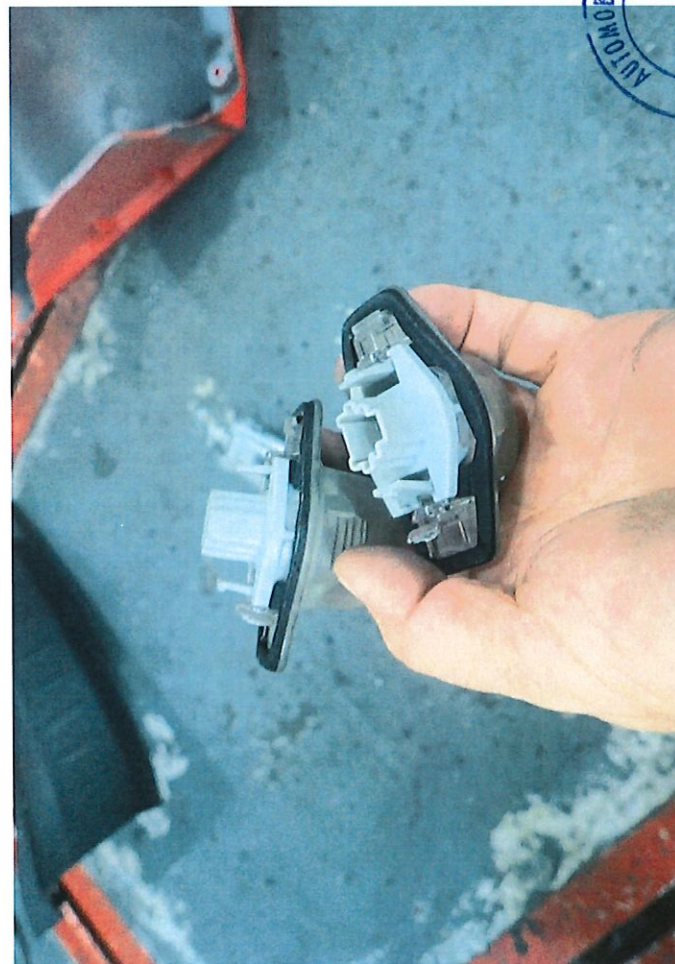
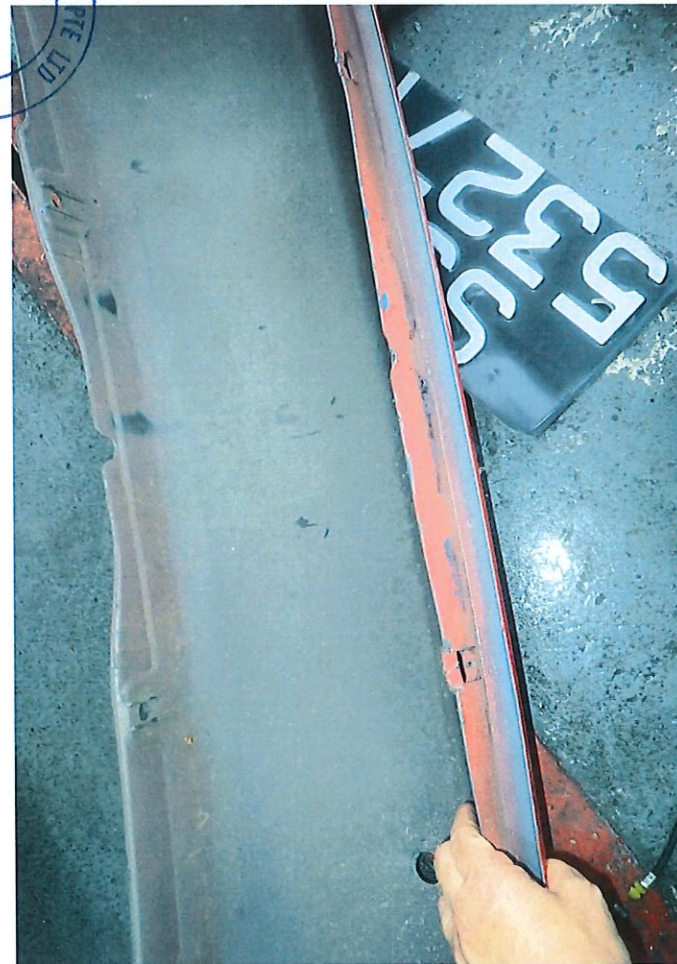
S/N	QTY	DESCRIPTIONS	COMMENTS/CONDITION	ORIGINAL QUOTATION	REVISED QUOTATION
<u>Material Items</u>					
1	1	REAR TAILGATE	DENTED	794.50	794.50
2	1	REAR TAILGATE EMBLEM "FIT"	NECESSARY	35.00	35.00
3	1	REAR TAILGATE OUTER GARNISH	DENTED	199.50	199.50
4	1	REAR TAILGATE OUTER GARNISH LOGO	NECESSARY	85.00	85.00
5	2	REAR TAILGATE NUMBER PLATE LAMP TORN LH & RH		71.60	71.60
6	1	REAR TAILGATE THIRD BRAKE LAMP	TORN	180.00	180.00
7	1	REAR TAILGATE WIPER ARM	DENTED	84.60	84.60
8	1	REAR TAILGATE WIPER BLADE	SERVICEABLE	45.00	0.00
9	1	REAR TAILGATE WIPER MOTOR	DENTED/BENT	238.70	238.70
10	1	REAR TAILGATE LOCK MECHANISM	DENTED/BENT	189.50	189.50
11	1	REAR TAILGATE LOCK STRIKER	SERVICEABLE	28.00	0.00
12	1	REAR TAILGATE INNER TRIM BOARD	DENTED/HOLDER TORN	138.20	138.20
13	1	REAR TAILGATE INNER TRIM BOARD HANDLE	DENTED	58.40	58.40
14	1	REAR TAILGATE WINDSCREEN GLASS	SHATTERED	800.00	800.00
15	1	REAR TAILGATE WINDSCREEN RUBBER	NECESSARY	58.00	58.00

ESTIMATED NORMAL PERIOD OF REPAIRS: (8)WORKING DAYS
IN ACCORDANCE WITH YOUR INSTRUCTIONS, WE HAVE NOT AUTHORISED REPAIRS.

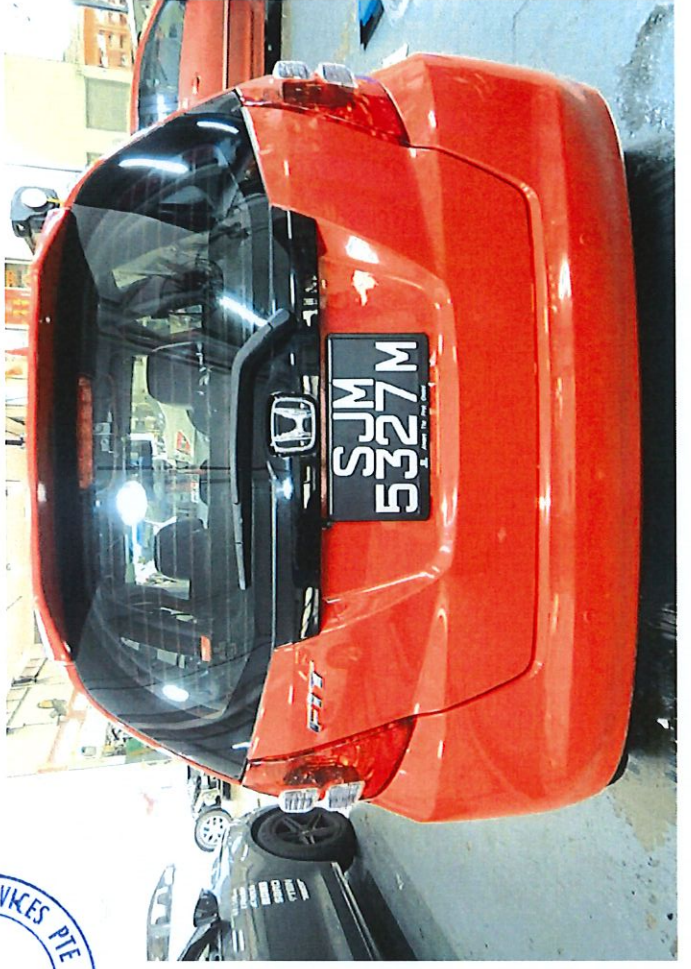
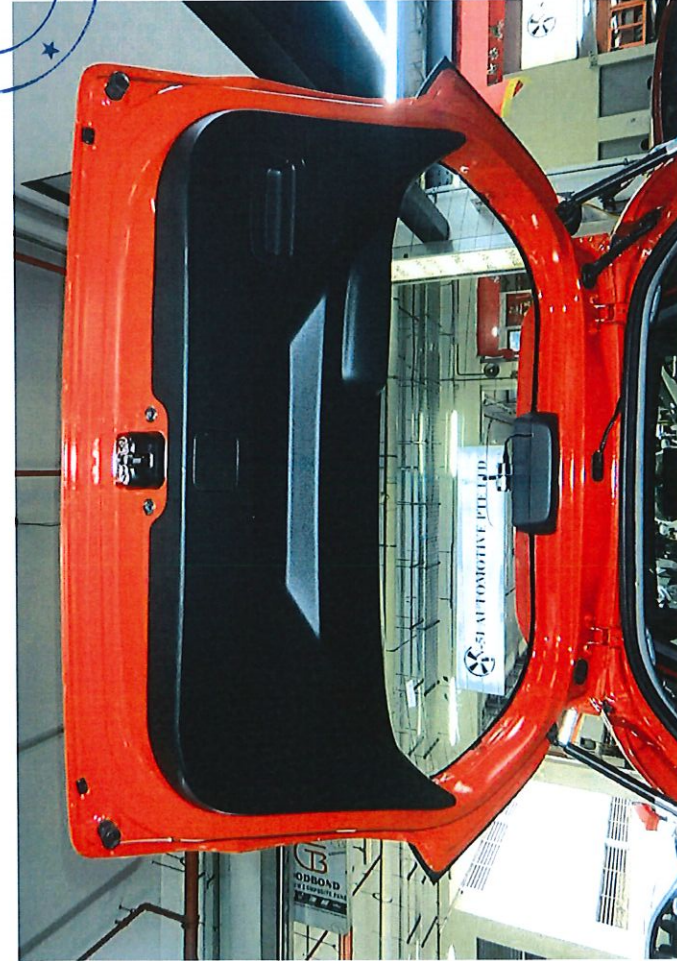
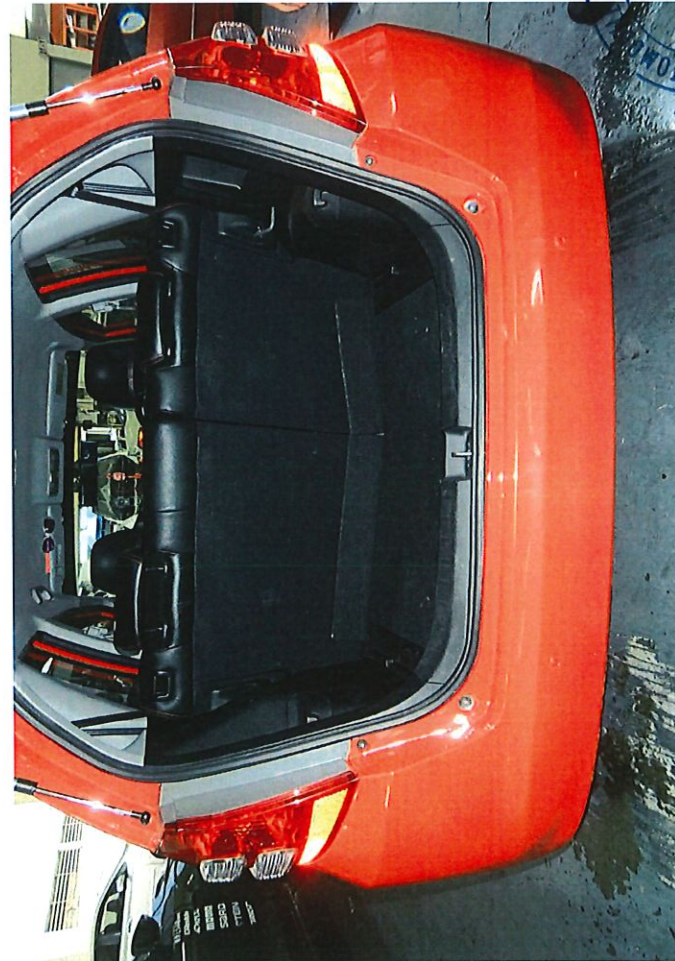
Reinspection

WE HAVE REINSPECTED THE ABOVE VEHICLE AND FOUND THAT IT IS IN ORDER
THIS SURVEY WAS CONDUCTED STRICTLY "WITHOUT PREJUDICE"
