1. Policy Particulars :- THIRD PARTY CLAIM			
Insured Veh.	YP 3039P	Veh. Inspected	SH 9597T
Policy No.	DMCVSNA00049832100	Coverage (\$)	0.00
Claim No.	SNM21D202950/C02	Excess (\$)	0.00
Assign From		Assign Date	17/05/2021

2. Vehicle Particulars & Condition			
Make & Model	TOYOTA PRIUS HYBRID 1.8	c.c	1798
Engine No.	HIDDEN	Year of Reg.	2017
Chassis No.	JTDKB3FU303563136	Colour	BLUE
Odometer	667128 KM	Steering	IN ORDER
Brakes	IN ORDER	Modification	STANDARD ALLOY RIM
General	GOOD

ADJUSTMENT ON REPAIR COST FOR VEHICLE NO. SH 9597T

PHOTOGRAPHS FOR VEHICLE NO. SH 9597T

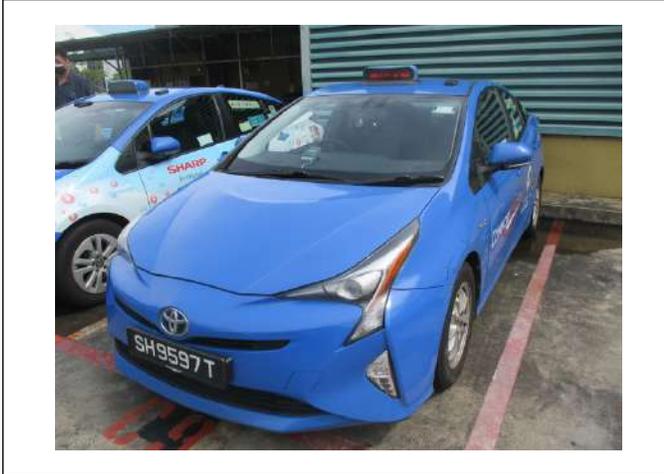
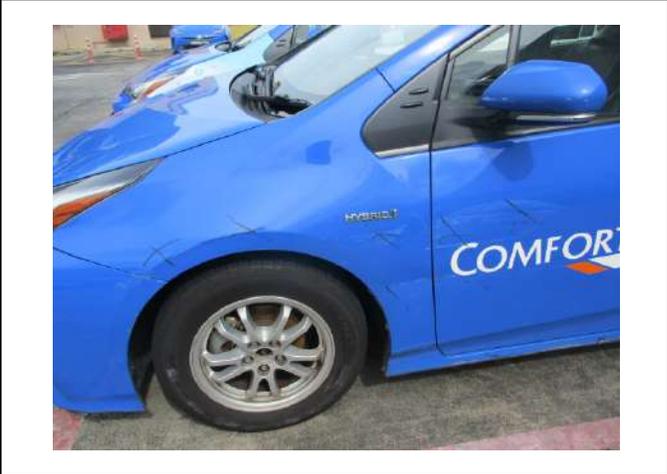
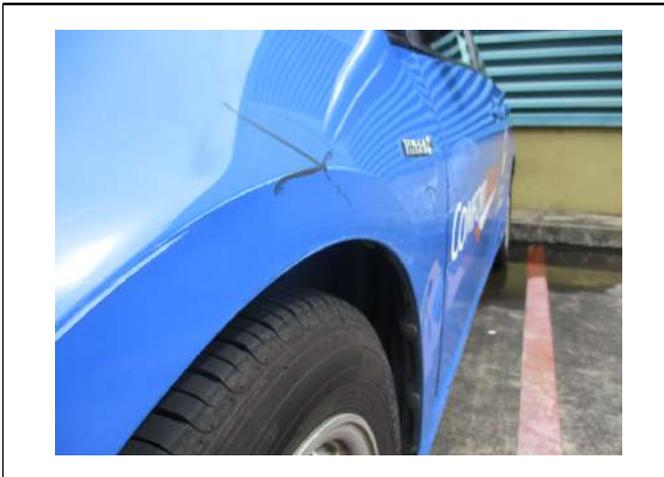
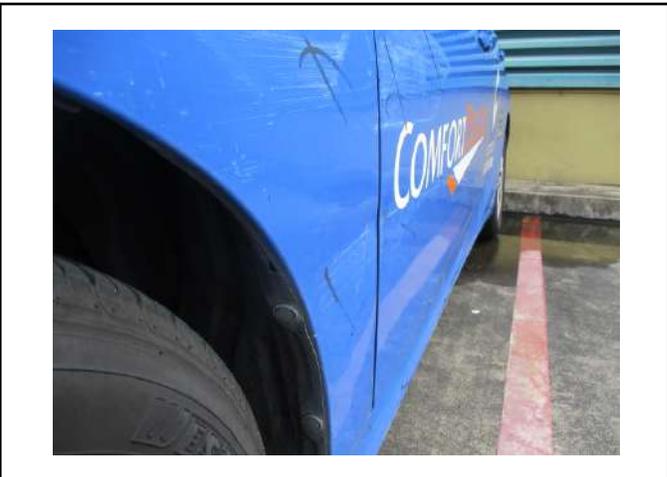
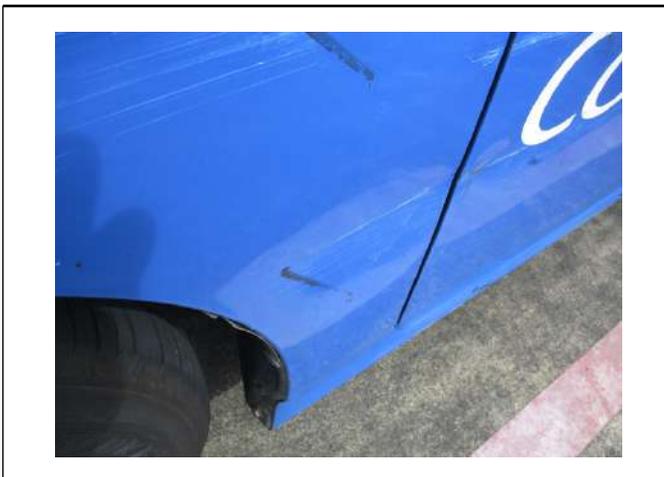
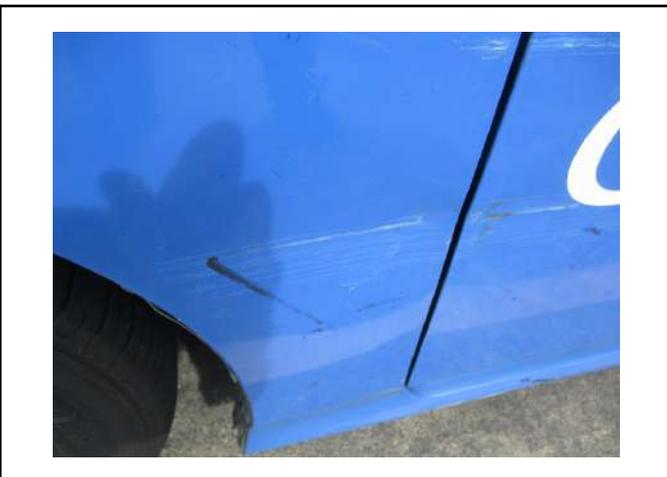
4. Description of Damages			
THE VEHICLE SUSTAINED DAMAGES AT THE N/S BODY. DAMAGES SEE DETAILS.			
5. General Information			
Accident Date	14/05/2021	Inspection Date	17/05/2021
Survey held at	COMFORTDELGRO ENGINEERING PTE LTD 59 LOYANG DRIVE SINGAPORE 508969		
5a. Remarks			
A)THE INSPECTION WAS CONDUCTED ON A"WITHOUT PREJUDICE" BASIS. B)IN ACCORDANCE TO YOUR INSTRUCTIONS, WE HAVE NOT AUTHORISED REPAIRS.			
5b. Estimate Days of Repair			
ESTIMATED NORMAL PERIOD FOR REPAIR:		3 Working Days

Qty	Description of Parts	Condition	Estimate By Workshop (\$)	Our Adjusted (\$)
REPLACEMENT OF PARTS				
1	FRT FENDER LH	BUCKLED	945.30	945.30
1	FRT FENDER (HYBRID) LH	NECESSARY	86.50	86.50
1	WING MIRROR LH	CRACKED	1,390.10	1,390.10
1	WING MIRROR OUTER COVER LH	TO REPAIR SEE LABOUR	141.90	-
1	ROCKER PANEL GARNISH LH	CUT	576.00	576.00
1	FRT WHEEL SPORT RIM LH	TO REPAIR SEE LABOUR	1,570.55	-
1	FRT DOOR LH	TO REPAIR SEE LABOUR	1,264.00	-
	LESS 25% DISCOUNT		-1,493.59	-749.48
			4,480.76	2,248.42
SPECIAL NETT ITEMS				
1	FRT DOOR COMFORTDELGRO LH (SN)	NECESSARY	75.00	75.00
1	FRT WHEEL TYRE LH (SN)	NOT NECESSARY	216.00	-

291.00	75.00
LABOUR				
	PANEL BEATING.INCLUSIVE OF THE REPAIR OF WING MIRROR OUTER COVER LH,FRT WHEEL SPORT RIM LH AND FRT DOOR LH .		800.00	350.00
	SPRAY PAINTING CHARGE.		1,500.00	950.00
	WIRING CHARGE.		40.00	20.00
	TUFF KOTE.		40.00	40.00
			2,380.00	1,360.00
GRAND TOTAL			7,151.76	3,683.42
RECOMMENDED COST OF LUMP SUM REPAIRS (TO ITS PRE-ACCIDENT CONDITION)				2,950.00
