SINGAPORE ACCIDENT STATEMENT

ACCIDENT STATEMENT

ACCIDENT VEHICLE INSPECTION / ASSESSMENT REPORT

Our Ref: CL 12192 GBK 4606 U

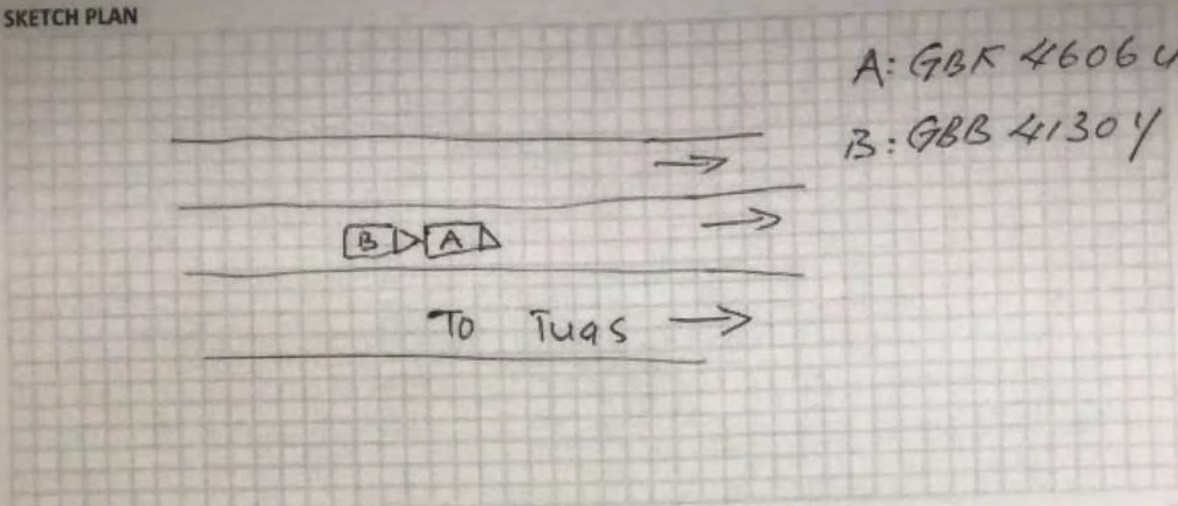
Sketch Plan #2

DESCRIBE CIRCUMSTANCES OF THE ACCIDENT

在 19/9/2020 3.35pm 我直走向 Tuas 方向走，
突然 GBB 4130 Y 撞上我的车后面。

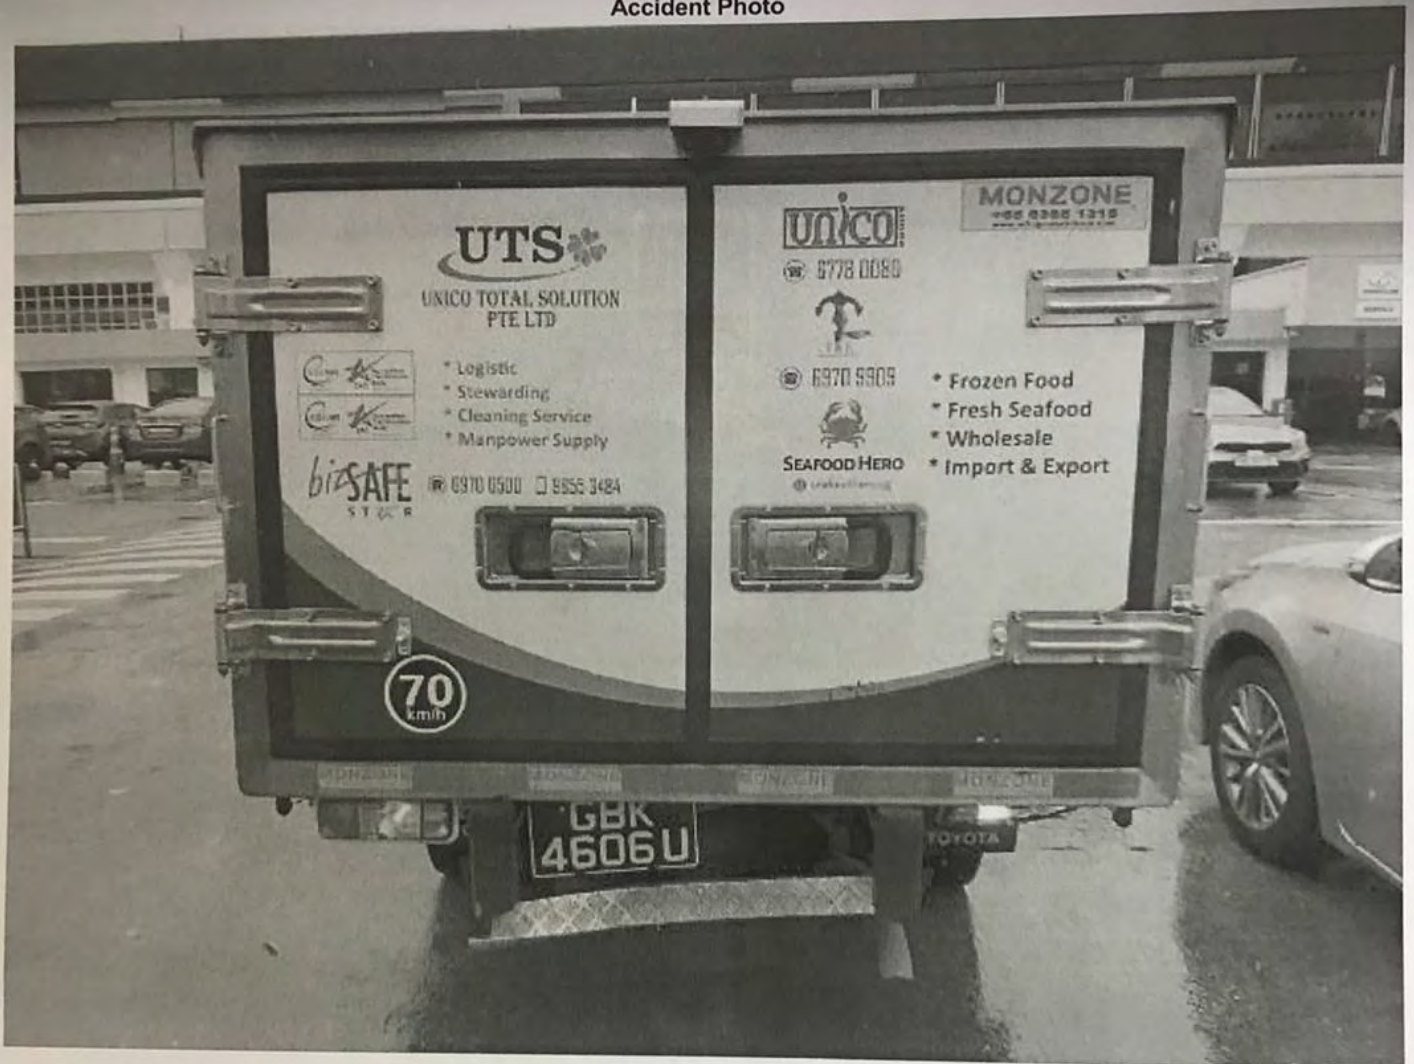
Accident Photo

5 POINT OF IMPACT			
See Annex(es) and Motor Accident Reports

Item	Vehicle Parts Description	Condition	Qty	W/shop Est. (\$)	Disc (%)	Adjusted Cost (\$)	
S/Nett Items							
1	Rear cold box door assy RH	Grazed/dented/warped	1	\$1,900.00		\$1,900.00	X SVC
2	Rear cold box door assy rubber seal RH	Cut	1set	\$400.00		\$400.00	/
3	Rear cold box door hinges RH	Bent	2	\$500.00		\$500.00	400 /
4	Rear cold box door design sticker c/w company logo, Monzone sticker, Unico, lettering sticker and etc	Grazed/dented/cut	1	\$600.00		\$600.00	X SVC
5	Rear door frame aluminium alloy panel RH (Vertical)	Serviceable	1	\$1,500.00		\$0.00	
6	Rear end panel aluminium alloy panel	Dented/bent/cut	1	\$1,800.00		\$1,800.00	/
7	Rear end panel foam insulated sandwich panel	Bent	1	\$850.00		\$850.00	/
8	Rear end panel insulated foam	Necessary	1	\$400.00		\$400.00	300 /
9	Rear end panel reflective Caution sticker	Necessary	1	\$150.00		\$150.00	100 /
10	Rear chassis override rubber bumper stopper	Deformed/cut	2	\$360.00		\$360.00	300 /

11	Rear chassis end cross member	Bent	1	\$550.00		\$550.00	X R
12	Rear RH chassis frame top cushion pad	Shifted/cut	1	\$180.00		\$180.00	X SVC
13	Rear bumper c/w bracket	Slack/buckled	1set	\$1,800.00		\$1,800.00	1300 /
14	Rear number plate	Dented/bent	1	\$38.00		\$38.00	/
15	Rear number plate lamp RH	Cracked	1	\$68.00		\$68.00	X SVC
16	Rear reverse camera c/w LED light	Cracked/faulty	1	\$750.00		\$750.00	500 /
17	Reverse sensors c/w control unit	Distorted/faulty	1set	\$360.00		\$360.00	200 /
18	Tail lamp RH	Cracked	1	\$250.00		\$250.00	/
19	Tail lamp bracket RH	Bent	1	\$85.00		\$85.00	/
20	Silicone white sealer	Necessary	2	\$160.00		\$160.00	/
21	Sika glue	Necessary	1	\$180.00		\$180.00	/
Total for Spare Parts :						\$12,881.00	\$11,381.00

We have inspected thoroughly the actual damages found on the vehicle and our assessment is appended in the Annex(es) attached. The condition and age of the vehicle was considered before we reached our recommendation as to whether the parts need replacement or repair.

M/S Sin Foo Hing Battery Service estimated repair cost is **S\$16,511.00** and we have adjusted it to **S\$14,211.00** on a part by part basis. However, taking into consideration the age of the vehicle and the availability of used/recondition components. We, therefore recommend a contract lump sum repair cost.

The repairer have agreed to undertake the repairs on a contract lump sum of **S\$12,100.00**, according to acceptable quality and standard. (Repairer discretion to repair parts, to replace with old parts, or to replace with OEM or genuine parts).
