Vehicle No. PC 8868E  
Insured Veh. GZ 1342L  
Claim No. 20/21/21/VC00/024612  
Policy No. Z/20/VC00/107563  
Accident Date 23/04/2021  
Inspection Date 03/06/2021

## ADJUSTMENT ON REPAIR COST FOR VEHICLE NO. PC 8868E

### PHOTOGRAPHS FOR VEHICLE NO. PC 8868E

### INSPECTION

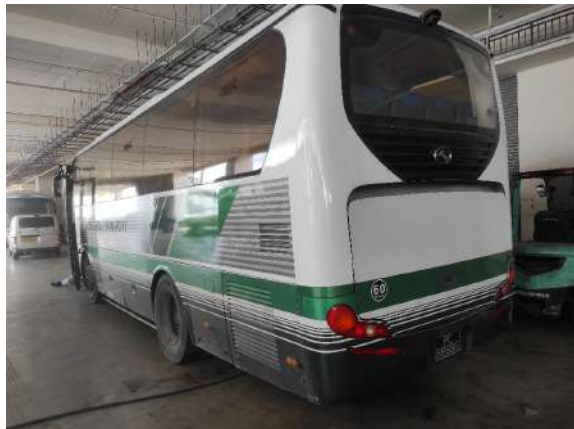
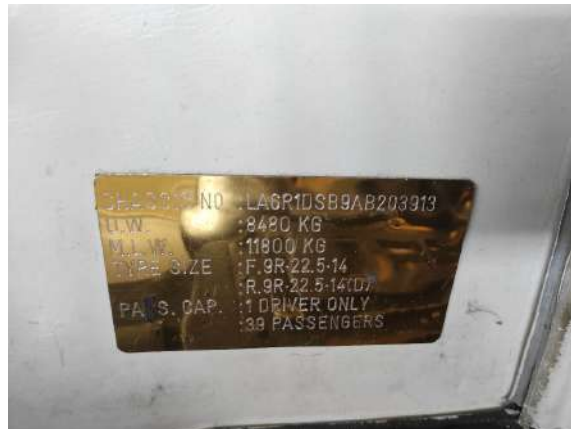
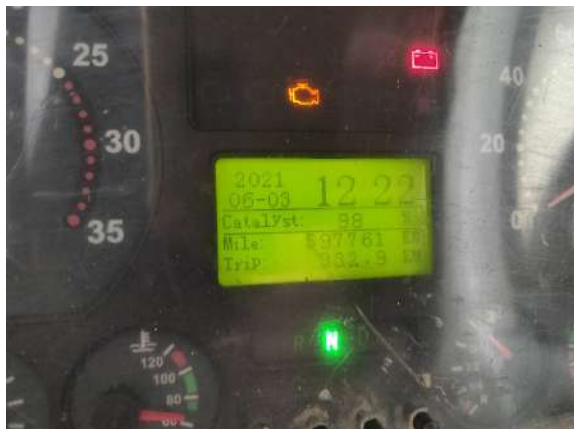
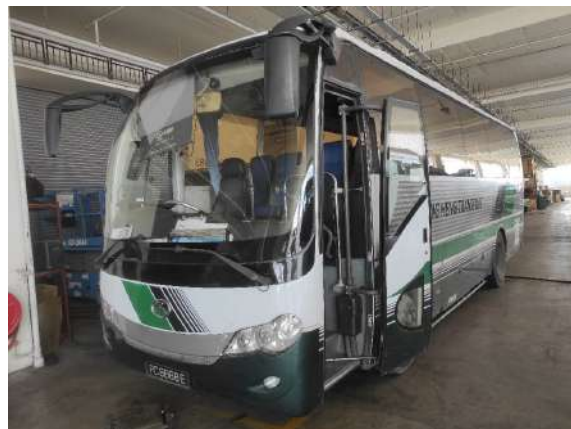
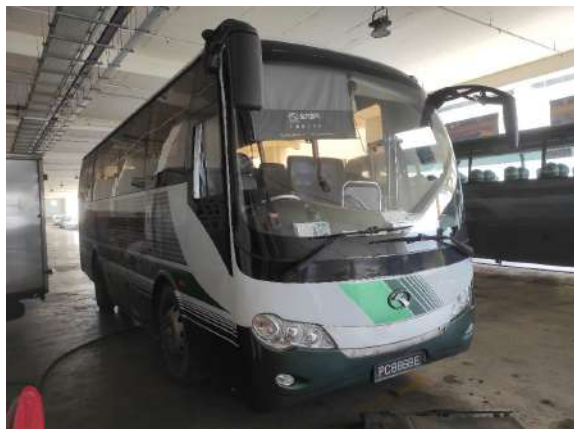
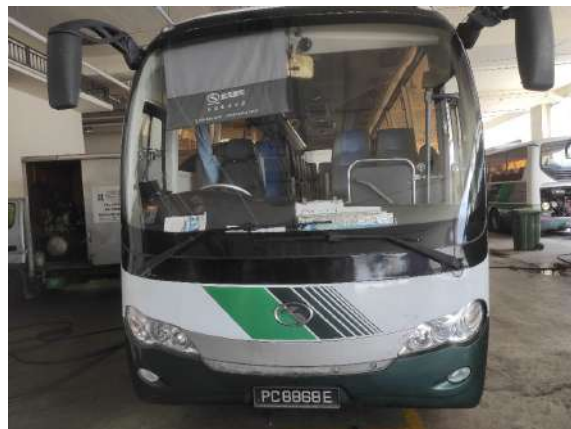
| Affiliated to Federation Internationale Des Experts En Automobile | | | | |
|---|---|---|---|--|
| THE VEHICLE SUSTAINED DAMAGES AT THE FRONT N/S PORTION.<br><br>DAMAGES SEE DETAILS. | | | | |

| Qty | Description of Parts | Condition | Estimate By Workshop (\$) | Our Adjusted (\$) |
|---|---|---|---|---|
| | TO PUTTY AND SPRAY PAINTING ON ALL AFFECTED ACCIDENT PARTS INCLUDING DESIGN PAINTING ON SAME (MULTI COLOR). | | 800.00 | 700.00 |
| | TO JACK /KNOCK /STRAIGHTEN ALL NECESSARY PARTS INCLUDING REPAIRING AND CHANGING OF ALL DAMAGED PARTS AND ALIGN SAME. | | 450.00 | 350.00 |
| | TO REMOVE COMBINATION HEADLIGHT AND REFIT NEW. | | 400.00 | 80.00 |
