## LKK Auto Consultants Pte Ltd

Vehicle No. SCH 8862Z  
Insured Veh. SKT 9046Z  
Claim No. 20/21/21/VP05/024633  
Policy No. Z20VP05027015  
Accident Date 07/06/2021  
Inspection Date 16/06/2021

## ADJUSTMENT ON REPAIR COST FOR VEHICLE NO. SCH 8862Z

### PHOTOGRAPHS FOR VEHICLE NO. SCH 8862Z

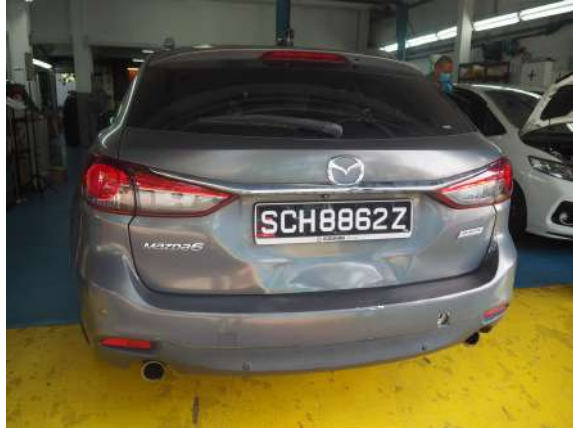
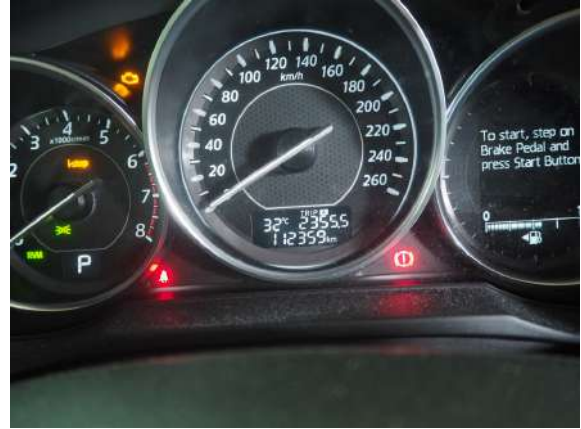
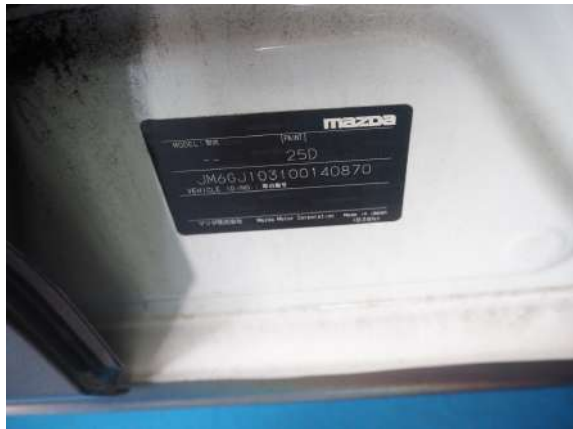
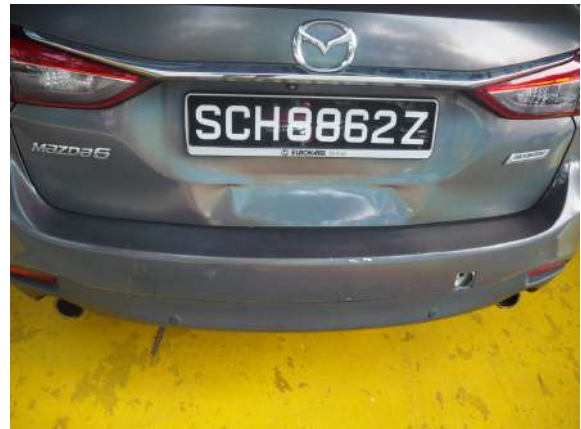
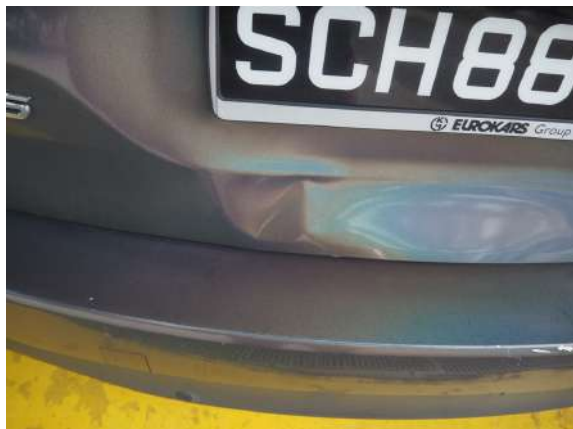
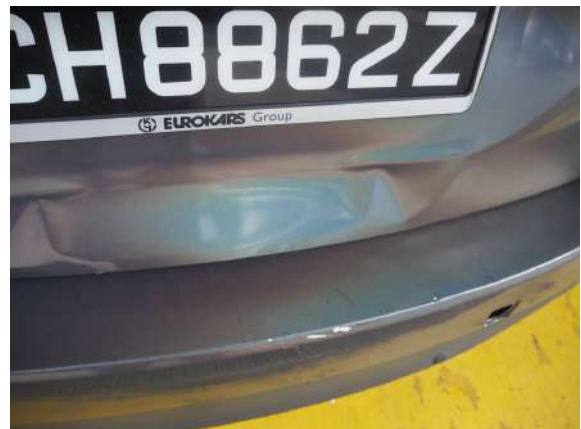
### INSPECTION

| Affiliated to Federation Internationale Des Experts En Automobile | | | | |
|---|---|---|---|--|
| THE VEHICLE SUSTAINED DAMAGES AT THE REAR PORTION.<br>DAMAGES SEE DETAILS. | | | | |
