ASSIGNMENT

Veh No: SHD 6128K Yr Regn: 2015 / NOV
Type: M.Car / M.Cycle / Bus / Van / Lorry / Taxi / Prime Mover /
Truck / Trailer or _____
Make: TOYOTA PRIMS TAXI c.c. 1798
Colour: MAROON A/C: Insured / Std / NI / NA
Sp. Reading: 532911 T/Radio: Insured / Std / NI / NA
Eng/No: _____
C/No: JDKN36U 805766681
Gen. Cond: Good / Fair / Poor / Burnt
Steering: Inorder / Jammed / Leaked / Burnt or _____
Brake: Inorder / Jammed / Leaked / Burnt or _____
Modi: Nil / SRIM / STD A/Rim or _____
Tyre Size: F: 195/65R15
R: 2

Case Reference Number : TAX/06/21/2036
Type of Repair : Accident Repair
Vehicle Registration Number : SHD6128K

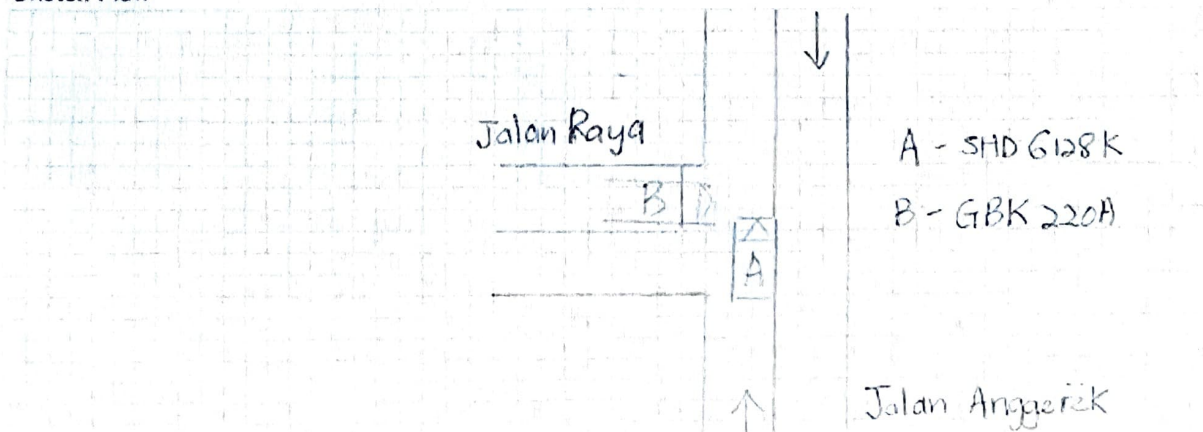
Sketch Plan

I WAS TRAVELLING ALONG JALAN ANGGEREK WITH 2 PASSENGERS (MALAY COUPLE) ON BOARD. SUDDENLY A LORRY GBK220A CAME OUT OF JALAN RAYA WITHOUT STOPPING AT THE STOP LINE AND COLLIDED ONTO THE LEFT FRONT PORTION OF MY TAXI.
