ASSIGNMENT

SMN 9680A

Remark: The veh had commenced its
repair at the time of inspection.

The U/C / Chassis frame / Body Structure affected due to collision.

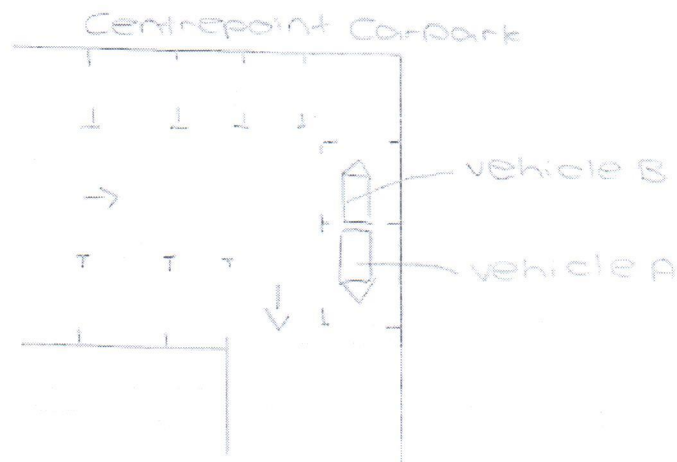
SKETCH PLAN

My car was parked stationary at Centrepunkt mall carpark lot. Based on my in-car video footage, vehicle B was reversing out from ~~the~~ the carpark lot. As he was reversing, ^{the rear portion of} vehicle B hit onto the rear portion of my vehicle (A)
