## ASSIGNMENT

To Inspect Vehicle No: GX 8385C

ACCIDENT REPAIR ON: GX8385C

MODEL : TOYOTA DYNA 150 MANUAL

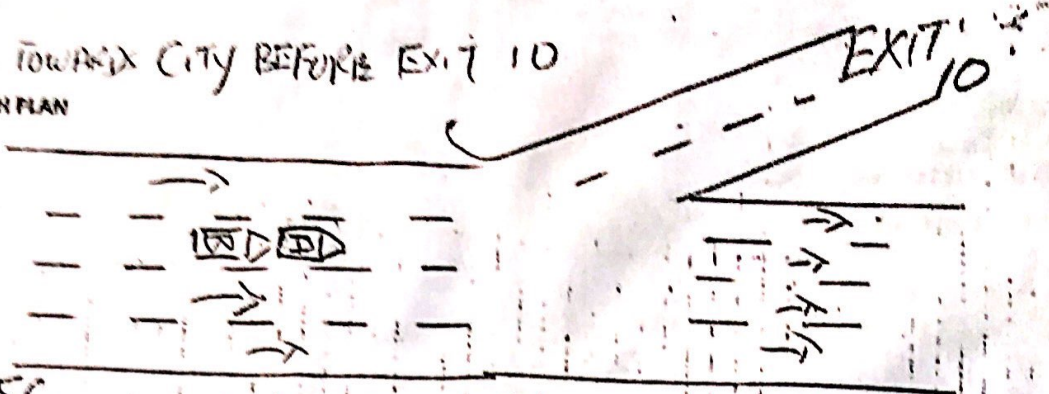
CTE TOWARDS CITY BEFORE EXIT 10  
SKETCH PLAN

- (A) GX 8385C
- (B) GRJ 115

On 26-6-2021 @ 1130hrs, I was driving along CTE towards City. The Vehicle in front of me suddenly brake and I also apply brake. The Van behind hit on to my Lorry Rear portion.
