Vehicle No. SLF 3483X  
Insured Veh. GN 1878X  
Claim No. 21/21/21/VC05/024737  
Policy No. Z/21/VC00/109599  
Accident Date 05/07/2021  
Inspection Date 08/07/2021

## ADJUSTMENT ON REPAIR COST FOR VEHICLE NO. SLF 3483X

### PHOTOGRAPHS FOR VEHICLE NO. SLF 3483X

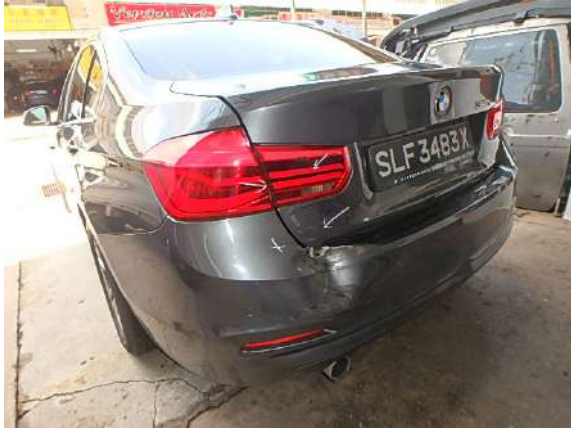
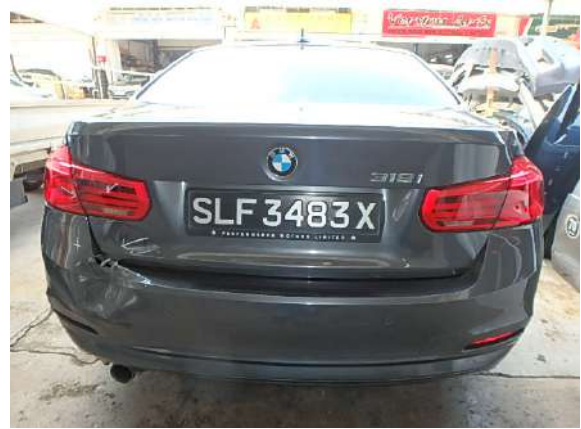
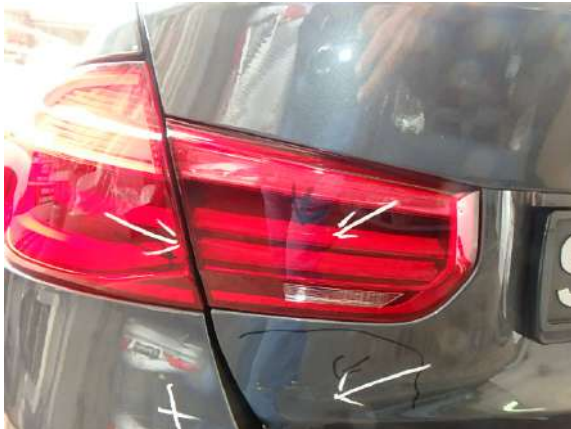
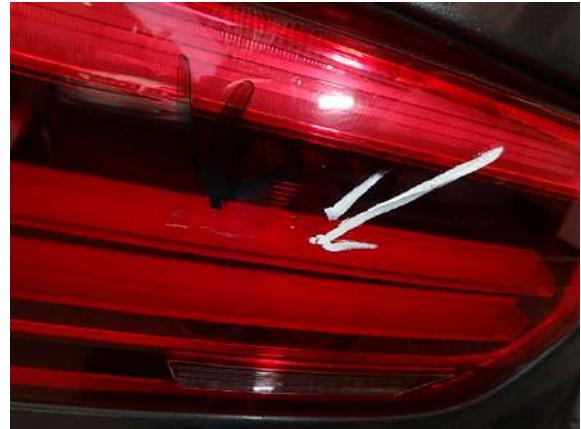
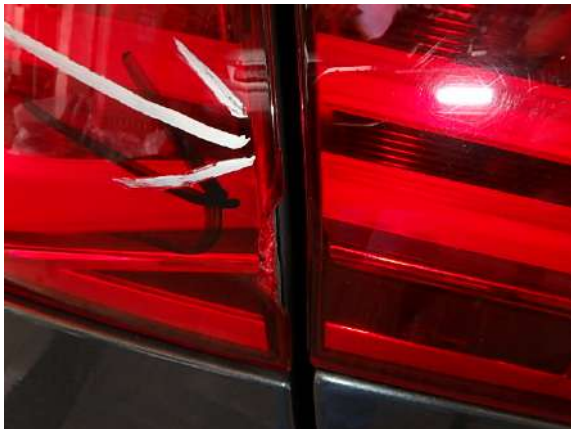
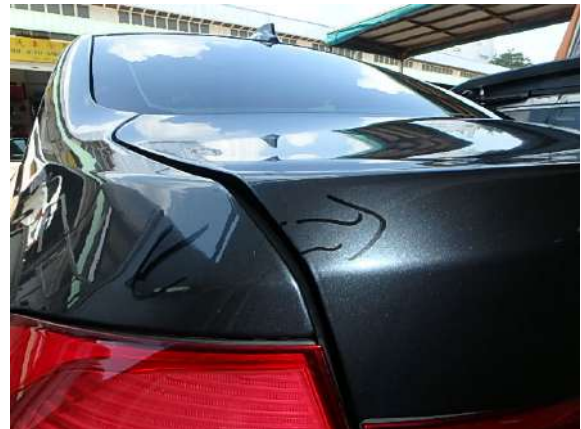
### INSPECTION

| Affiliated to Federation Internationale Des Experts En Automobile | | | | |
|---|---|---|---|--|
| THE VEHICLE SUSTAINED DAMAGES AT THE REAR N/S PORTION.<br>DAMAGES SEE DETAILS. | | | | |
