VEHICLE APPRAISAL REPORT

Regn. No : FBH 6966 H

Make Model : Piaggio

: Vespa GTS Super/Supersport 300 : July 2018 (COE Exp: July 2028)

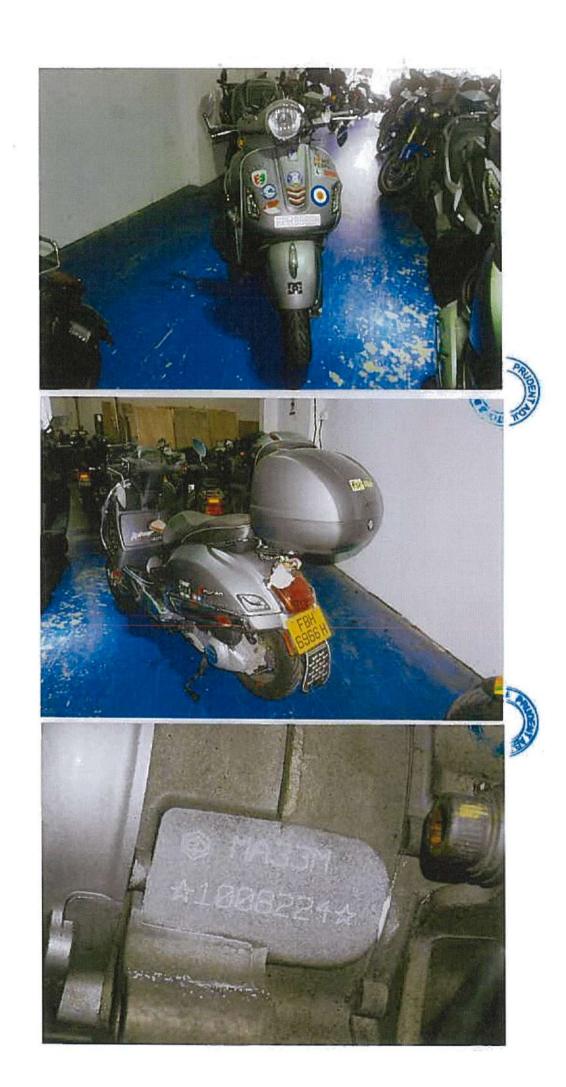
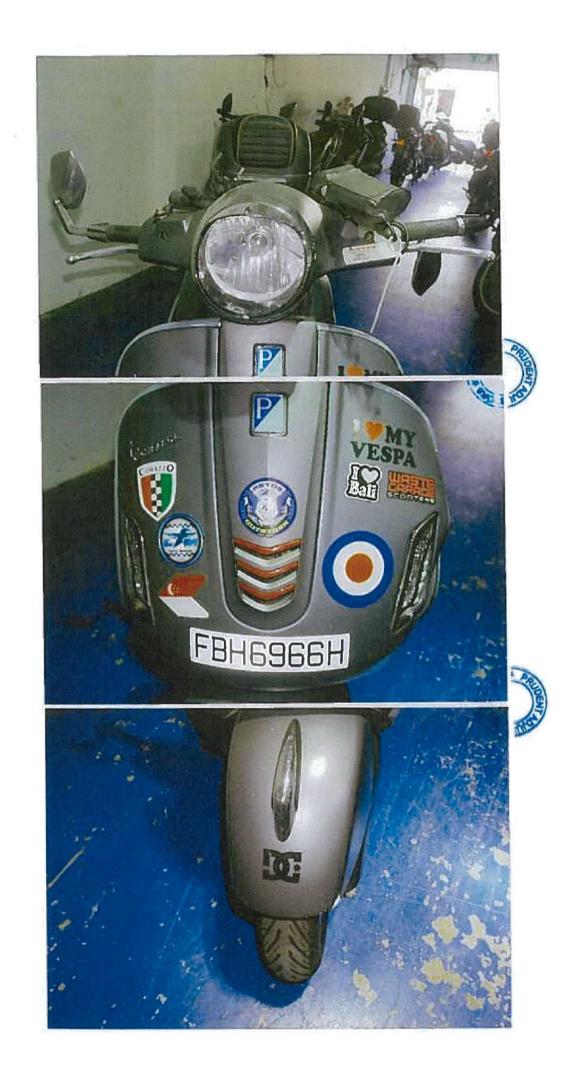
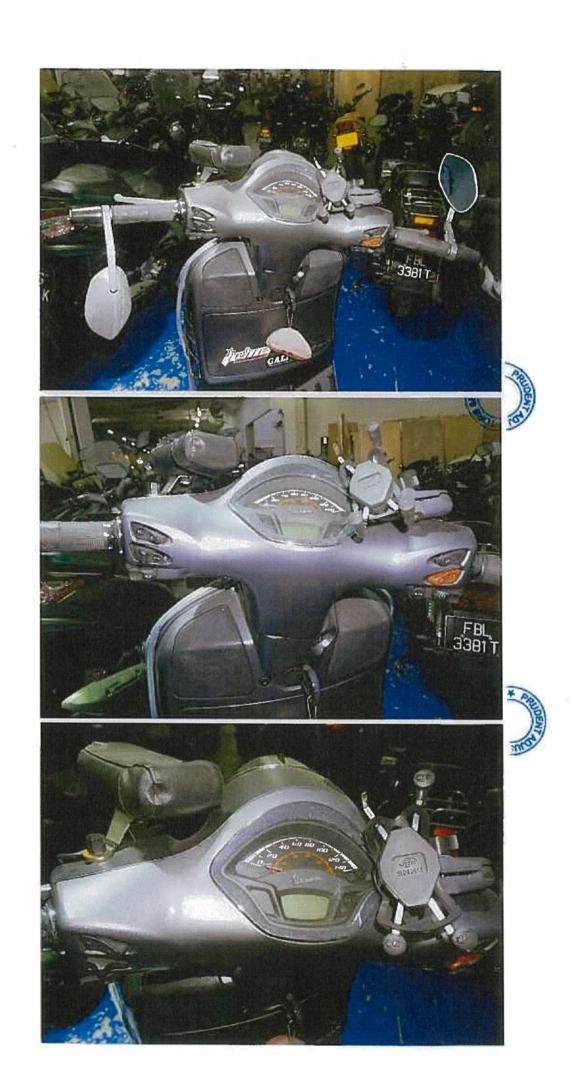
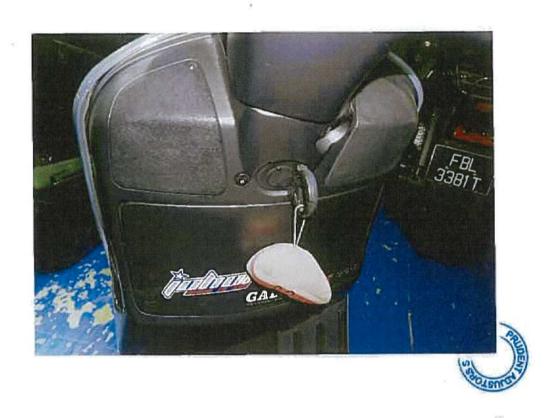
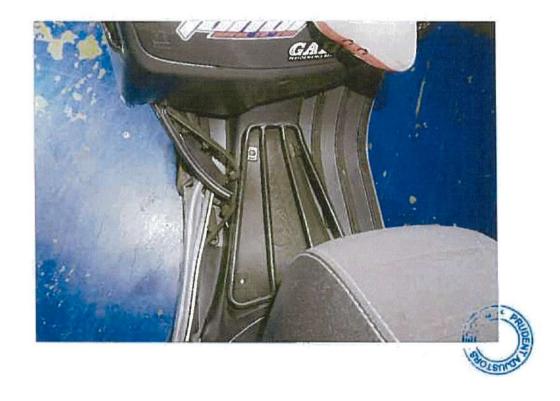
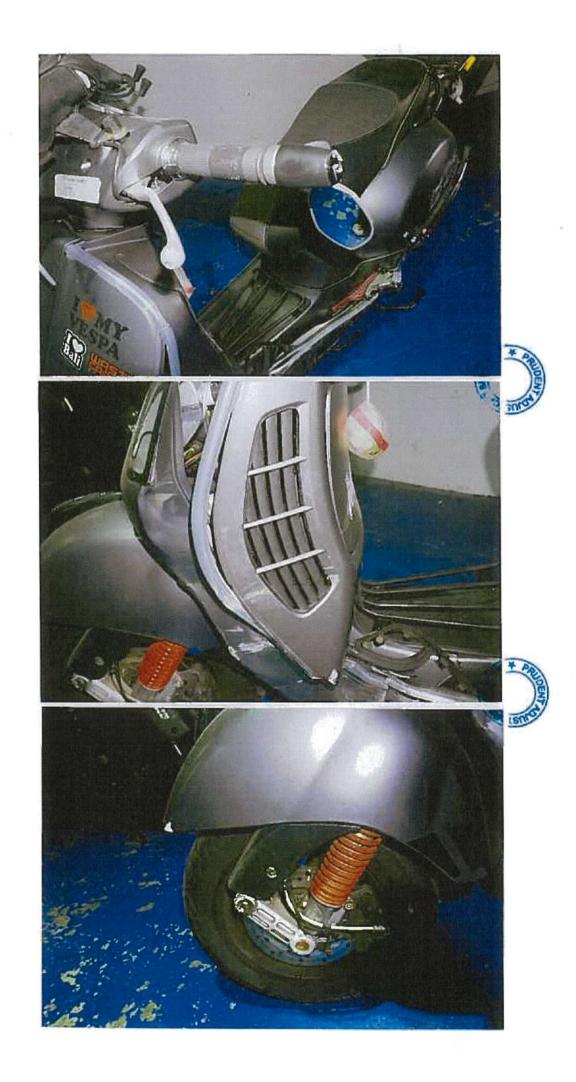
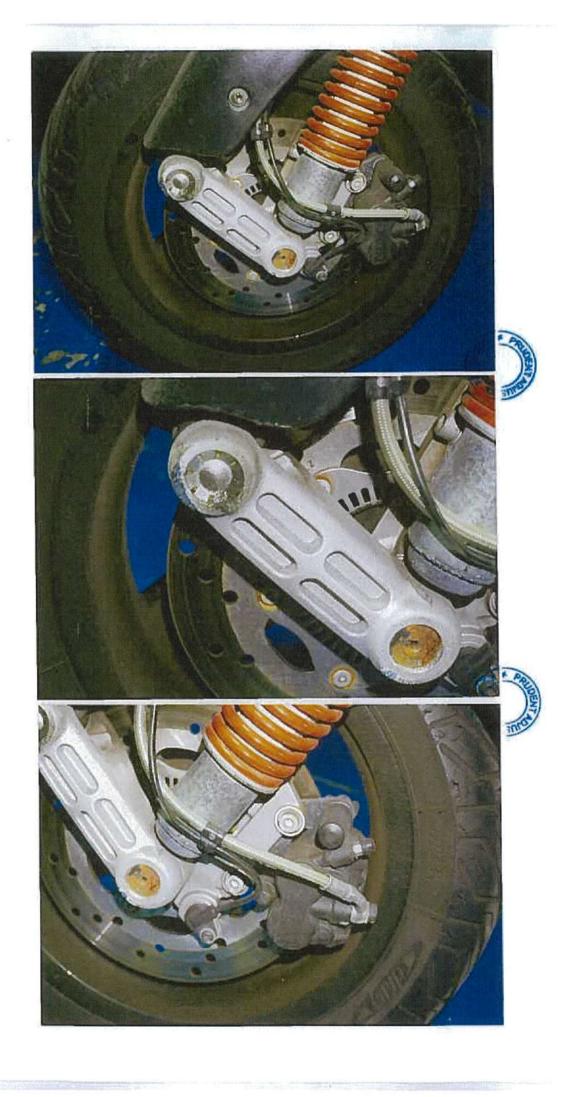
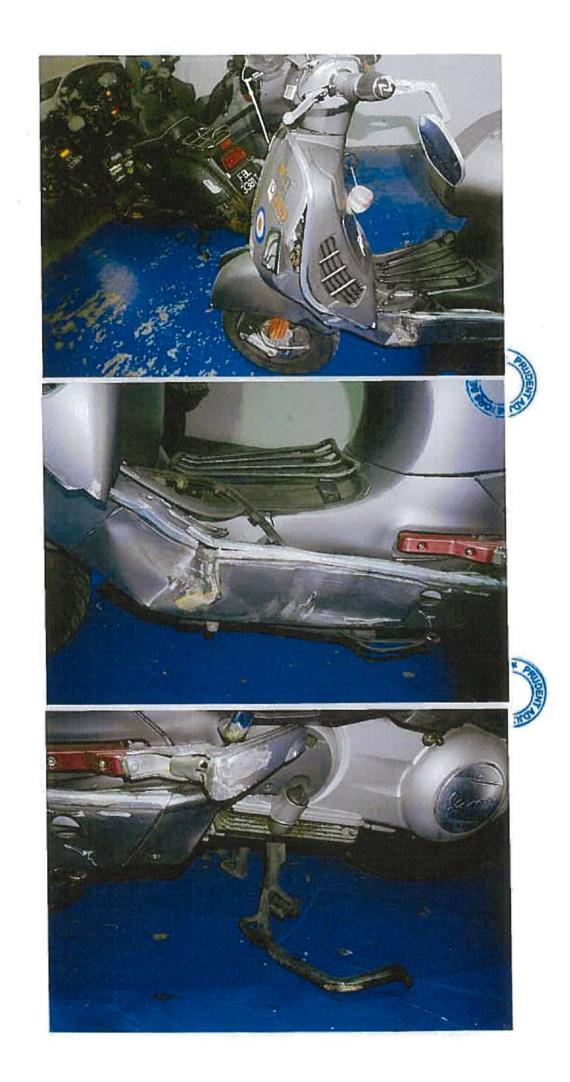
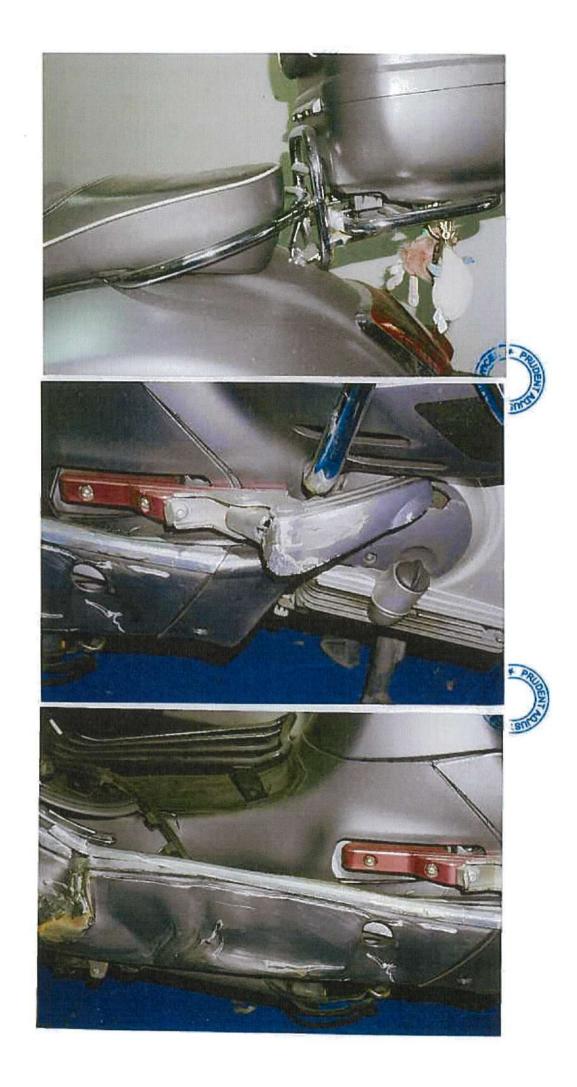
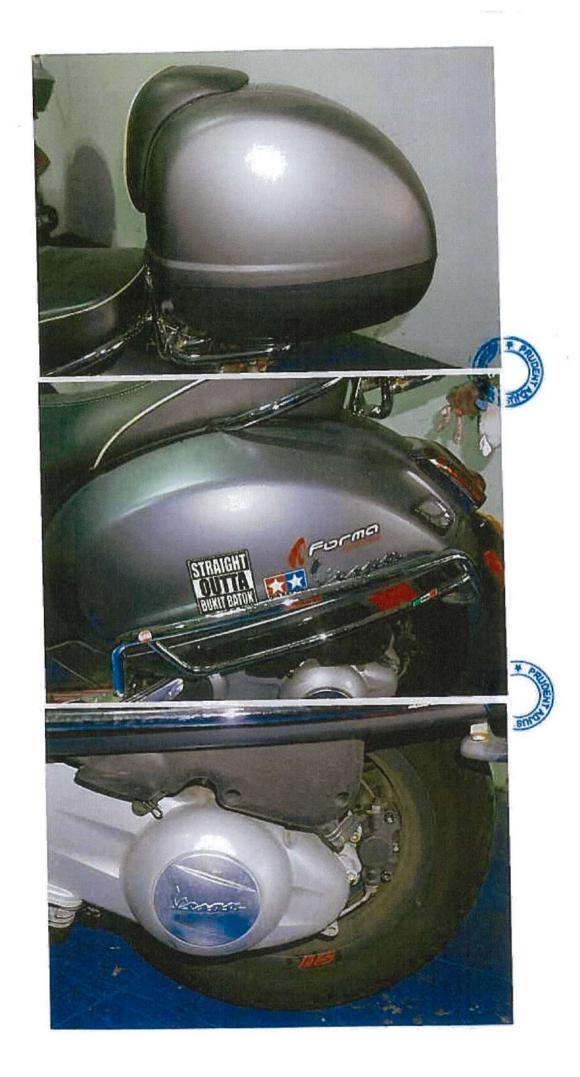
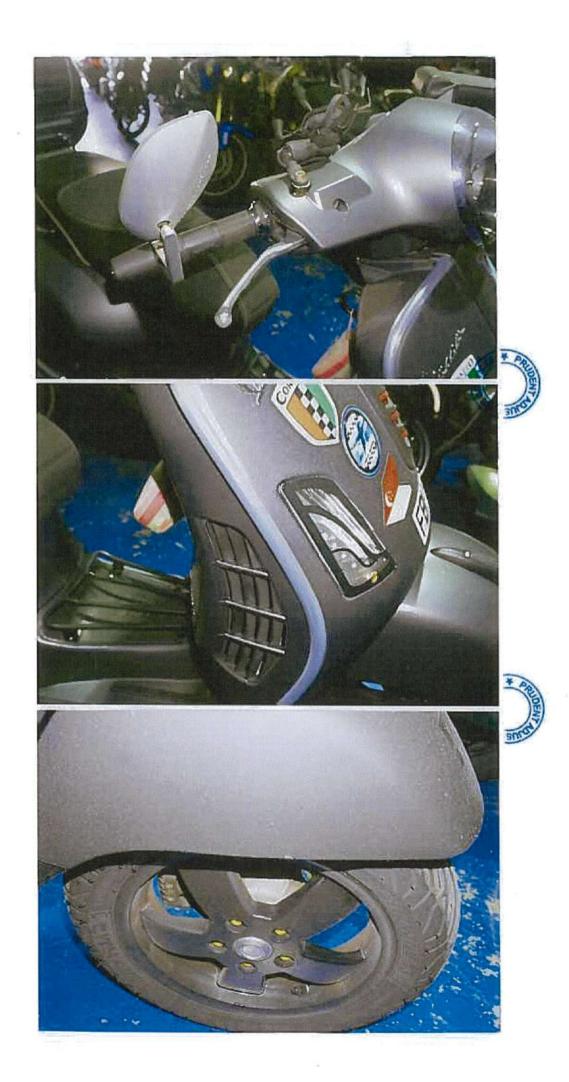
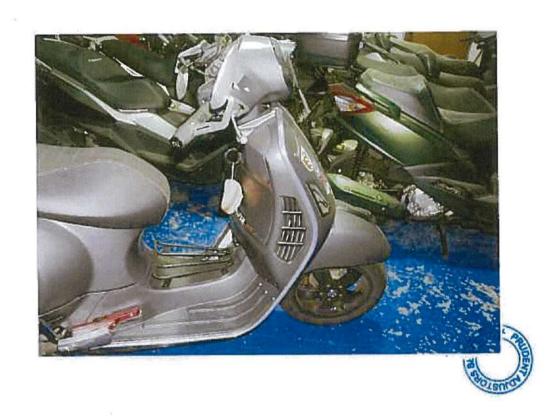
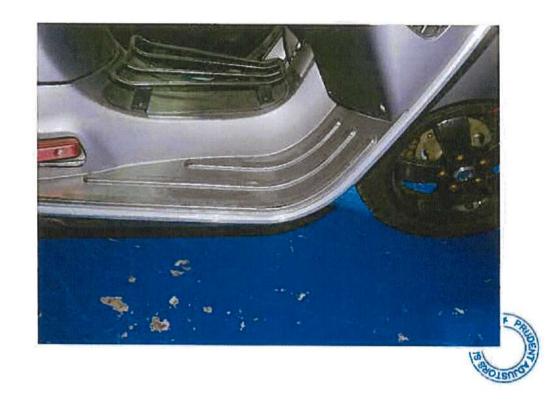
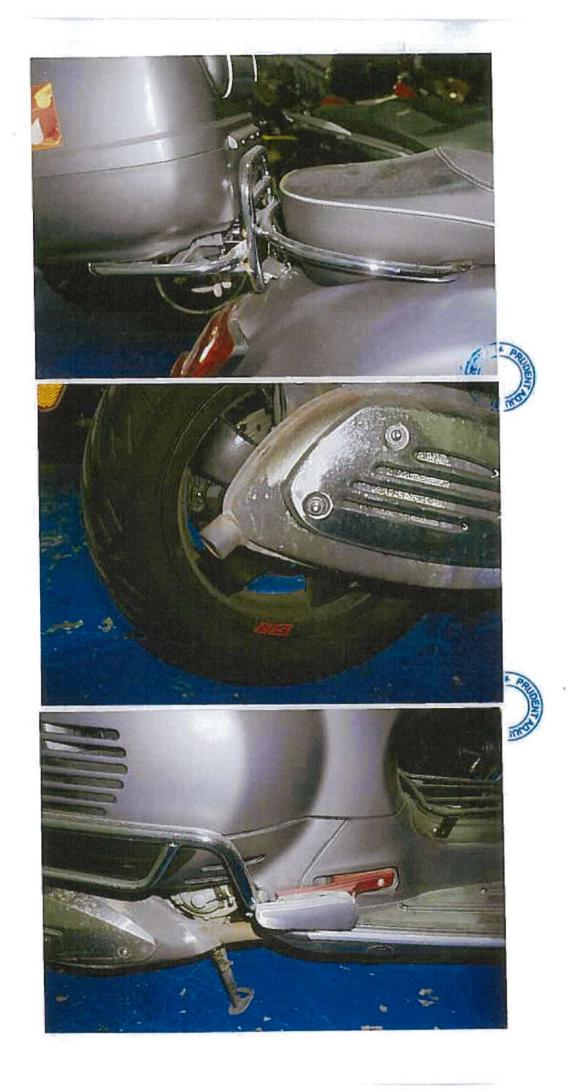
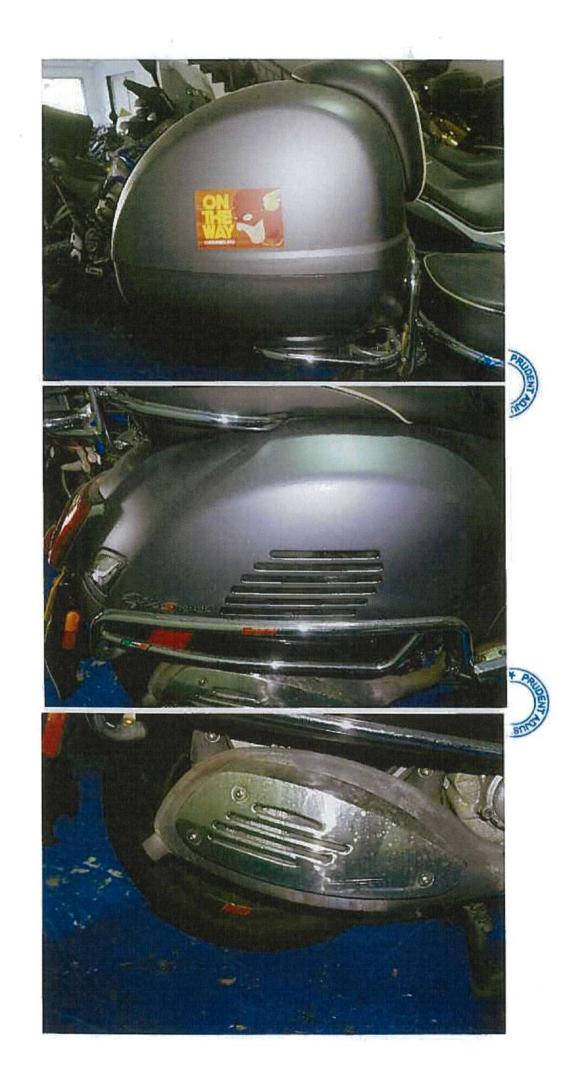
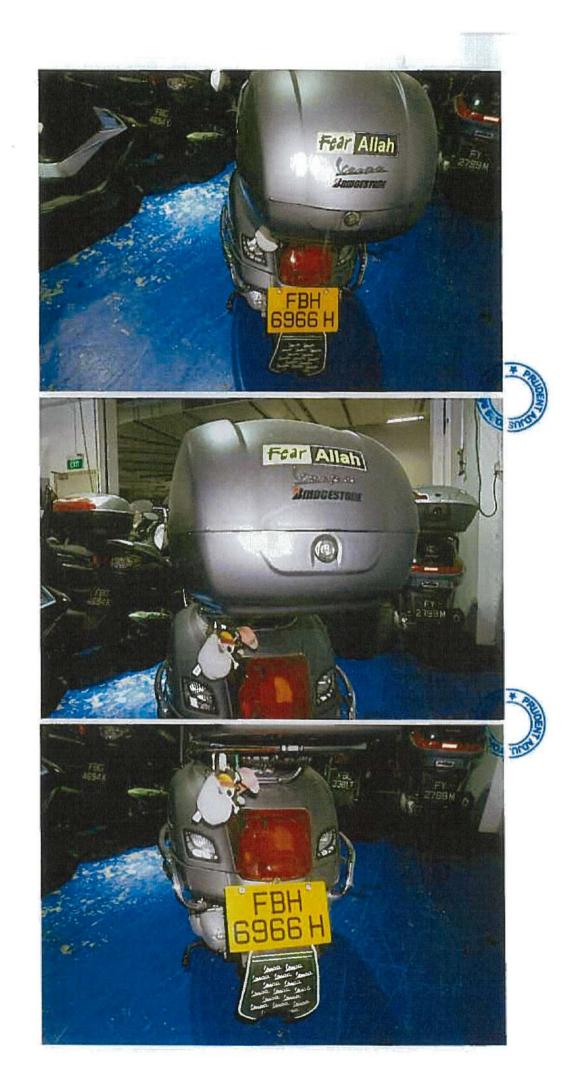
Enclosed (40) photographs depicting damage to the vehicle.

The Scooters sustained severe damage at all sides. Chassis frame badly distorted and damaged beyond repair. The Scooters was not able to restore to road worthy condition.

The Scooters was rendered not safe to repair. Hence recommended as Total Loss.
