SINGAPORE ACCIDENT STATEMENT

Report No: 0041-21-HLm

ACCIDENT VEHICLE SURVEY REPORT

Vehicle Reg No.:	SGD5595M	Odometer:	105589km
Make & Model:	Mazda 6 4-Door Sedan 2.5L	Colour:	Black
Chassis number:	JM6GJ1031F0147273	Date of accident:	12/03/2021
Year of Regn.:	12/02/2015	Date inspected:	15/03/2021
Repairer at:	Hiap Lek Automobile Trading	Date inspected (After Repair):	20/03/2021
	160 Sin Ming Drive #05-17 Sin Ming Autocity		
	Singapore 575722

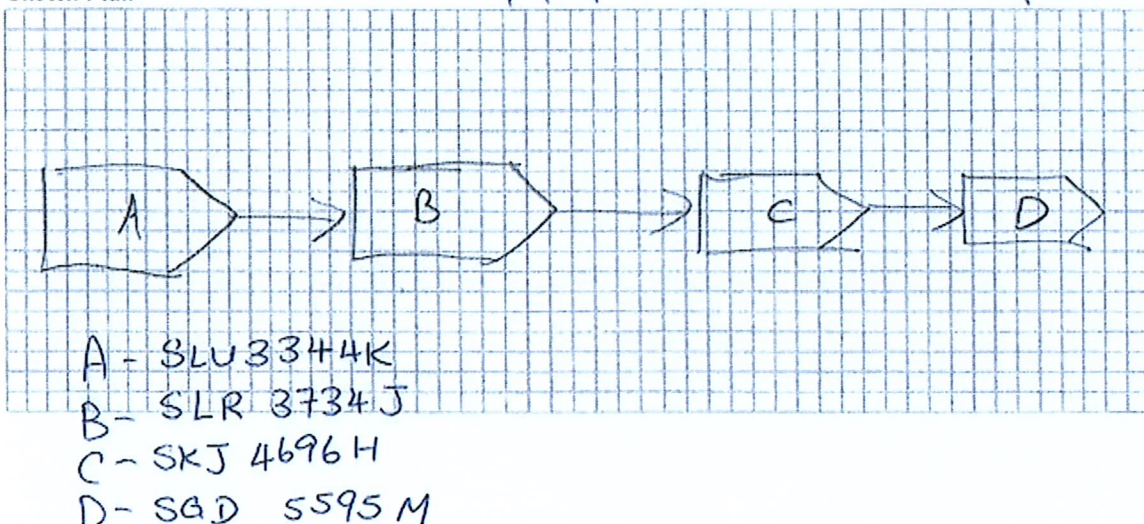
Sketch Plan

I was travelling along PIE towards Changi (Location: 24.2km
Car in front jam brake and I also jam brake, and ~~collided~~
collided into the car in front.

I came out of the car and realized it was a 4
car collision.

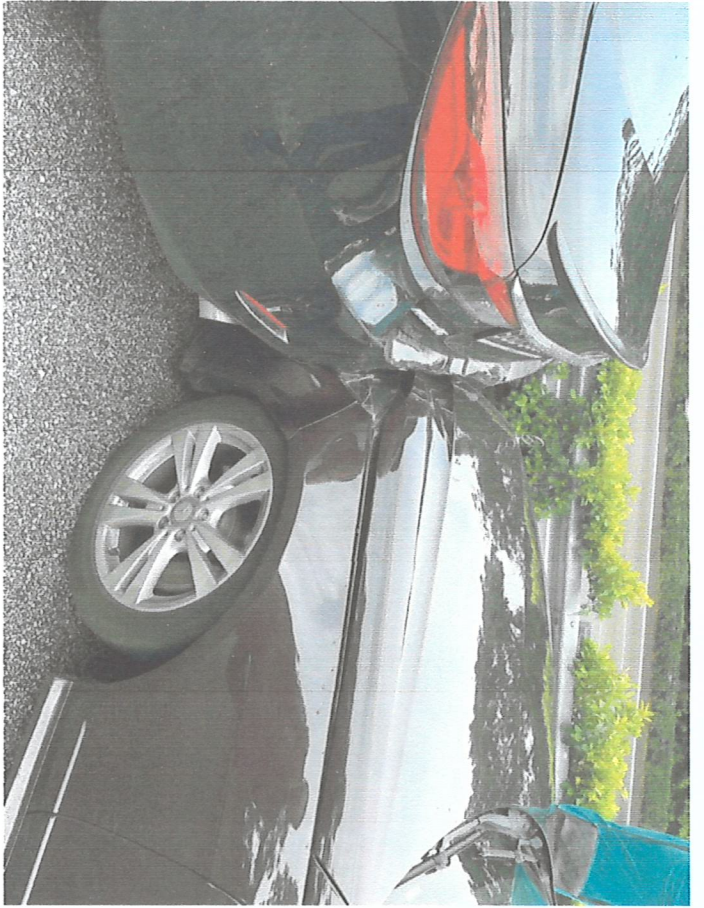
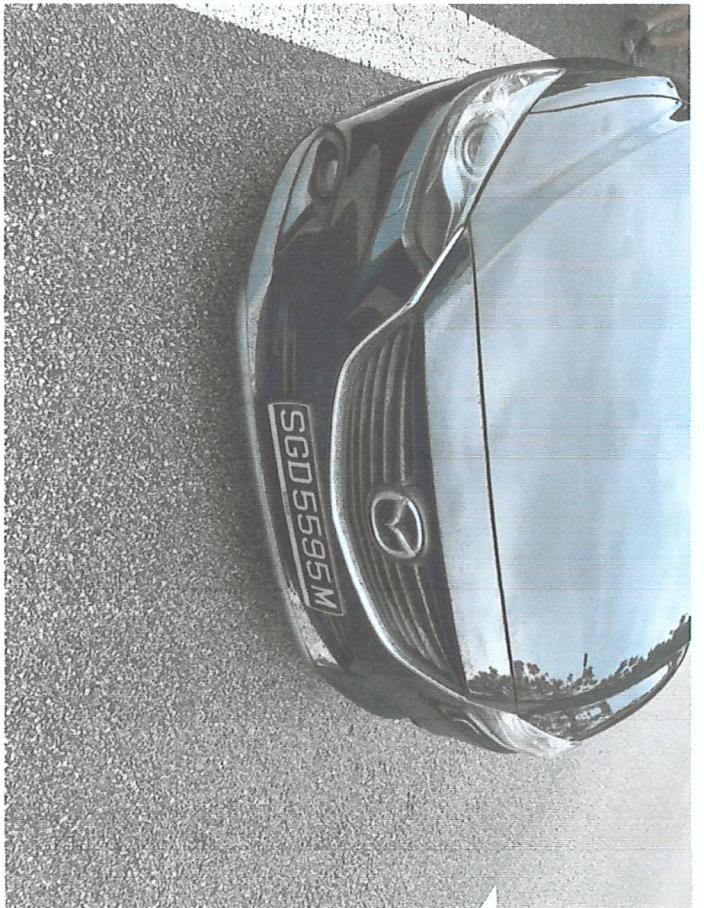
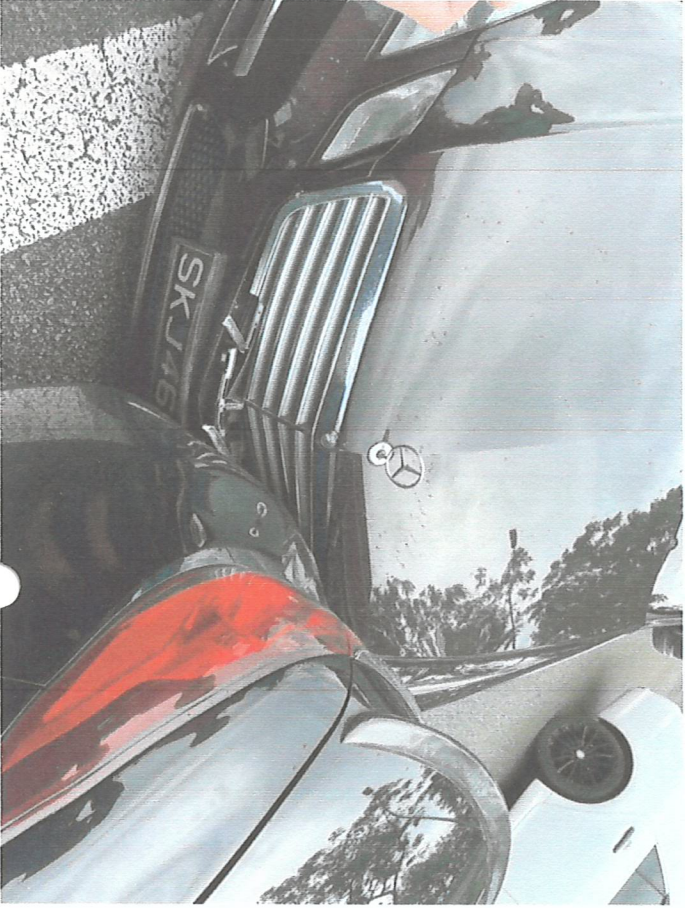
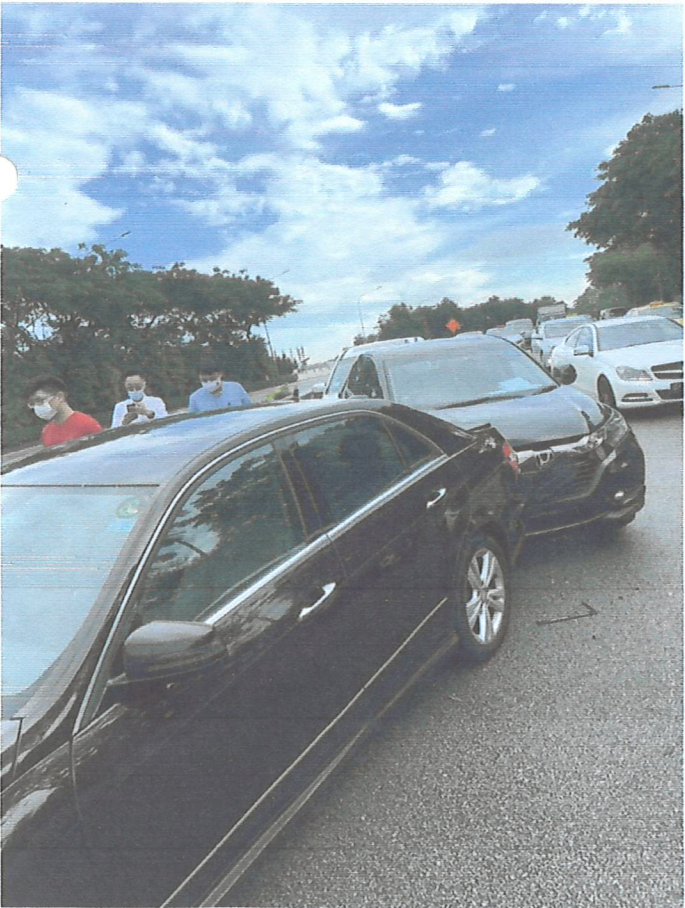
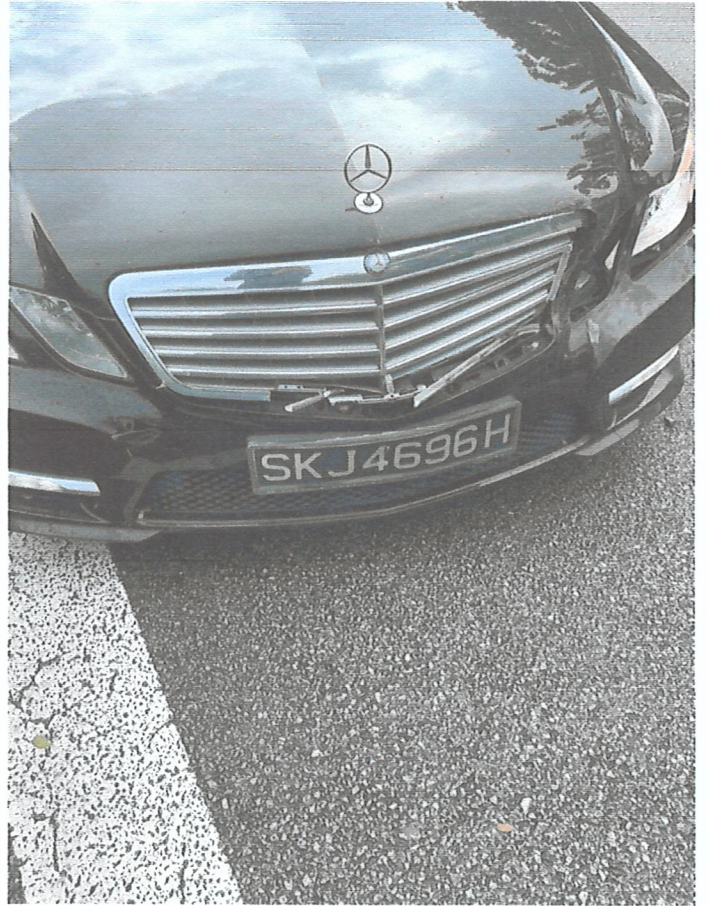
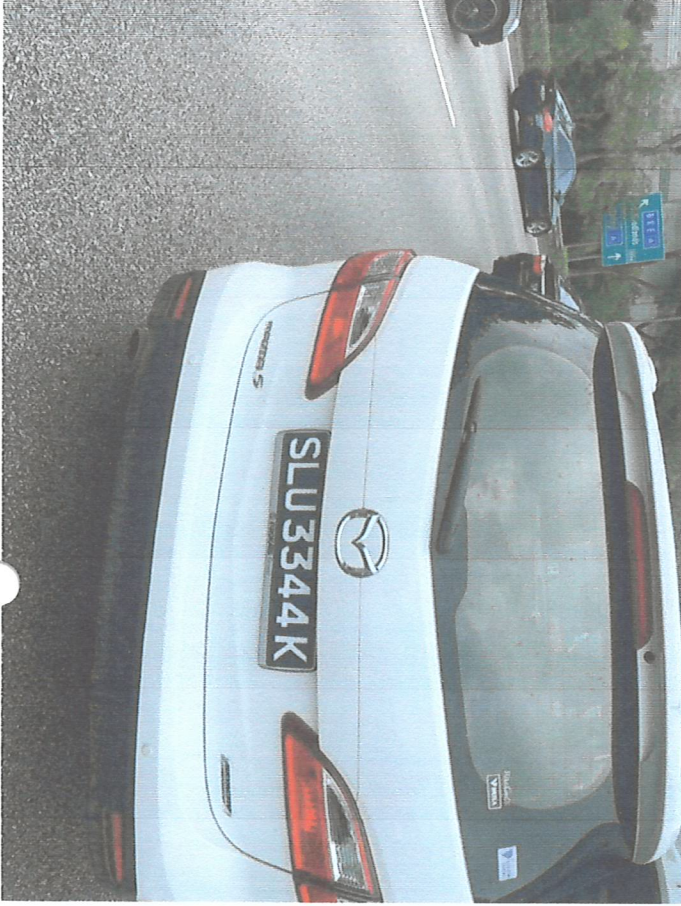
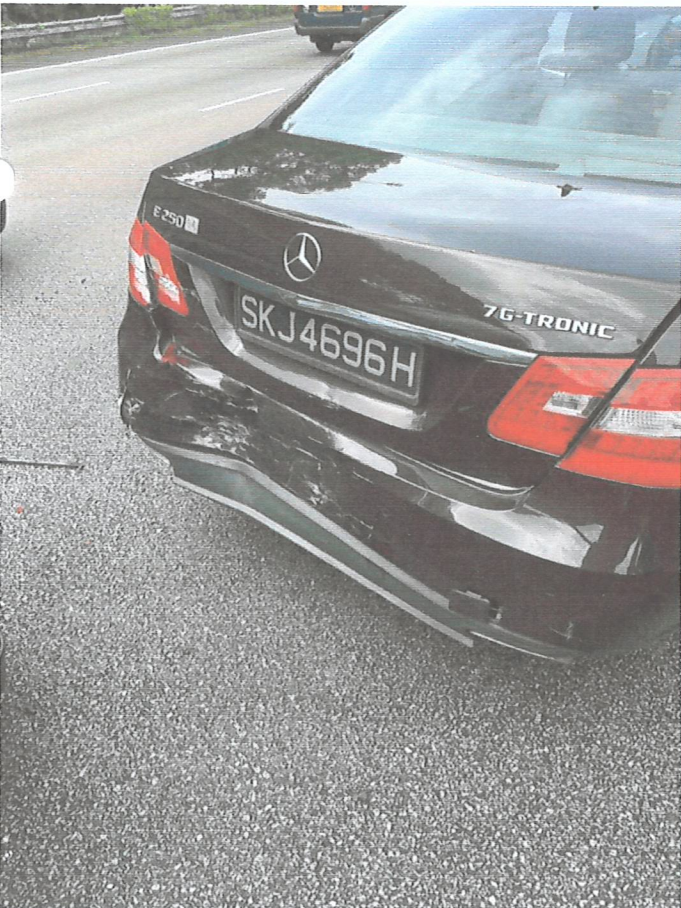
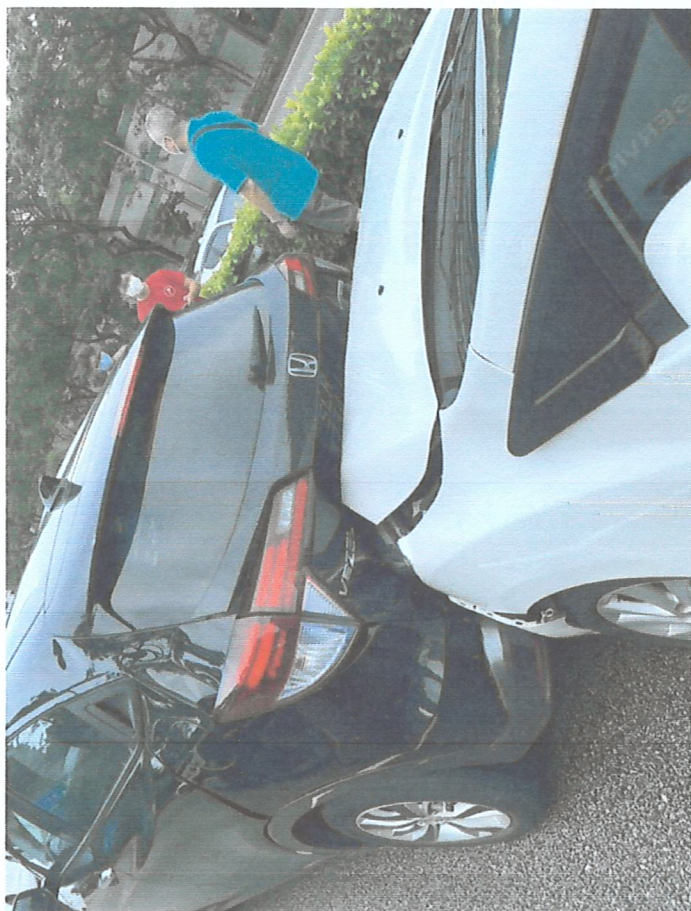
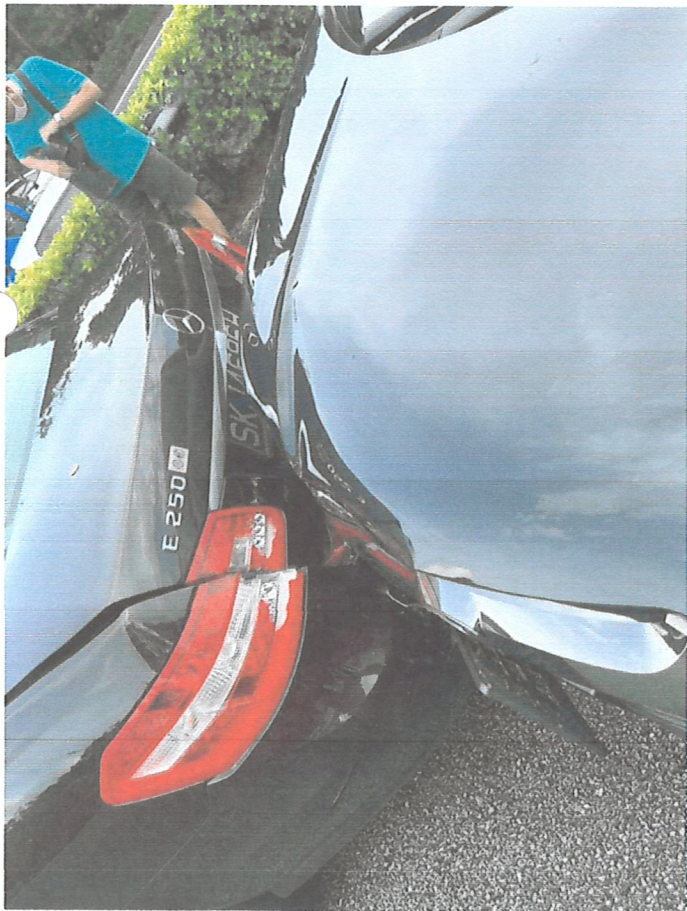
Impact on the rear portion.

Description of part	Qty	Condition as inspected	Repairer's estimate	Our adjustment
Rear boot lid	1	buckled	1,062.00	1,062.00
Rear boot lid hinges	2	repair	296.60	0.00
Rear boot lid emblem 'Mazda' logo	1	necessary	47.00	47.00
Rear boot lid chrome moulding	1	fractured	288.00	288.00
Rear boot lid lamp RH/LH	2	fractured	1,466.00	1,466.00
Rear boot lid opener switch	1	shorted	139.00	139.00
Rear boot lid number plate lamp RH/LH	2	fractured	80.00	80.00
Rear boot lid emblem '6'	1	necessary	36.00	36.00
Rear boot lid emblem 'Skyactiv Technology'	1	necessary	72.00	72.00
Rear boot lid inner lock	1	bent	153.00	153.00
Rear boot lid lock striker	1	bent	34.00	34.00
Rear boot lid upholstery trim	1	deformed	173.00	173.00
Rear boot lid upholstery trim clip	10	necessary	84.50	84.50
Rear boot lid pull handle	1	deformed	16.00	16.00
Rear boot weatherstrip	1	deformed	130.00	130.00
Rear tail lamp RH/LH	2	fractured	3,032.80	3,032.80

Rear tail lamp gasket RH/LH	2	necessary	51.00	51.00
Rear bumper	1	squashed	1,173.00	1,173.00
Rear bumper parking sensor	4	shorted	814.40	814.40
Rear bumper parking sensor holder	4	necessary	64.00	64.00
Rear bumper parking sensor wire harness	1	shorted	135.00	135.00
Rear bumper reflector RH/LH	2	fractured	102.00	102.00
Rear bumper reinforcement	1	bent	513.00	513.00
Rear bumper side retainer RH/LH	2	necessary	78.00	78.00
Rear bumper clip	10	necessary	40.00	40.00
Rear end panel	1	buckled	667.00	667.00
Rear end panel top garnish	1	deformed	117.00	117.00
Rear fender upholstery trim RH/LH	2	deformed	590.00	590.00
Rear boot floor panel	1	repair	1,517.80	0.00
Rear boot floor top cover board	1	deformed	563.00	563.00
Rear boot floor tool sponge	1	deformed	325.00	325.00
Rear spare tyre panel sponge	1	deformed	98.00	98.00
Rear spare tyre retainer lock	1	bent	32.00	32.00
Rear end panel sensor antenna	1	shorted	106.00	106.00

Distronic sensor radar RH/LH	2	shorted	4,251.60	4,251.60
Rear exhaust pipe	1	bent	1,746.00	1,746.00

Rear exhaust pipe rubber mounting	4	deformed	136.00	136.00
Rear exhaust pipe gasket	1	necessary	25.00	25.00
<i>Subtotal before discount</i>			20,254.70	18,440.30
<i>Percentage discount</i>	0%	<i>and 20%</i>	0.00	3,688.06
Parts-total			20,254.70	14,752.24

1. To straighten and panel beating rear RH/LH fender, rear boot floor panel and rear frame members. To cut/weld rear end panel. To remove and refit above parts.	1,500.00	1,250.00
2. To putty, re-spray painting and polish affected areas.	1,800.00	1,320.00
3. To check and rectify wiring system.	80.00	50.00
4. To rust proof affected areas.	120.00	60.00
5. To remove and refit rear exhaust pipe.	200.00	150.00
Labour total	3,700.00	2,830.00
Parts & Labour total	23,954.70	17,582.24

Hence, the recommended cost of repairs based on LUMP SUM repairs is : **\$14,000.00**
 and the recommended number of working days for the repairs is : **8**
