Vehicle No. GBH 4288U  
Insured Veh. GBB 6764E  
Claim No. 20/21/21/VC05/024884  
Policy No. Z20VC05006251  
Accident Date 24/08/2021  
Inspection Date 26/08/2021

| Affiliated to Federation Internationale Des Experts En Automobile | | | | |
|---|---|---|---|--|
| <b>1. Policy Particulars :- THIRD PARTY CLAIM</b> | | | | |

## ADJUSTMENT ON REPAIR COST FOR VEHICLE NO. GBH 4288U

### PHOTOGRAPHS FOR VEHICLE NO. GBH 4288U

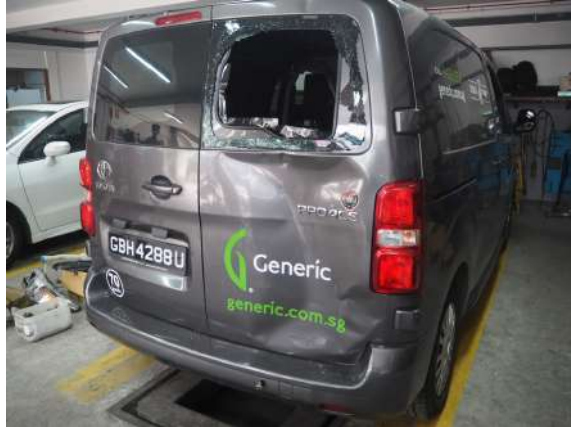
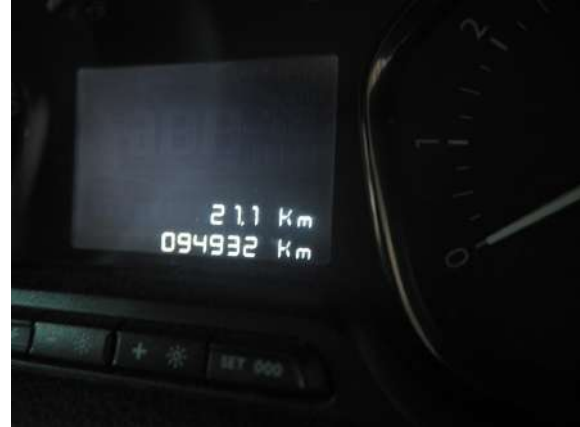
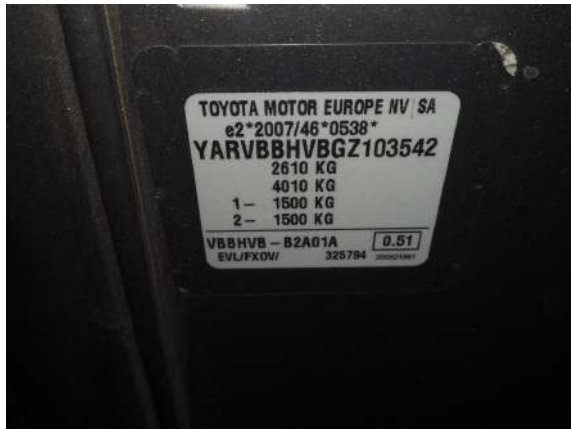
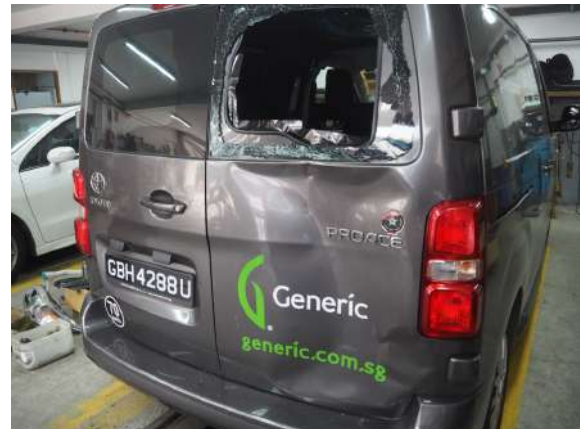
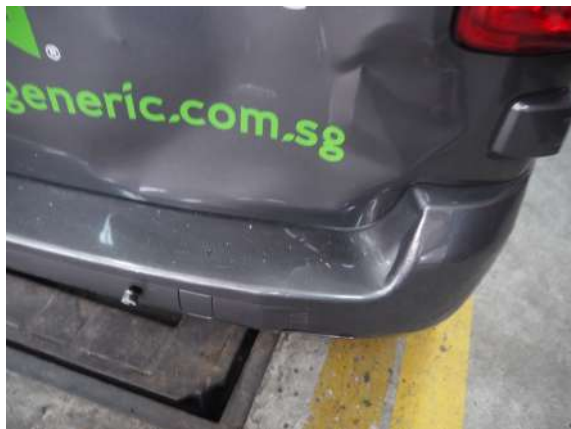
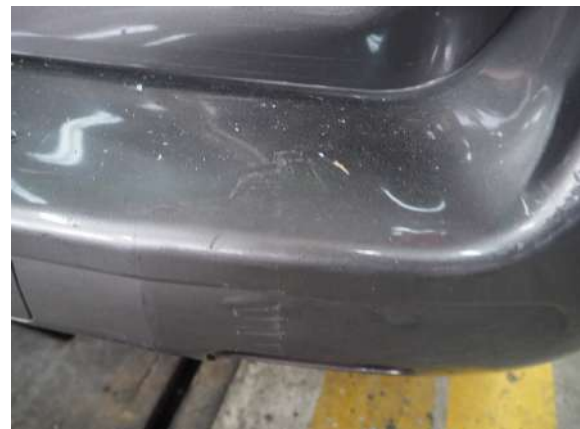
### INSPECTION

| Affiliated to Federation Internationale Des Experts En Automobile | | | | |
|---|---|---|---|--|
| THE VEHICLE SUSTAINED DAMAGES AT THE REAR PORTION.<br>DAMAGES SEE DETAILS. | | | | |

| Qty | Description of Parts | Condition | Estimate By Workshop (\$) | Our Adjusted (\$) |
|---|---|---|---|---|
| RECOMMENDED COST OF LUMP SUM REPAIRS (TO ITS PRE-ACCIDENT CONDITION) | | | | 4,500.00 |
