VEHICLE INSPECTION REPORT

TP/0027/09/2021

GBK 821R

Toyota 24 December 2019 23 December 2039 23 December 2029 Vehicle Model ; Hiace Van Turbo 5Dr MT Engine No. Chassis No.

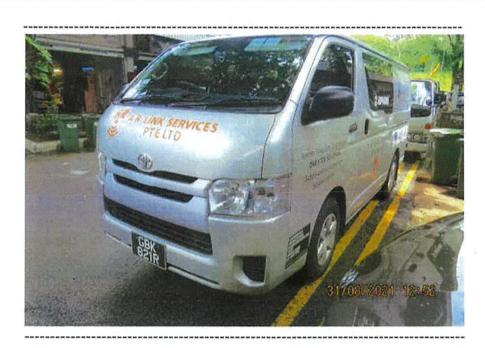
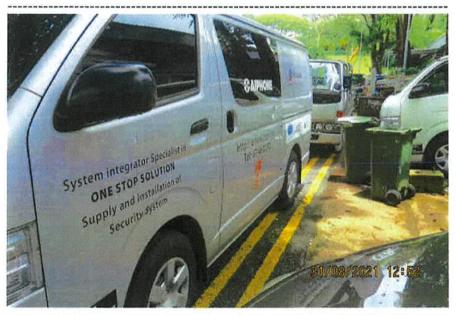
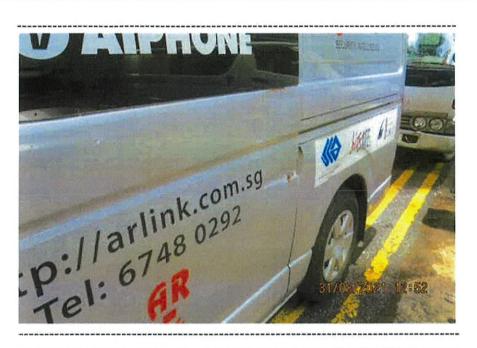
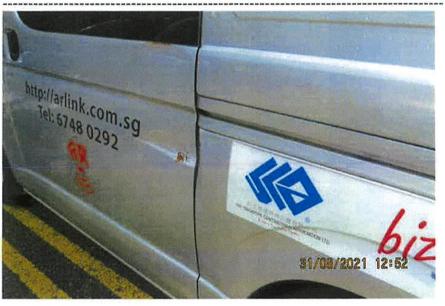
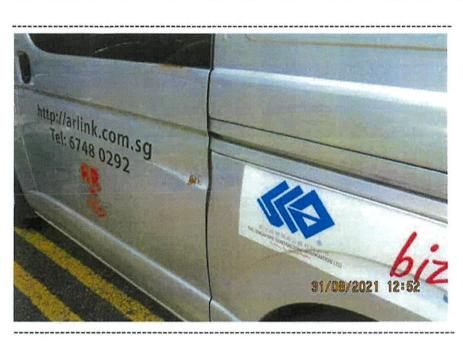
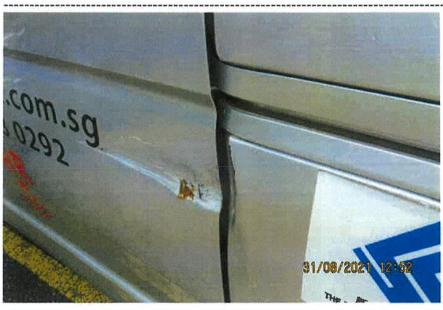
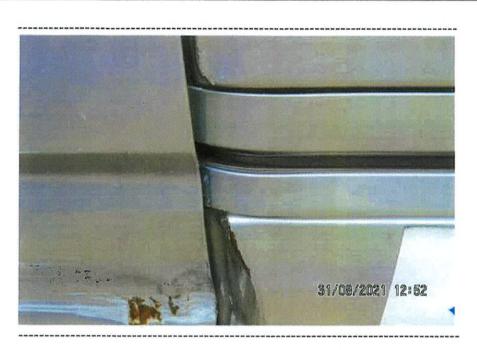
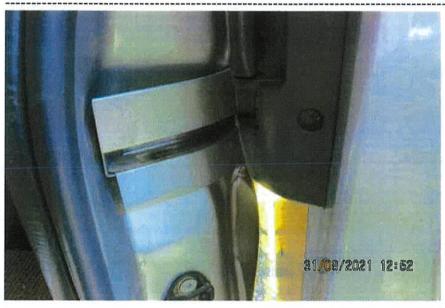
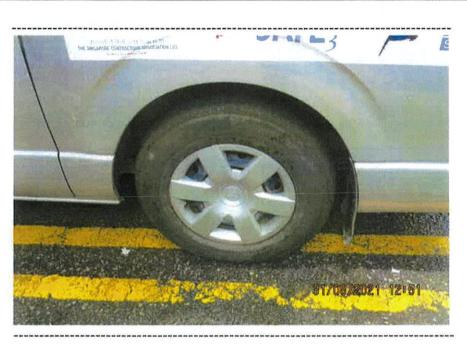
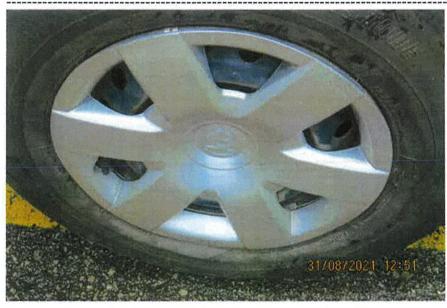
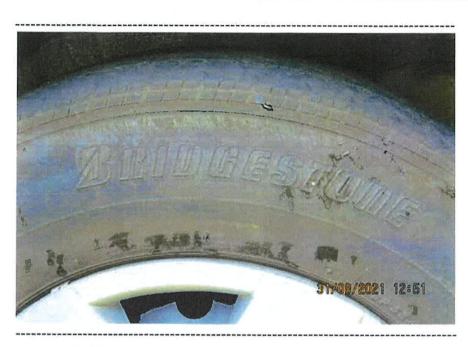
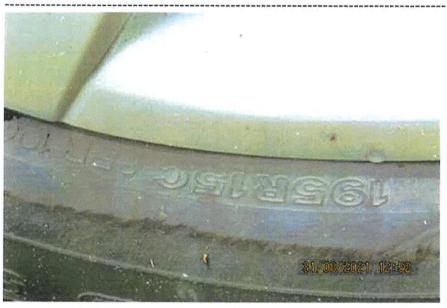
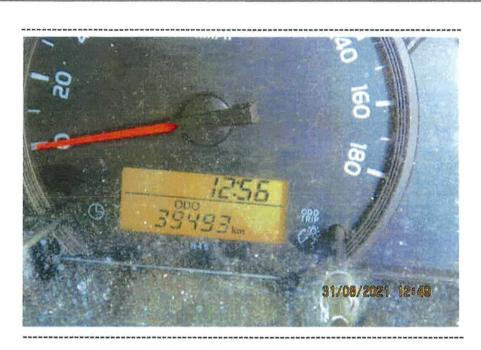
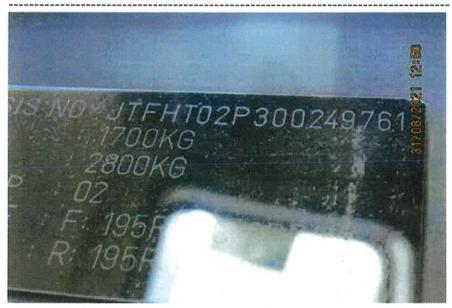
Photographs: SURVEYED PHOTOGRAPHS

The owner's vehicle sustained damages on the LH side portions.

REPAIRER'S ESTIMATE			OUR RECOMMENDATIONS		
Replacement Of Damaged Panels/Parts and Labour Charges		S\$ Price	Conditions	S\$ Price	
	REPLACEMENT OF DAMAGED PARTS	LESS 25%	LUMP SUM REPAIR	LESS 25%	
1.	1 pc LH sliding door 🗸	1,255.95	Dented/Bent - Allowable	1,255.95 🗸	
2.	1 pc LH body panel	1,063,95	Dented/Bent - Not Allowed	To repair	
3.	1 pc LH body panel sliding door rail 🗸	243,10	Dented/Bent - Allowable	243,10 🗸

04.	Labour charges - Spray painting	800.00	Necessary Reason being: 01. To respray paint on new LH sliding door, sliding door rail and LH body panel.	700.00 500

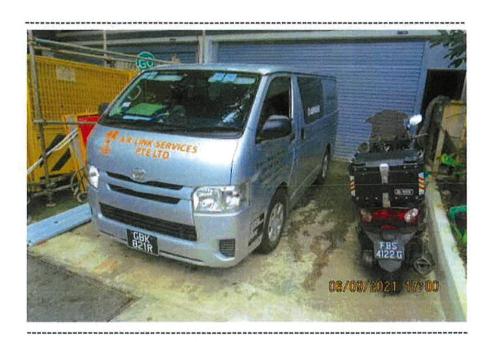
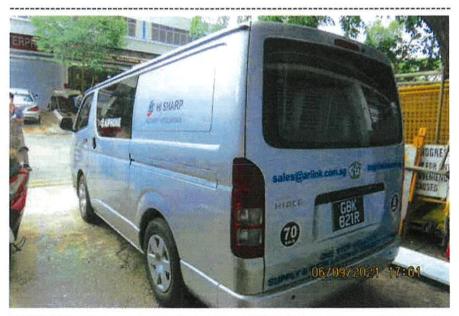
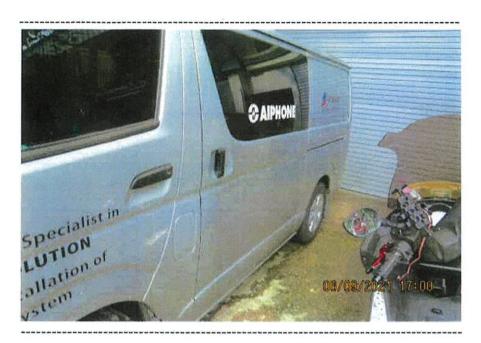
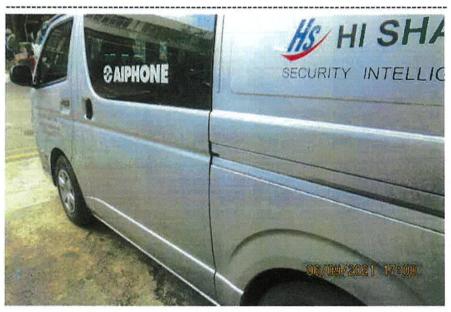
Photographs: FOLLOW-UP SURVEYED PHOTOGRAPHS Attachment to report no. TP/0027/09/2021

(After Repair/Spray Painting)

Repairer completed the repair in: 07 (Seven) days inclusive of Sunday and Public Holiday
