## ASSIGNMENT

To Inspect Vehicle No: SNA 96244

BMW 116d 5Dr

The U/C / Chassis frame / Body Structure affected due to collision.

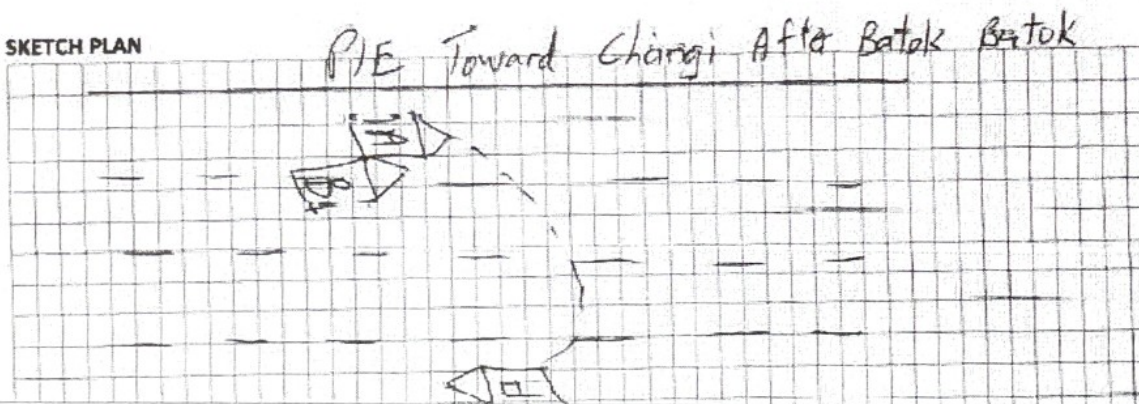
**SKETCH PLAN**

At mentioned Date and Time, I was  
 driving PIE Changi After Bukit Batok, suddenly  
 feel a strong impact from my right portion  
 and my vehicle spin and facing opposite  
 direction.

A: SNA 9642 U  
 B: XD 8106X
