YOUR REF / CLAIM NUMBER : MT/1043109-001
OUR REF : AVS2019-18867/SA
TP VEHICLE NO : FBN8491R
CLAIM TYPE : PRE-REPAIR SURVEY
DATE OF SURVEY : 07 May 2019

PRE-REPAIR SURVEY REPORT

Veh. No:	FBN8491R	Make/Model:	Yamaha 135
Colour:	Black	Engine No:	NA
Engine Capacity:	NA	Chassis No:	NA
Odometer:	NA	Reg. Date:	NA

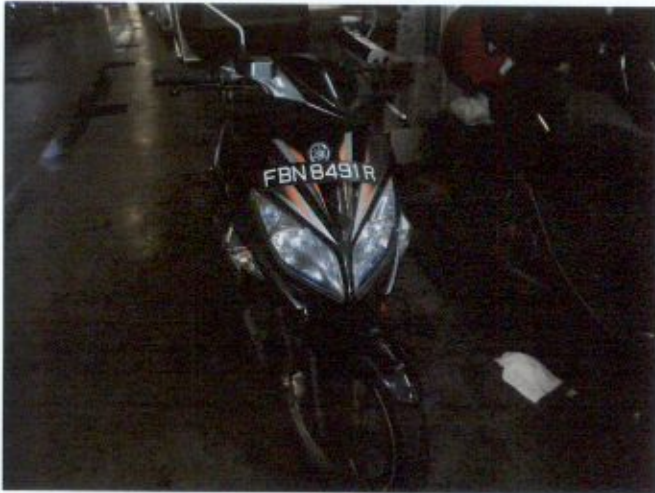
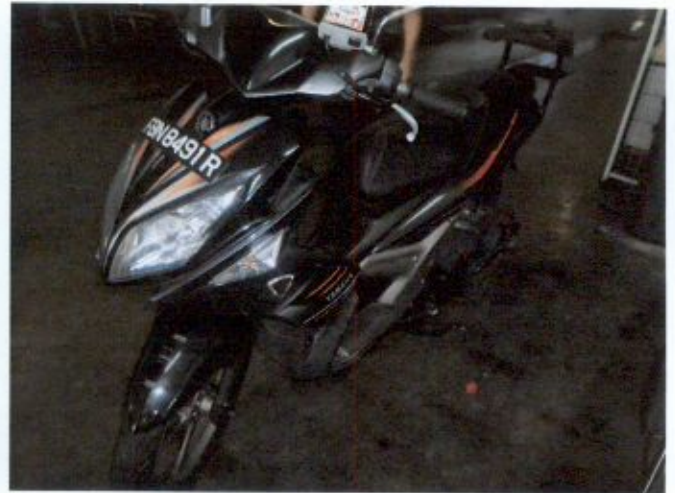
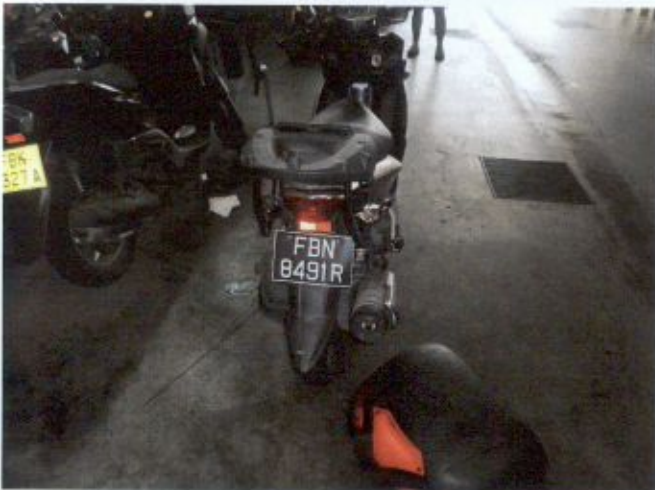
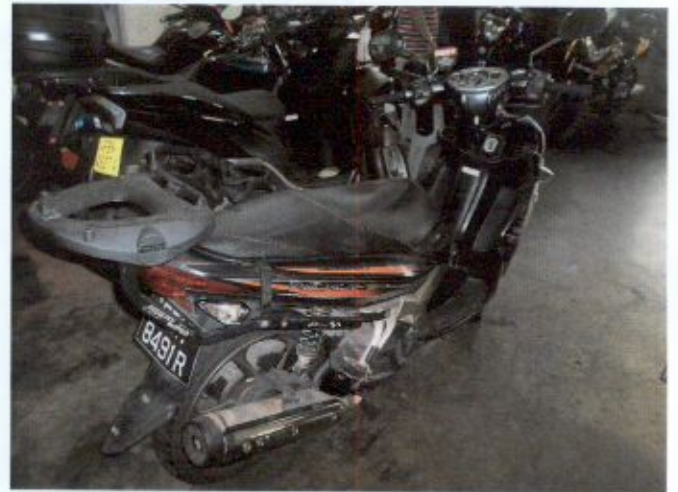
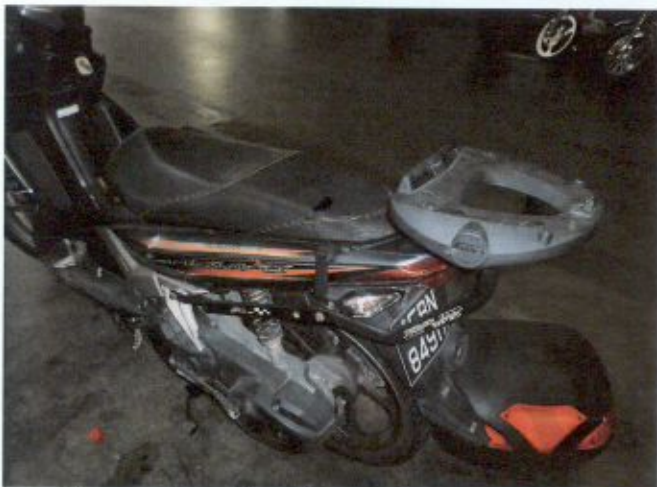
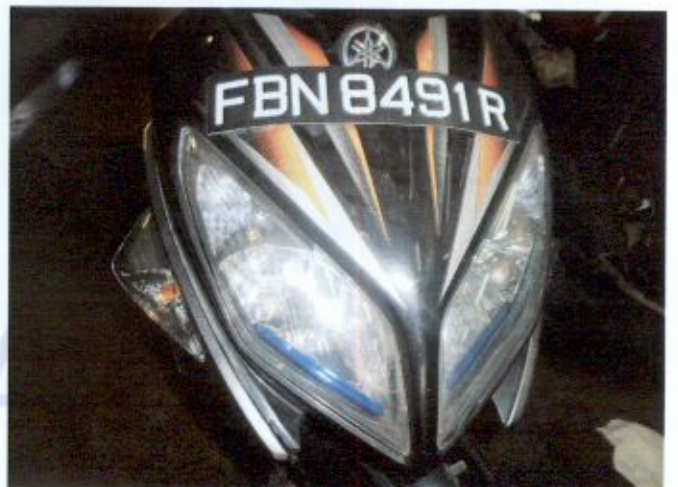
Pre-repair survey

The vehicle sustained damage on the left and right portions.

The box compartment, footrest, footrest bracket, clutch lever, centre console, mudguard, fork assy and sport rim were among the items affected.

Based on visual survey of the vehicle without any repair estimate provided, we viewed that the repair cost should not be more than S\$2,200.00 and could take approximately four (4) working days to complete.
